# AVIATION SAFETY DIGEST

DEPARTMENT OF CIVIL AVIATION

MARCH, 1966

# FIRE

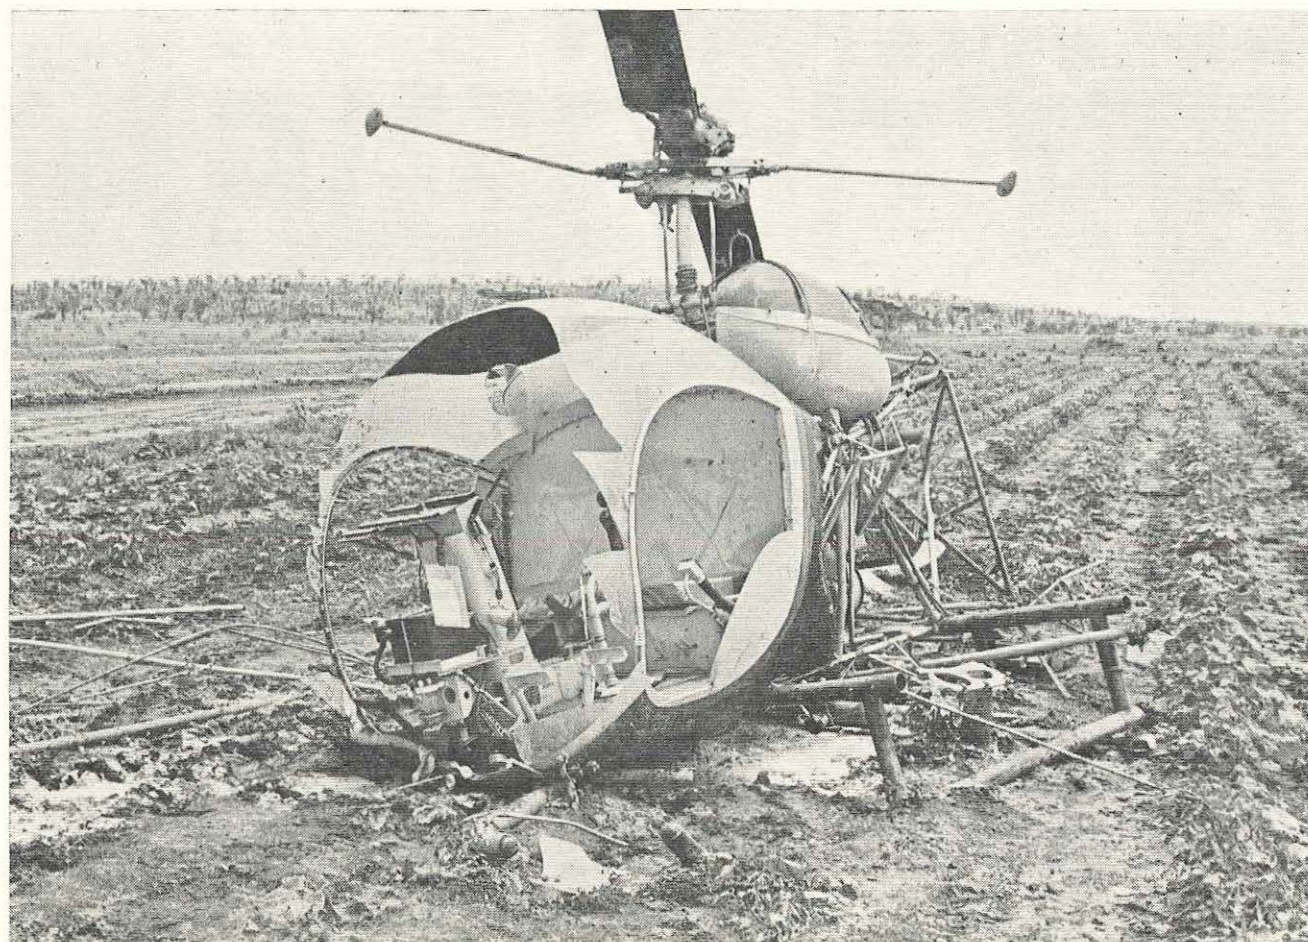
Investigation of the accident established that the engine failure had been caused by contamination of the fuel system by water. The contents of the main fuel filter, the fuel line from the filter to the carburettor and the carburettor itself, aggregating together about

a pint, were drained into a jar and were found to consist entirely of water. With the aircraft's fuel selector turned on, the fuel filter line was drained again and a further half pint of water was discharged before fuel began to flow. The amount of residual water in the fuel tanks could not be positively determined because one tank had been split open in the crash and the other was lying in a position from which the contents could not be readily drained. It was nevertheless clear that there had been sufficient water in the tanks to occupy all the unusable fuel space and to cover the base of the fuel line stand pipes.

*This picture was taken from where the helicopter landed for the first refuelling. The tender was parked as shown, and the refuelling hose was afterwards dragged back through the canal before being replaced on the vehicle.*

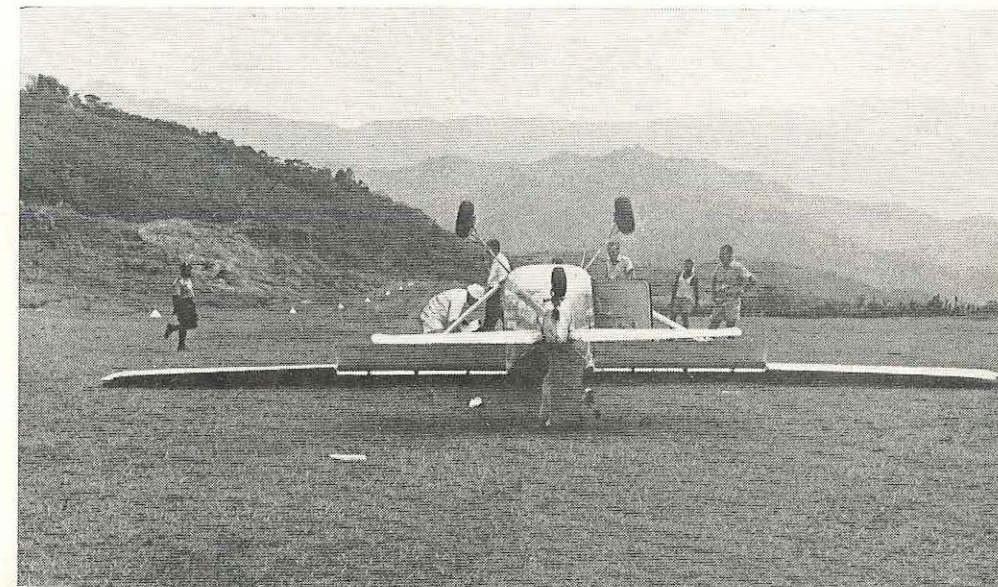
**Attempting to land at Tabibuga, a one-way airstrip in the New Guinea highlands, a Cessna 185 carrying freight for the nearby Patrol Post overshot and touched down too fast. The pilot braked heavily, the aircraft skidded for some distance then tipped over on its back. The aircraft was badly damaged, but the pilot was not injured.**

The approach technique that the pilot employed was in complete disregard of a company instruction requiring pilots to complete full circuits at non-controlled aerodromes, and was also a contraven-

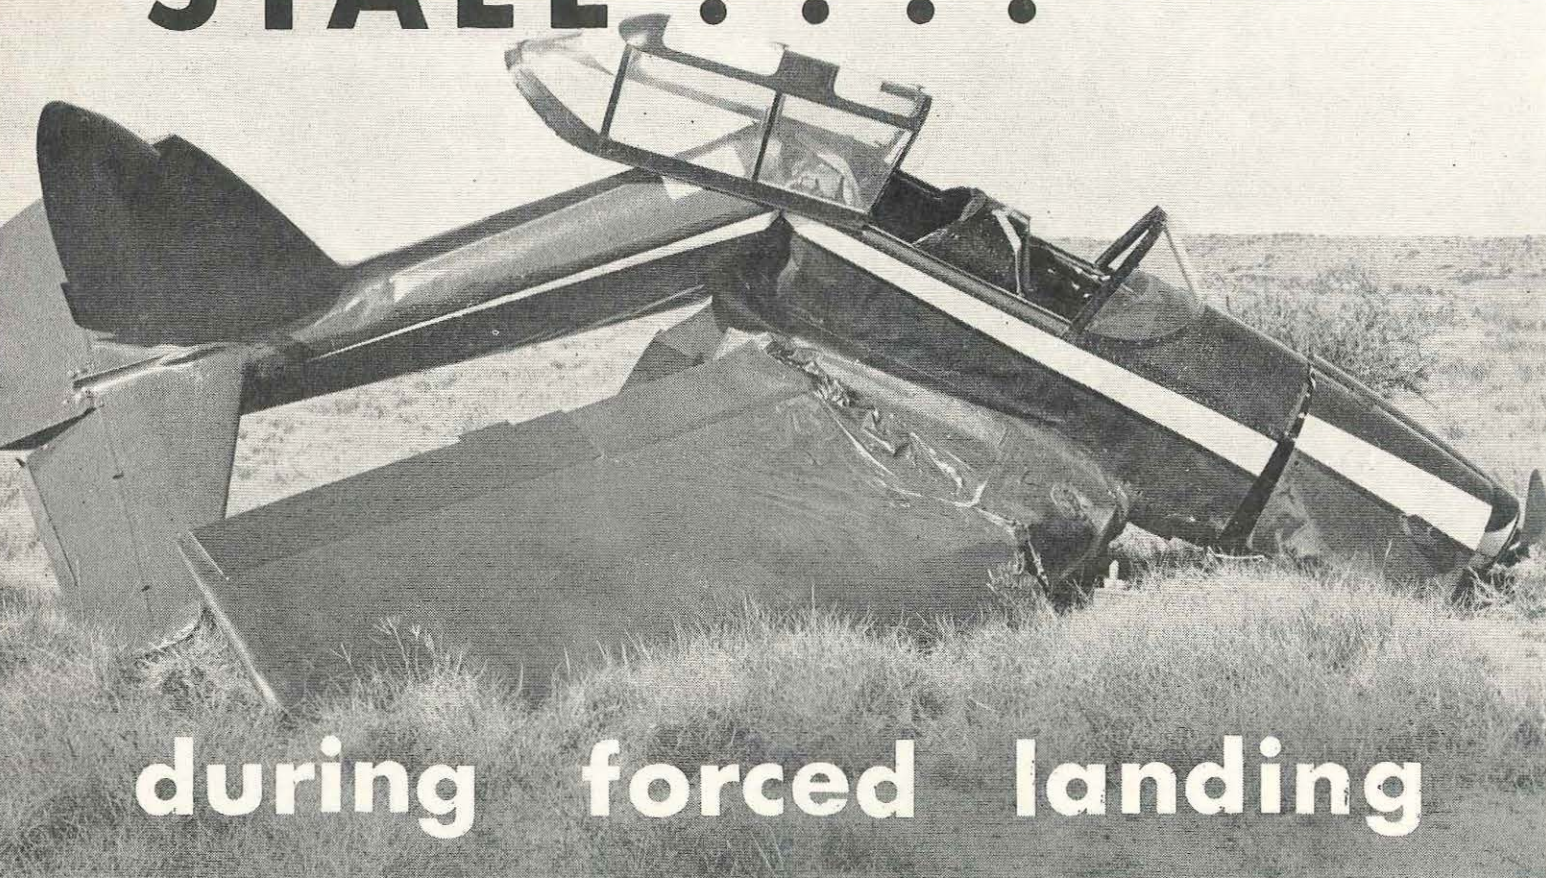
Soon after departing from a Western Australian cattle station for Carnarvon, Western Australia, a Chipmunk sustained a complete loss of engine power. During the ensuing forced landing approach, the pilot lost control and the aircraft nosedived into the ground. The Chipmunk was virtually destroyed but the pilot and passenger escaped with a shaking.

Investigation of the wreckage showed that the throttle linkage had failed when the throttle control rod connecting the carburettor to the cross shaft behind the engine became disconnected. The failure no doubt resulted from wear in the ball joint and consequent looseness of the fittings. The Maintenance Release for the aircraft, which was registered in the private category, had been issued fourteen months previously, and was valid for 100 hours' flying or twelve months, whichever occurred first. Although the aircraft had flown only 79 hours since the last inspec-

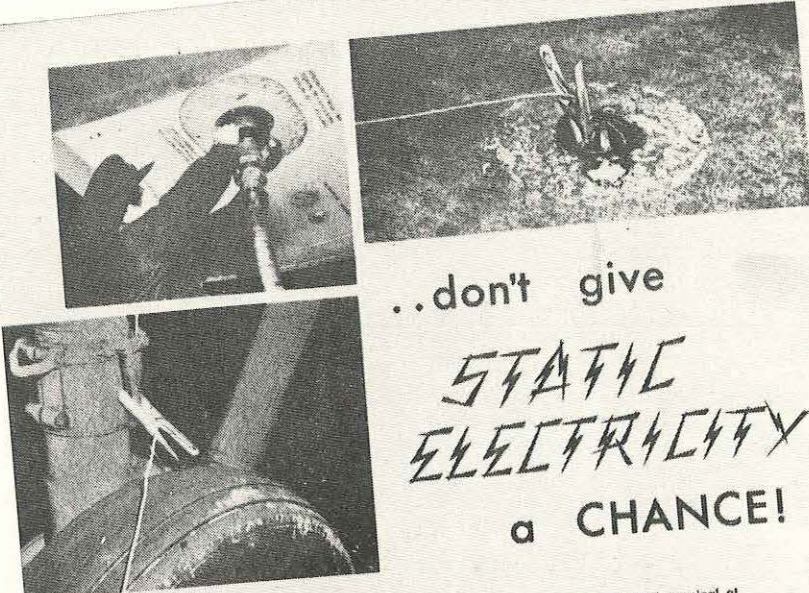
While an aircraft refuelling tanker was being filled at an oil company's bulk terminal of Fremantle, Western Australia, an explosion inflicted fatal injuries to the tanker driver who was conducting the loading. Though not strictly an aviation accident, its inclusion in the Digest is warranted by the obvious lessons that can be applied to aircraft refuelling practices.

The tanker, a semi-trailer unit with a carrying capacity of 6,000 gallons, was being loaded with aviation turbine fuel. On its previous trip the vehicle had carried a load of motor spirit. The vehicle tank comprised six separate compartments, four of which had already been filled to capacity. Compartments three and four in the centre section were being filled simultaneously from separate hoses. When about three-quarters full, vapour in the No. 3 compartment exploded, causing severe and extensive burns to the driver's head, arms and upper part of the body. The driver later died from his injuries. Weather conditions

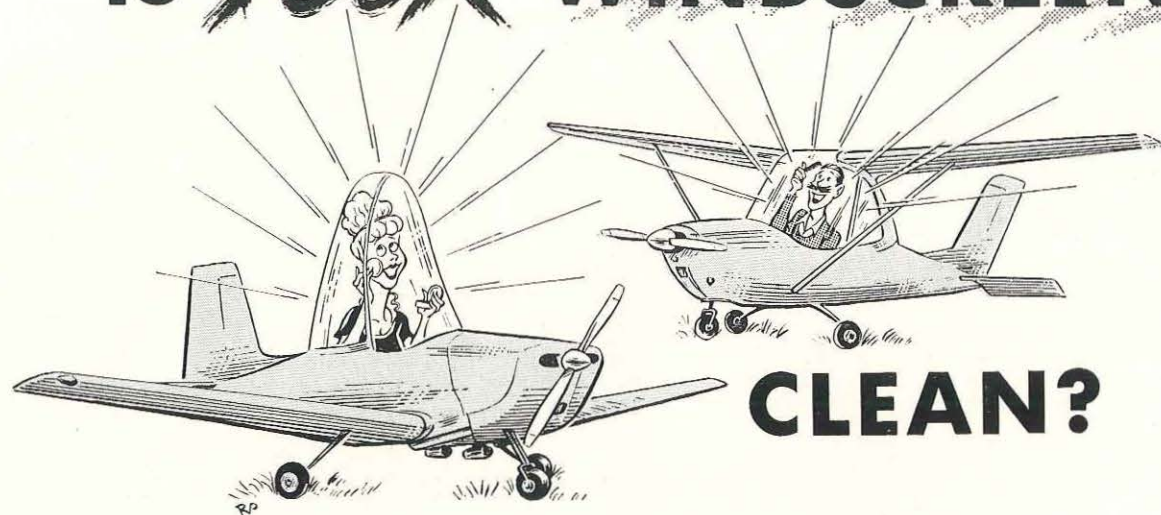
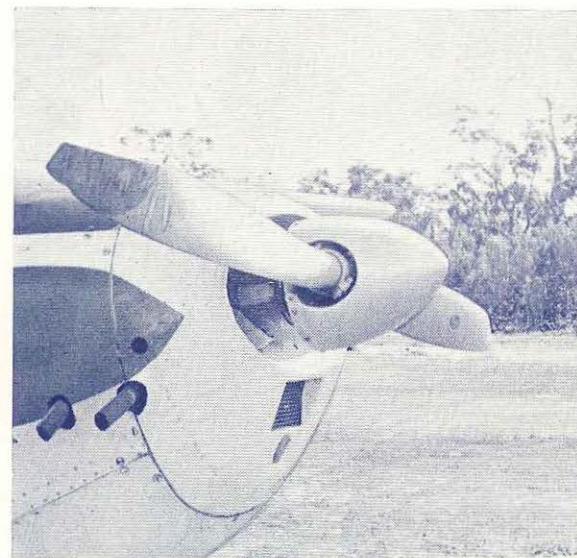
It was just after first light, at a country aerodrome in Western Australia, and the pilot of an EP-9 had carried out his daily inspection and climbed into the cockpit, ready to ferry the aircraft to an agricultural airstrip for top-dressing operations. He started the engine and let it warm and, after completing a satisfactory run-up, he released the brakes and began to taxi. The aircraft was facing into the east and the rising sun, low on the horizon, made visibility from the pilot's seat difficult. The aircraft had rolled only a few yards when the spinning propeller struck an empty 44-gallon drum that had been used for refuelling the night before. The pilot straight away switched off the engine and braked the aircraft to a stop, but both propeller blades were already damaged beyond repair.

*Below: After taxi-ing forward a few yards, this EP9 collided with a fuel drum, damaging its propeller. Even if the propeller had missed the drum, the aircraft would still have run into the refuelling equipment. Inset: The bent propeller. Both blades were damaged beyond repair.*
