AVIATION SAFETY DIGEST

DEPARTMENT OF CIVIL AVIATION

No. 52

SEPTEMBER, 1967

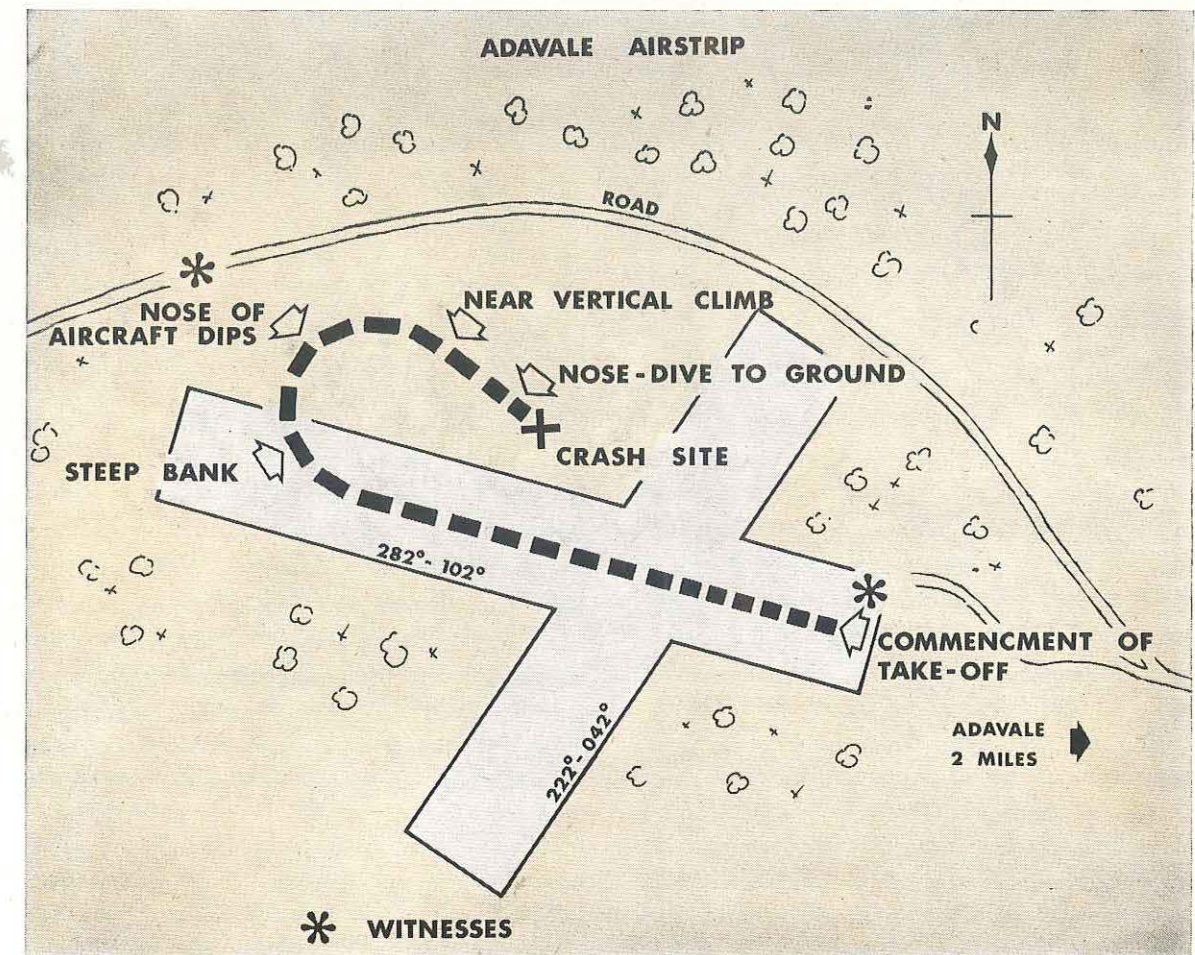
Plan of airstrip at Adavale showing direction of take-off, final flight path and position of witnesses.

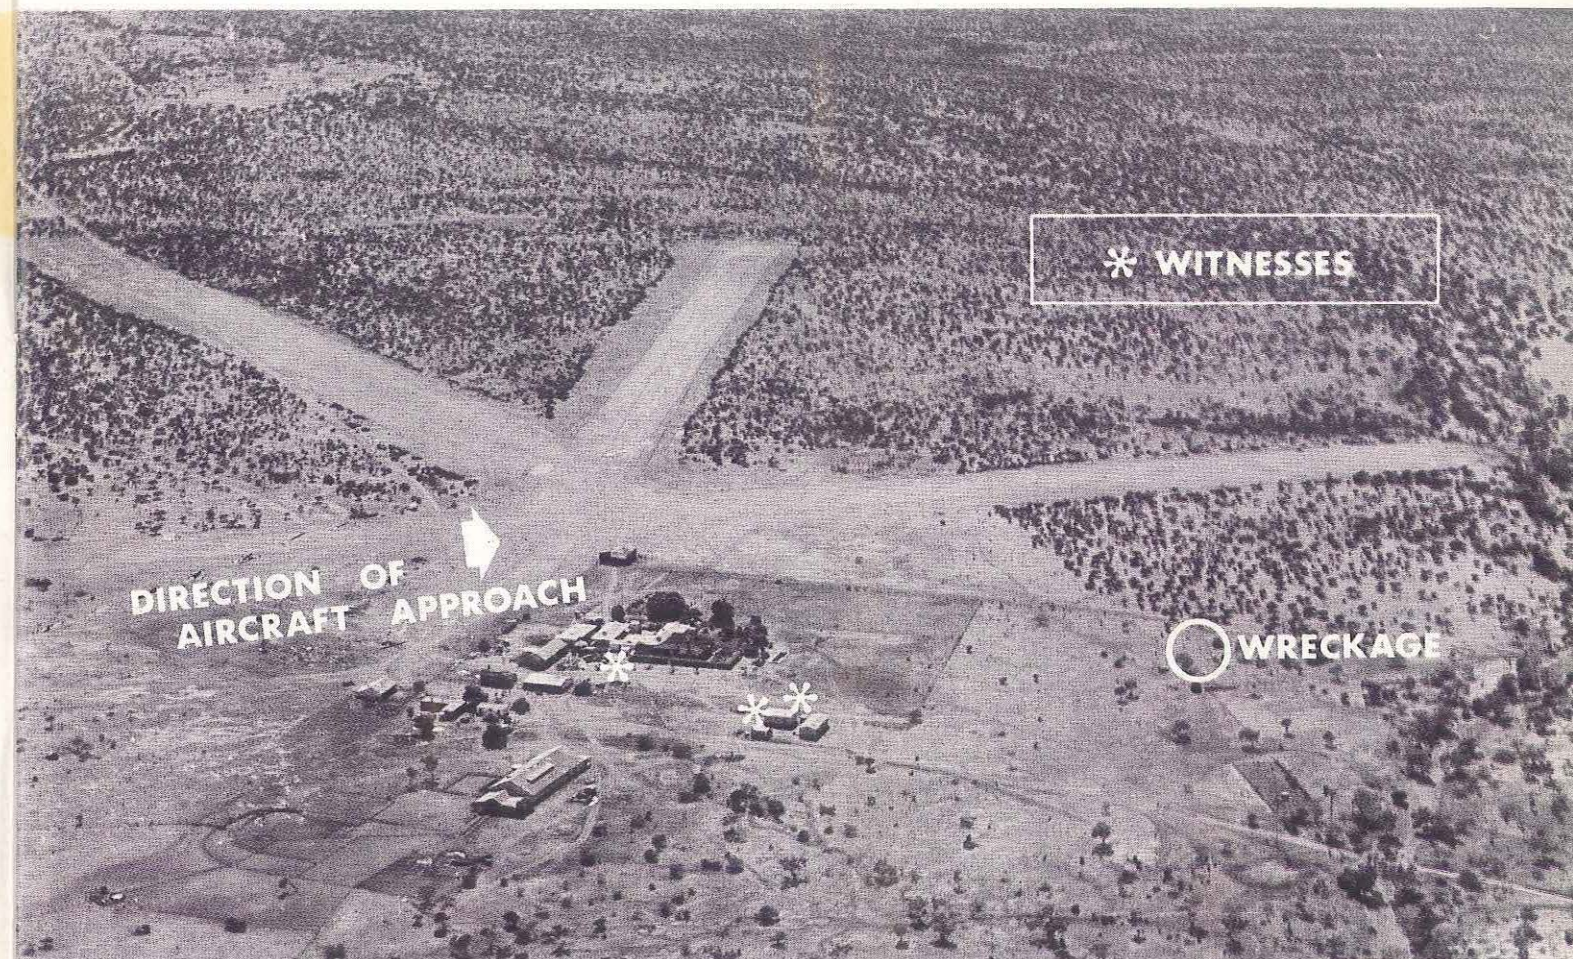
Examination of the wreckage showed that the aircraft had struck the ground nose-first while sharply banked to starboard. The aircraft had then cartwheeled for 100 feet and come to rest inverted. It was determined that no mechanical condition in the aircraft had contributed to the accident and there was no evidence of fuel contamination in the aircraft's fuel system.

Aerial view of station buildings and airstrip, showing positions of witnesses and accident site.

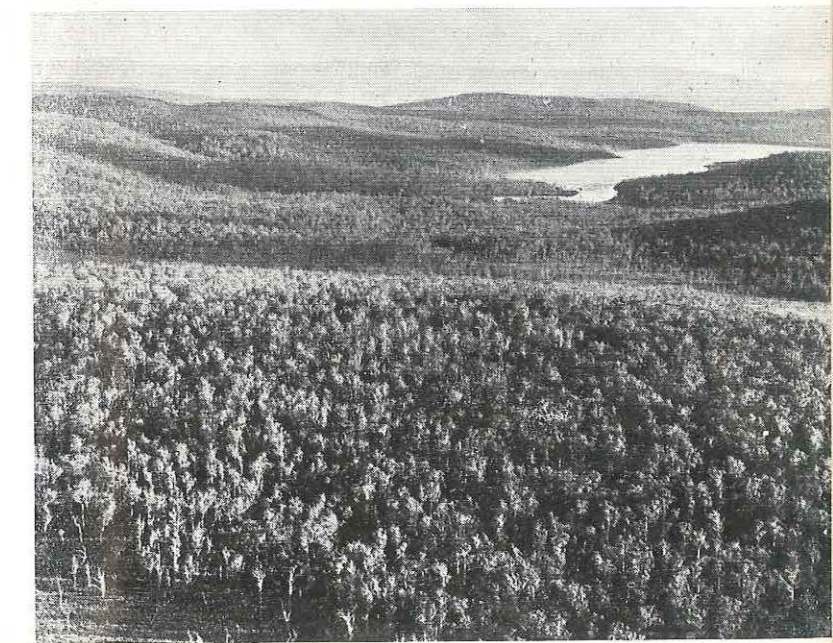
General view of the terrain over which the aircraft was flying when control was lost. The photograph was taken looking south-west and shows Tooms Lake in the background. The wreckage lies amongst the heavy timber in the immediate foreground of the picture.

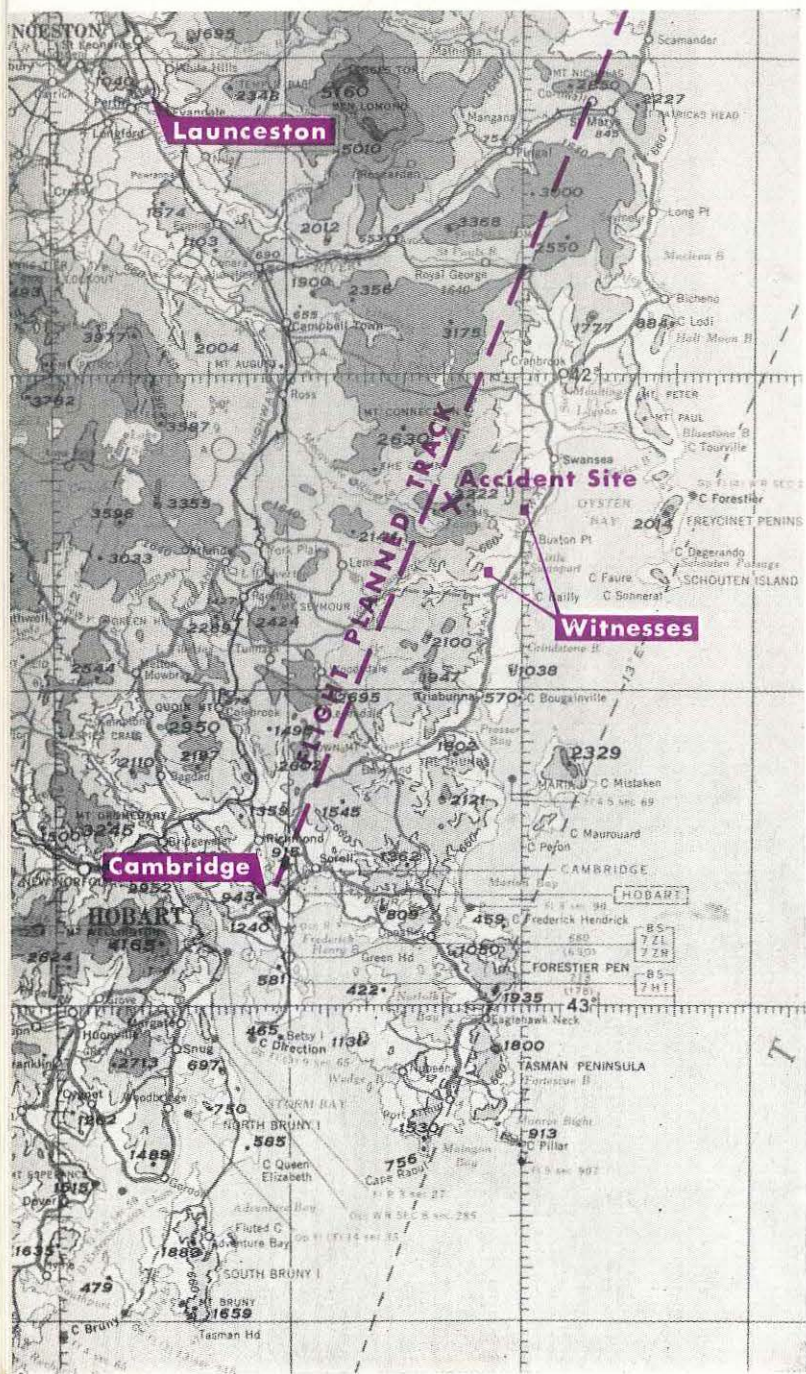
Map showing flight planned track, accident site, and location of witnesses.

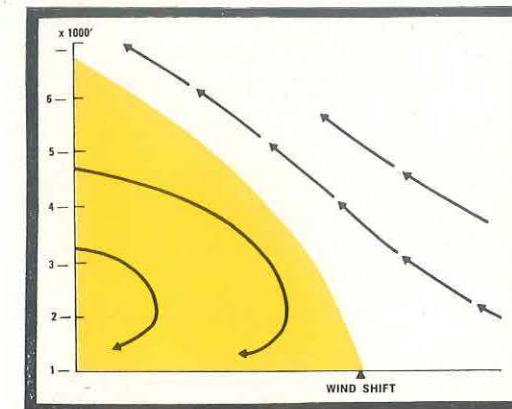
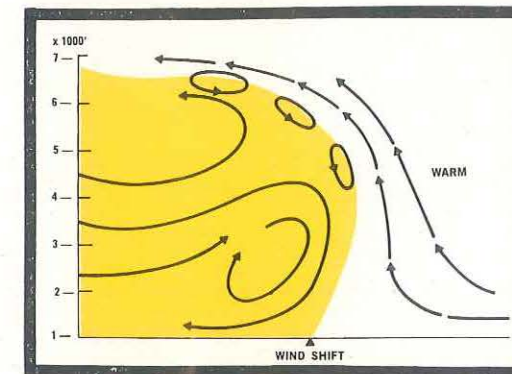
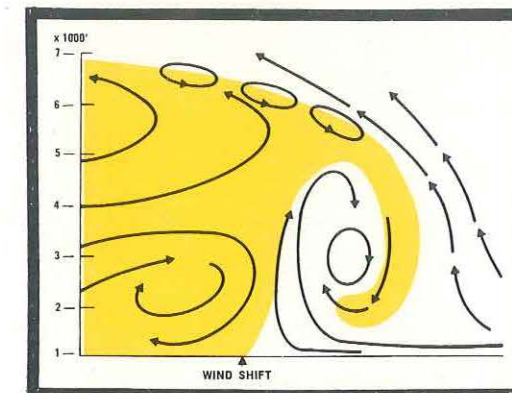
Growth of a roller begins with the mass of cold air pouring out from beneath a group of thunderstorms. This spreads out in front of the primary storm line and forces warm air upward, forming more thunderstorms, possibly forming a squall line. As the cold air mass is fed by increasing pressure from behind, it overruns itself, or topples like a wave breaker, spilling over and trapping warm air. The warm air struggles to rise, aggravating the rolling effect and adding strength to the tremendous shear forces.

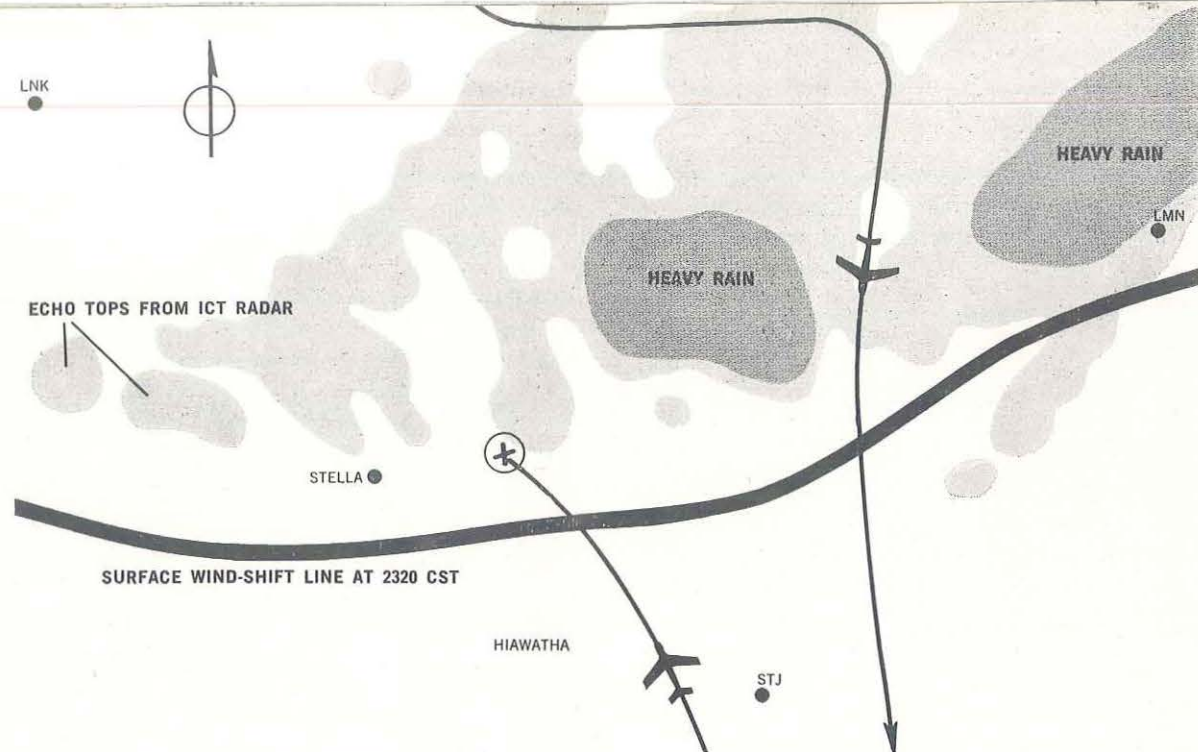
Above is the weather system facing the pilots of two aircraft on the night of August 6th, 1966, near the south-east corner of Nebraska. A line of thunderstorms was spread across northbound and southbound flight courses and moving south-eastward. Both aircraft altered course to avoid the areas of strong radar returns. The southbound aircraft at 7,000 feet, flew through its radar "hole" unscathed. The other turned to another echo-free hole and broke up in mid-air.

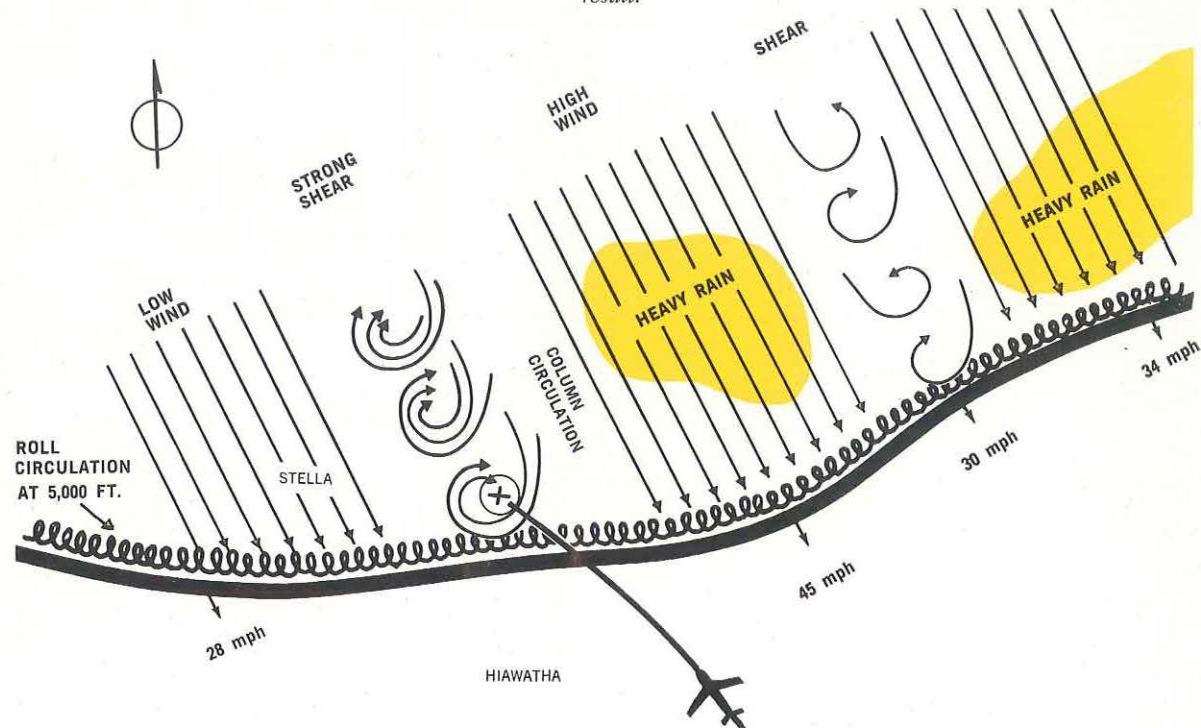
Below, according to the theory of Dr. Tetsuya Fujita, professor of meteorology at the University of Chicago, is the trap that was waiting for the northbound Braniff BAC 1-11. A wave of cold air preceded the squall line, fed by heavy downdrafts spewing out from the bases of the storm cells. This flow was surging and tumbling, similar in some respects to a breaker at the beach—but it did not show up on radar. Flying just beneath the cloud bases at 5,000 feet, the Braniff pilot ran smack into it with the consequent, and tragic, result.
