AVIATION SAFETY DIGEST

DEPARTMENT OF CIVIL AVIATION

No. 53

NOVEMBER, 1967

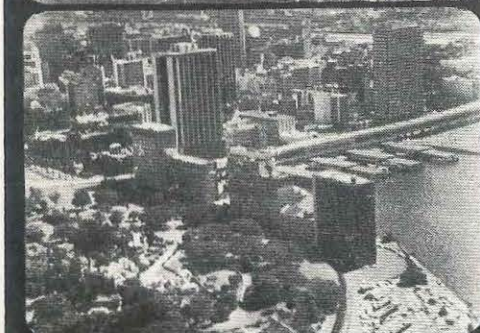
The pieces which were seen to separate from the helicopter immediately before it began to rotate, had fallen into the water close to the Manly ferry wharf at Circular Quay. One of the pieces remained afloat and, on being retrieved from the water, was found to be one of the tail rotor blades. Skin divers later recovered the other blade, still attached to the rotor hub and gearbox, from the harbour bed.

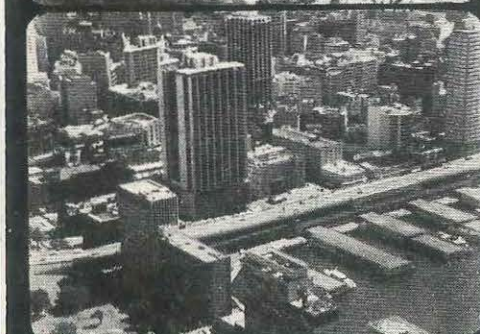
Examination of these components and the wreckage itself, showed beyond any doubt that the helicopter had lost its tail rotor after the retaining bolt for one of the two tail rotor blades failed as a result of fatigue cracking. The tail rotor blade was flung off, and almost immediately the extreme out-of-balance forces imposed on the rotor hub, pulled the entire gearbox and hub assembly from its mounting on the tail structure. Further careful examination of the complete wreckage of the helicopter, revealed no other evidence of any mechanical fault or malfunctioning which could have contributed to the accident.

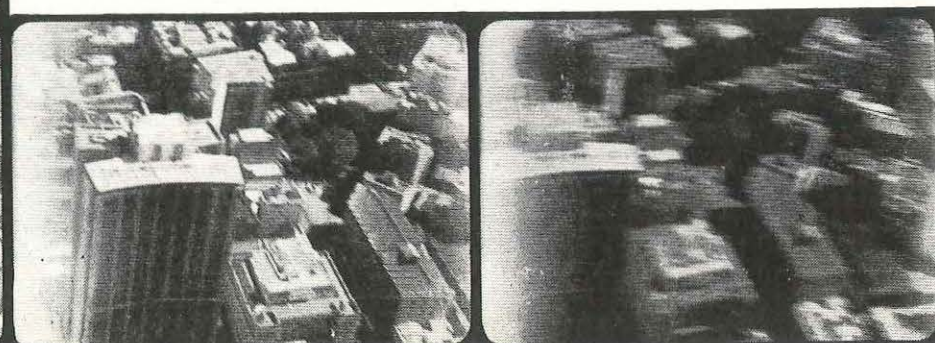
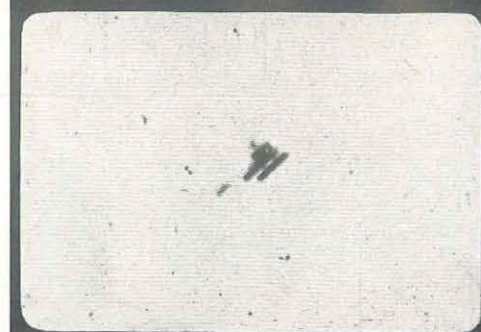
Film sequence taken from the helicopter showing the aircraft's approach to the city up to the point of tail rotor failure. In the final two frames the nose drops abruptly as the tail rotor is lost and the rotation begins.

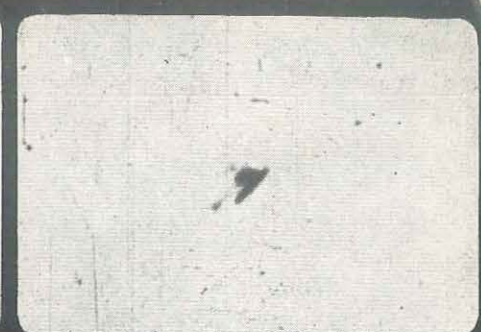
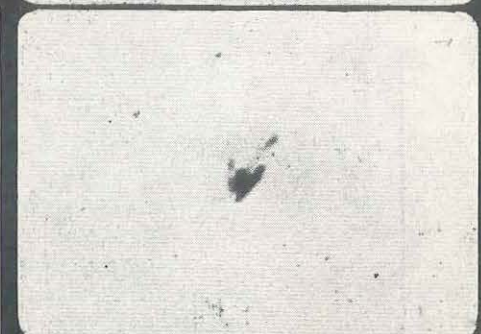
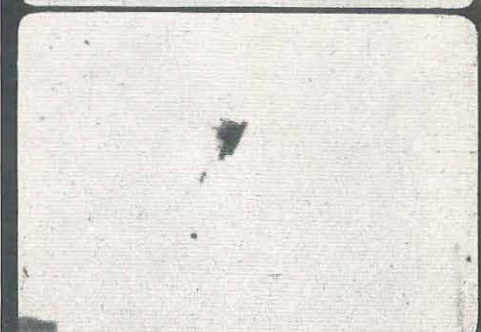
Film sequence taken from the tug in Farm Cove. The first frame shows the helicopter rotating in a relatively level attitude. In the following frames the plane of rotation topples, and the helicopter tumbles, still rotating, until it strikes the top of Gold Fields House.

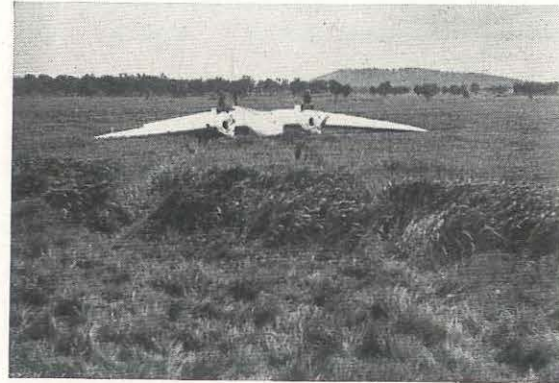
The take-off seemed normal until the aircraft became airborne but almost immediately it began to settle back towards the runway surface again. In the cross-wind condition, however, the aircraft had already acquired a considerable amount of starboard drift and the pilot attempted to hold the aircraft off the ground. As he was doing so, the starboard wing dropped violently and the wing tip, the starboard undercarriage and tail wheel struck the ground simultaneously, slewing the aircraft sharply to the right. The pilot closed the throttles to abandon the take-off and the aircraft settled on all three wheels but it ran off the strip to the right and into an adjoining wheat crop. The growth was two feet high and particularly thick with the ground beneath wet and muddy. After running through the crop for 230 feet the main wheels dug in and the aircraft nosed over on to its back. Amongst other damage sustained by the aircraft in the crash, the cockpit canopy was broken and distorted, and

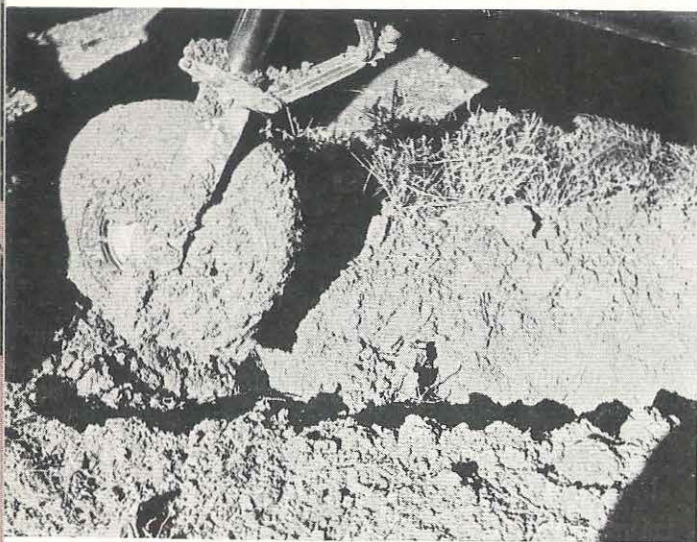
Winter rains turned this small area of an outback strip into a bog, though it was not apparent on the surface. Before the aircraft landed, the strip had been inspected and passed as serviceable.

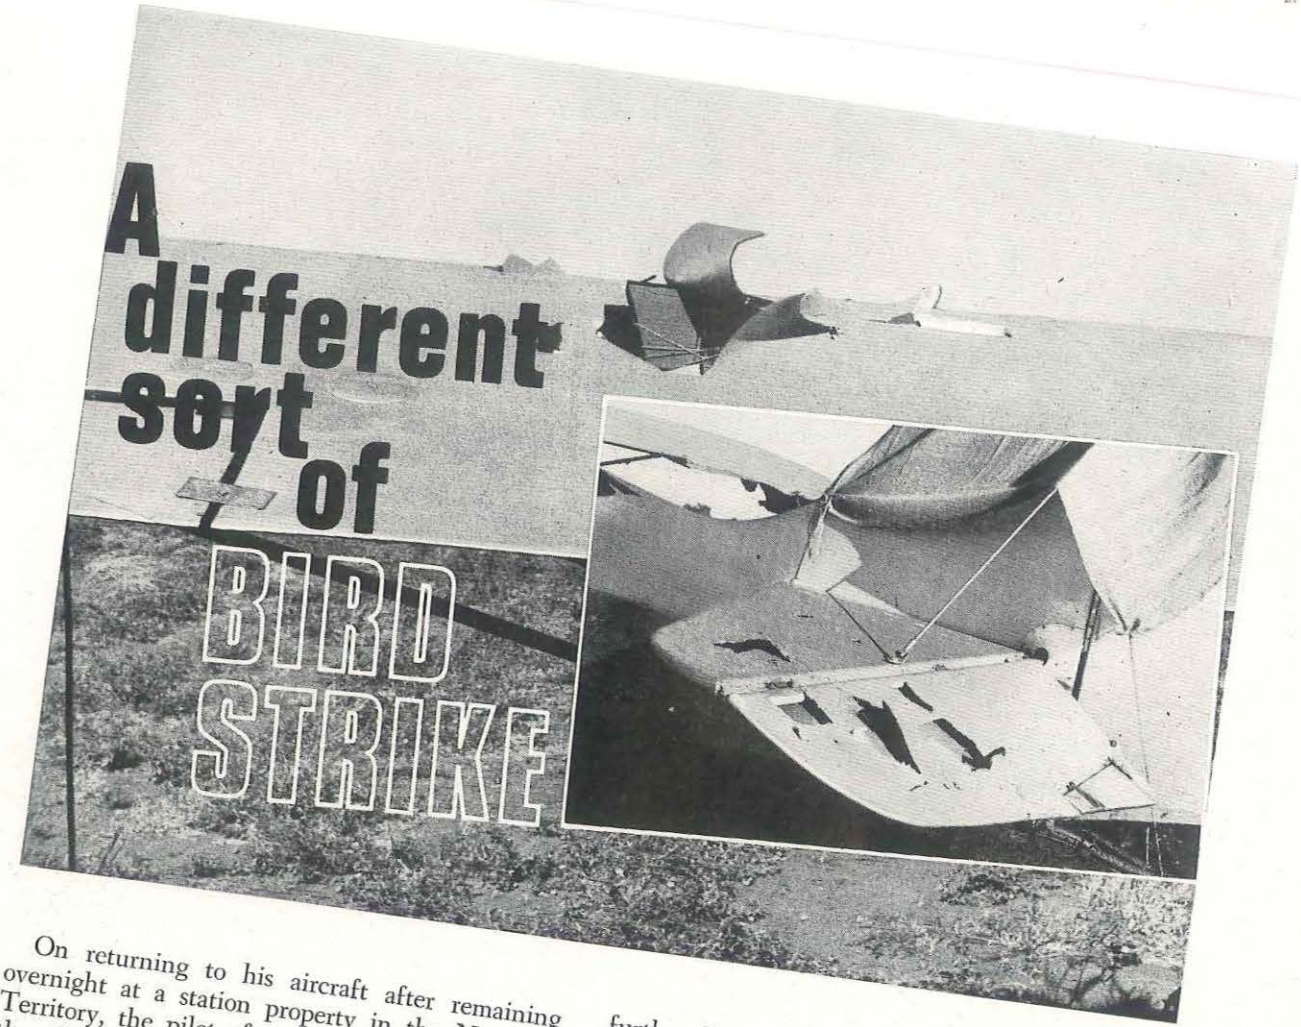
On returning to his aircraft after remaining overnight at a station property in the Northern Territory, the pilot of an Auster Autocar found that the fabric on the upper surface of the wings had been badly damaged and torn. Some pieces of the torn fabric were lying on the ground nearby. The station's airstrip is situated close to the Stuart Highway and as the aircraft was plainly visible from the road, the pilot's first thought was that vandals had caused the damage so he returned to the station to obtain the services of some native trackers.

The aircraft had been resprayed all over in aluminium dope shortly before the incident and the registration lettering had been repainted in red. In view of this and the damage to the red pitot cover, the pilot said he thought it likely that the red colouring had attracted the birds. A number of crows remained in constant attendance around the aircraft while the repairs were being carried out, and displayed a marked interest in pieces of the fabric.
