AVIATION
SAFETY
DIGEST

No. 57

JULY 1968

Tragedy at Barracouta	1
Sideslip Leads to Forced Landing	8
707 Breaks Up in Air	10
Misunderstandings — On Both Sides	14
Clean it First	16
Fuel Exhaustion	17
History Repeats Itself	18
Flight Over Mountains	22
This Concerns You	26
Don't Become Complacent About Cloud	27

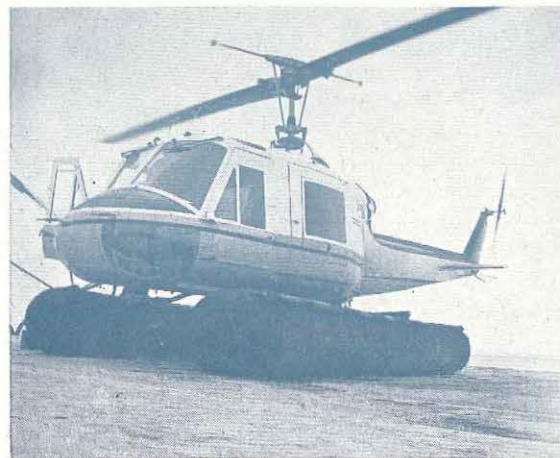
The photographs are reproduced in this article and the first, reproduced on Page 4, was taken when the undersurfaces of the helicopter pontoons were approximately 10 feet above the helipad with the helicopter in the hover position. It shows, towards the top of the tail fin on the port side along the line of ultimate failure, a crack which has been opened up very substantially by the loads being imposed on the tail fin at the time. It is relevant that the tail rotor in this type of helicopter is a pusher type and thus, whilst it is operating, the port side of the tail

Left: This photograph was taken when the helicopter had reached a hovering position approximately 10 feet above the helipad. The final stage in the failure of the tail fin is just beginning.

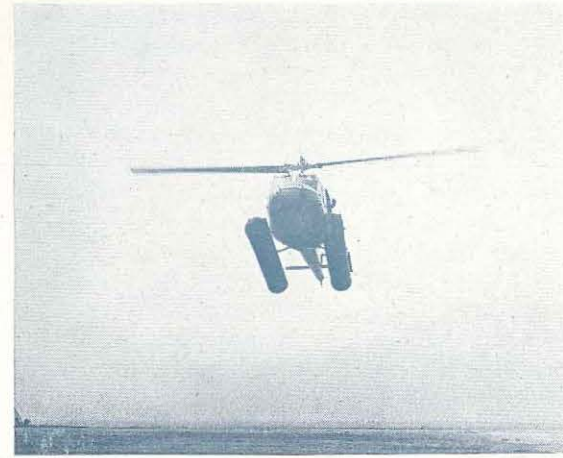
Above: This remarkable picture was the last to be taken of the helicopter before the accident. At this point the helicopter's pontoons were only four feet above the deck of the helipad. The enlargement at right shows clearly that the final failure of the tail fin had just occurred and the tail rotor shaft has pivoted into a vertical position, depriving the pilot of directional control.

The second photograph on Page 5, was taken when the undersurfaces of the pontoons were approximately four feet above the helipad deck and it shows that the ultimate structural failure of the tail fin has just occurred. The upper forward section, including the tail rotor gearbox and the tail rotor itself, has rotated upwards about a hingeline running approximately fore and aft along the starboard side of the tail fin, so that the tail rotor is, in fact, rotating in a near horizontal plane. Having regard to the positions from which these two photographs were taken, it is apparent that the helicopter has yawed some 25 degrees to the right in the time interval between the two exposures but there is still no sign of the helicopter rolling from its normal hover attitude.
