No. 65 NOVEMBER 1969

AVIATION SAFETY DIGEST

DEPARTMENT OF CIVIL AVIATION AUSTRALIA

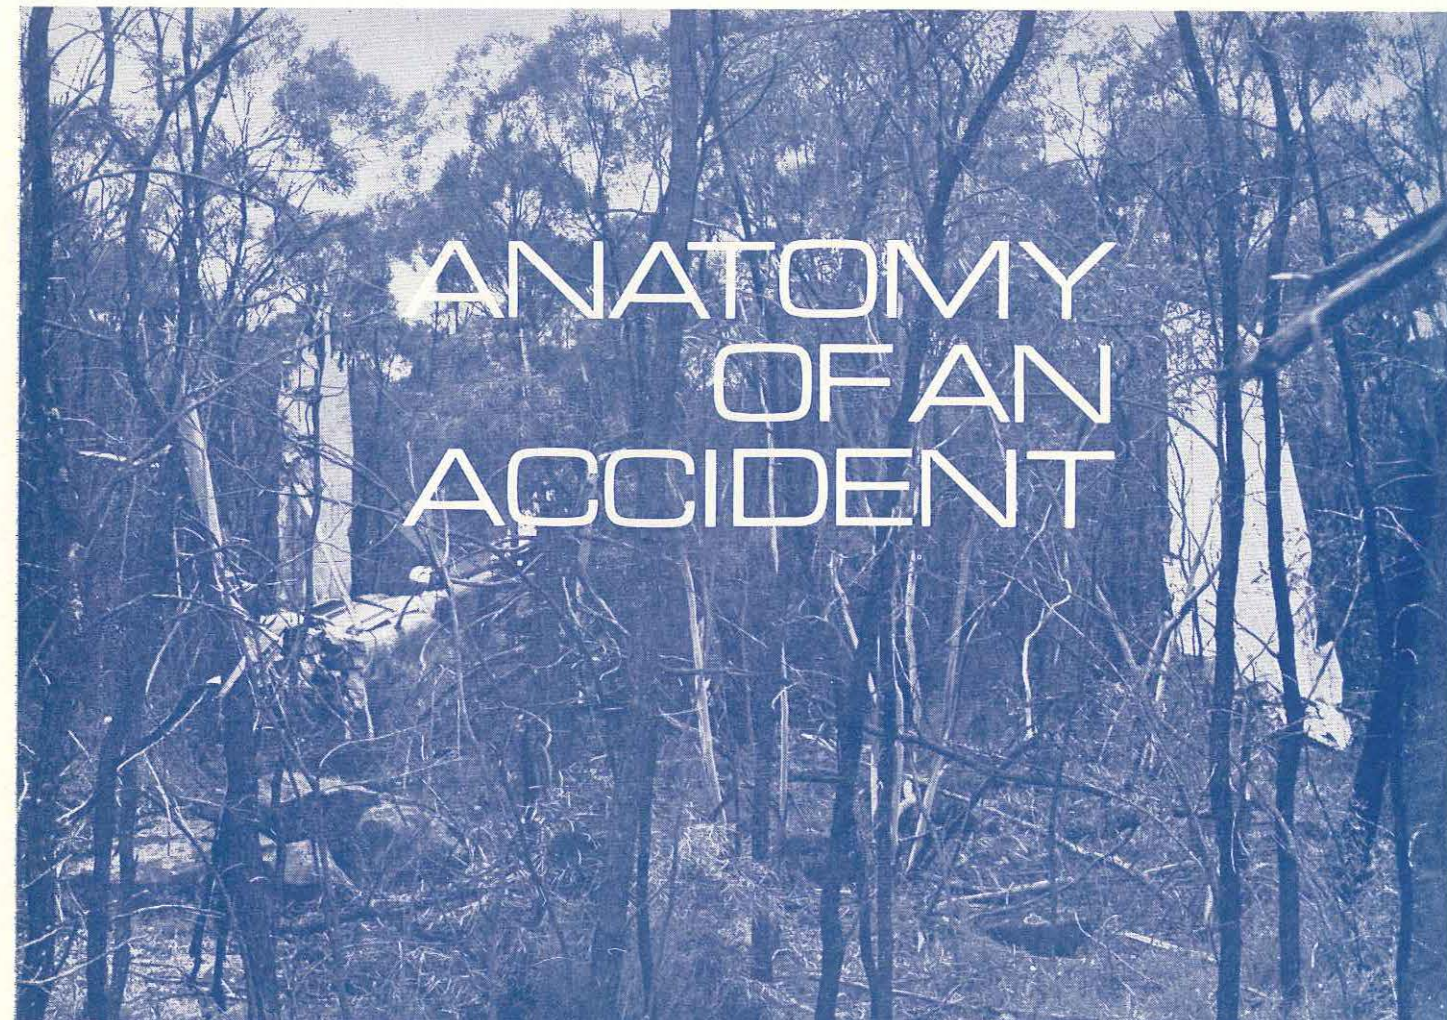
THE photographs on these pages show how an intended charter flight ended on a mountain top in New South Wales after the pilot continued into weather conditions in which he could not maintain visual flight. The circumstances of the accident and the operational lesson it provides are by no means new. It is a theme that has been repeated tragically time and again and the safety message it contains has been presented in the Digest through the medium of the reports of such accidents on many occasions. What is unique about this particular accident is the fact that all four occupants survived to tell us what happened. This fact, far from blunting the edge of the further object lesson in air safety that this accident provides is, of course, the very factor that enables us to derive the maximum benefit from it. By examining as it were, an "accident in the making" we see how very simple the ingredients of tragedy can be.

The passenger's reference to a "darker cloud" just before the impact was undoubtedly the vegetation on the mountain range which was considerably darker than the generally cleared terrain over which the aircraft had been flying, and the "turbulence" would most likely have been the result of the pilot's violent manoeuvre in the unsuccessful attempt to avoid the trees. When the pilot first observed the trees, the aircraft was in a gully on

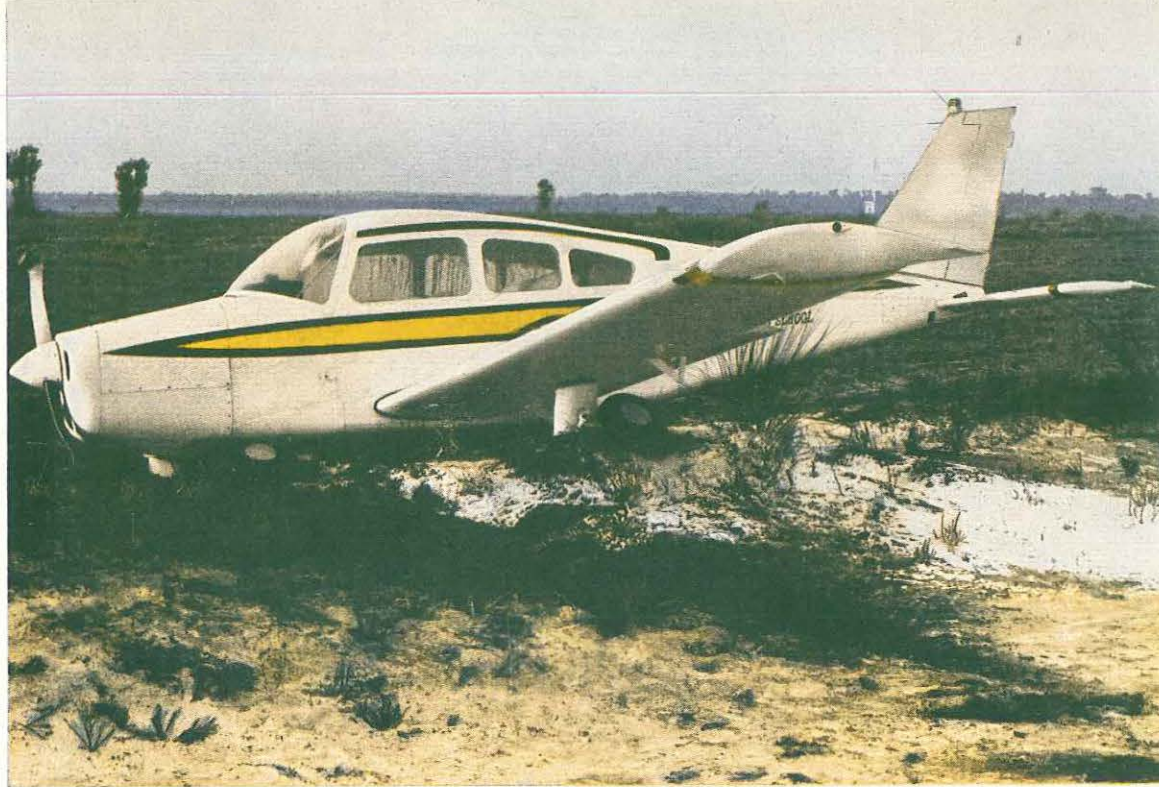
AFTER a period of upper air work, a student pilot flying solo in a Beech Musketeer returned to Jandakot Airport from the light aircraft training area, intending to carry out several touch-and-go landings. The weather was fine, with an eight knot south-westerly wind producing a crosswind component of three or four knots from the left on the duty runway.

Americans aptly term "wheel-barrowing," places the aircraft in a highly unstable situation requiring only a slight deviation in heading, caused by either a wind gust or steering effects, to induce a ground-loop type manoeuvre.

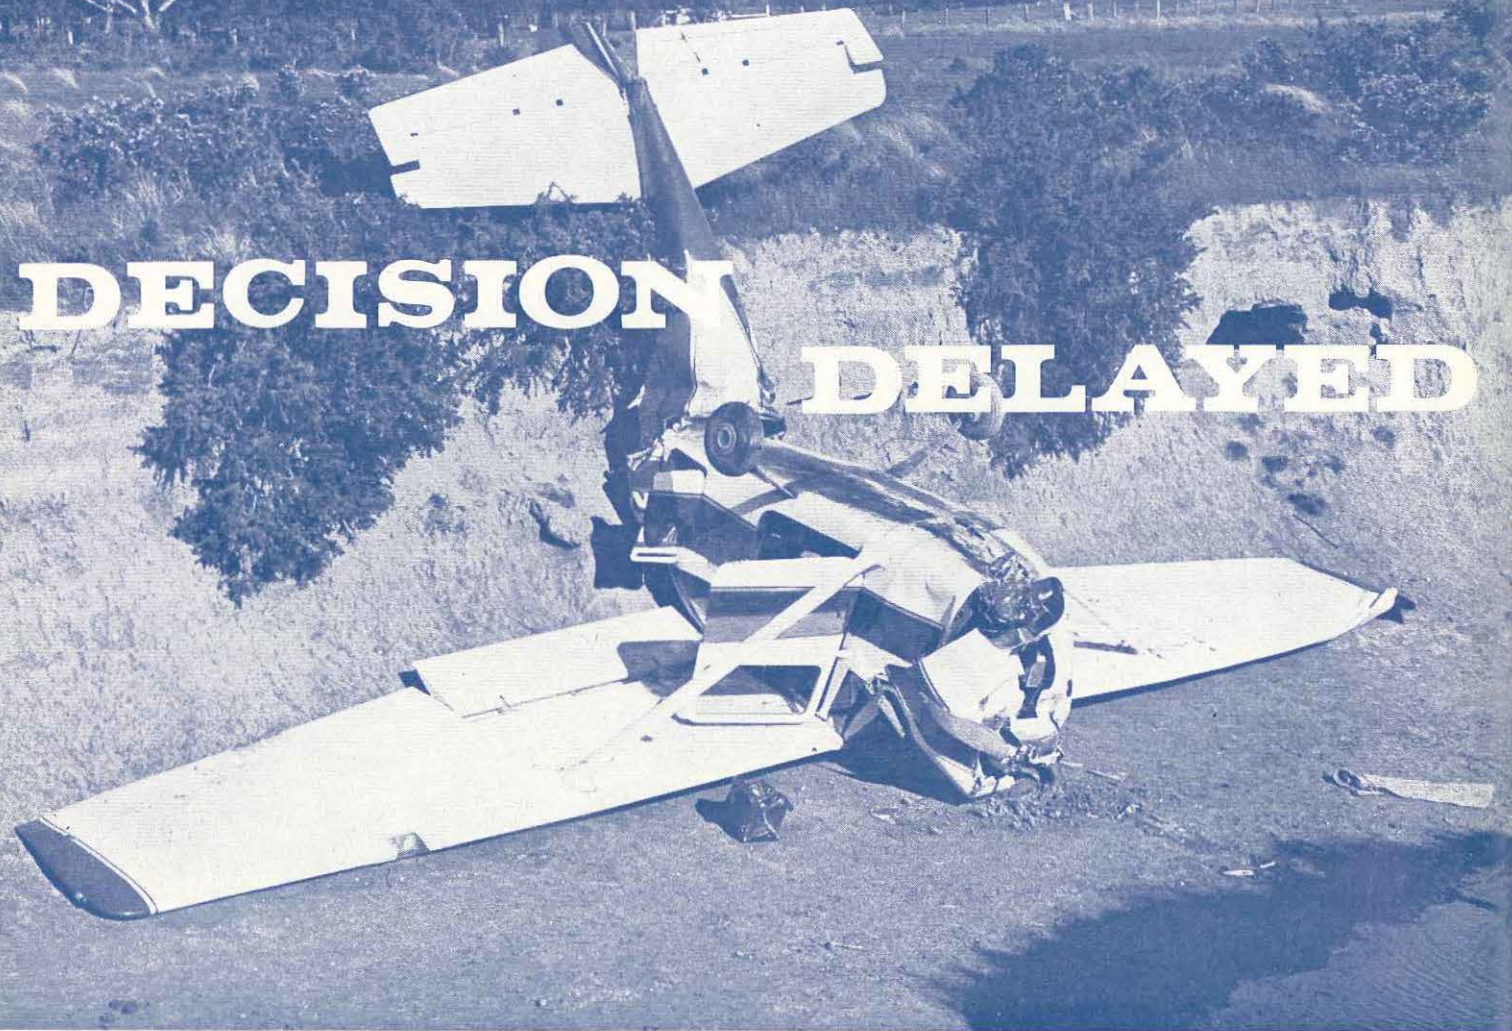
he would have to act quickly and took over the controls. Lowering some 15 degrees of flap, he applied full power, but by this time the aircraft was less than 200 feet from the end of the strip. It failed to become airborne in the distance remaining, and struck a low embankment a short distance beyond the end markers.

The impact dislodged the nosewheel and the aircraft dropped on to its nose and slid for a further 100 feet before it plunged into a steep-sided creek bed, where it somersaulted and came to rest inverted against the far bank. The student pilot received serious injuries and the aircraft, as is clearly evident from the photographs, was damaged beyond repair.

In view of the outcome of the attempted go-around and in the absence of any mechanical failure in the aircraft, it was evident that the manoeuvre had been left far too late for it to have any hope of success. Investigation into the reasons for the instructor not taking over the controls earlier revealed that, while he was intending to demonstrate the poor braking effect on the wet grass, he also anticipated that the student, of his own accord, would recognise that the aircraft would be unable to stop on the strip and initiate the overshoot himself.

The cause of the accident was that the instructor, as pilot-in-command, did not take timely action to initiate a go around.

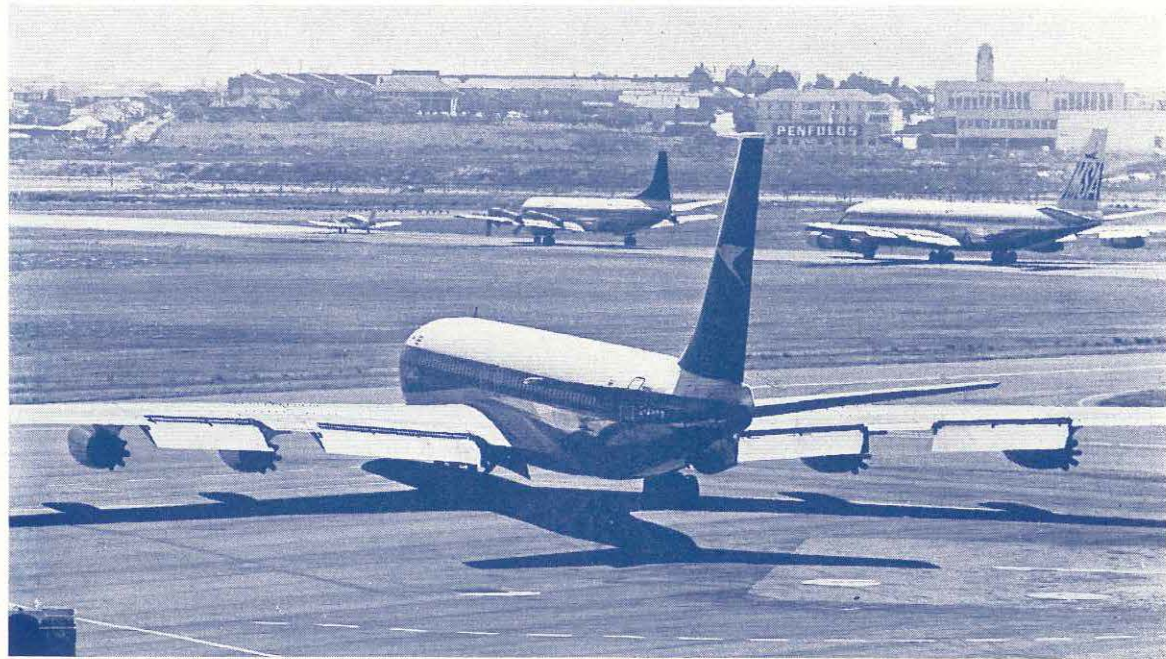
PREPARING to depart from Sydney Airport, a light twin-engined aircraft was cleared to the holding point for the duty runway. When the pilot called the tower to advise that he was ready for take off, he was informed there would be a three or four minute delay, "due to arriving traffic".

The pilot of the Lockheed Electra said that while taxi-ing out to the holding point, he had moved the power levers back to the ground idle range to prevent the aircraft gaining speed without having to "ride" the brakes. He had parked close behind the small aircraft, not realising there was a wash of air going forward, and this, mixing with the light twin's own slipstream, had apparently produced the buffeting. The pilot added that during further flying of the Electra, he noticed that the No. 3 engine was leading appreciably into reverse thrust, and that this could have aggravated the condition.

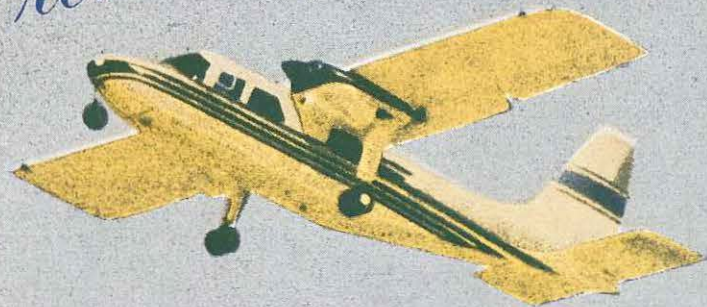
TAKING-OFF late in the afternoon from Ningerum in western Papua for a flight to Kiunga, some 30 miles to the south-east on the Fly River, the pilot of a Britten-Norman Islander had just begun a turn to set course when he felt the rudder pedals suddenly go slack and found he had lost rudder control.

It was not possible to determine who was responsible for removing the locking wire without recording the fact. The engineers who made the duplicate inspections certainly did so adequately on all sections of the control run that they believed were affected, but in not checking the integrity of the whole control run, they must be held partly responsible for the control failure.

As a result of this incident, the operator has stipulated that any work performed on a primary flight control system will first of all be recorded as a defect on the operator's work sheets or, if being performed in the field, on the aircraft's maintenance release. The entry will be specific as to the exact location of the interference or disconnection to be made to the control run. As well, the engineers or pilots responsible for performing the duplicate inspection at the completion of the work will inspect the whole control run for security and correct locking, and not merely the section of the controls that has been disturbed.

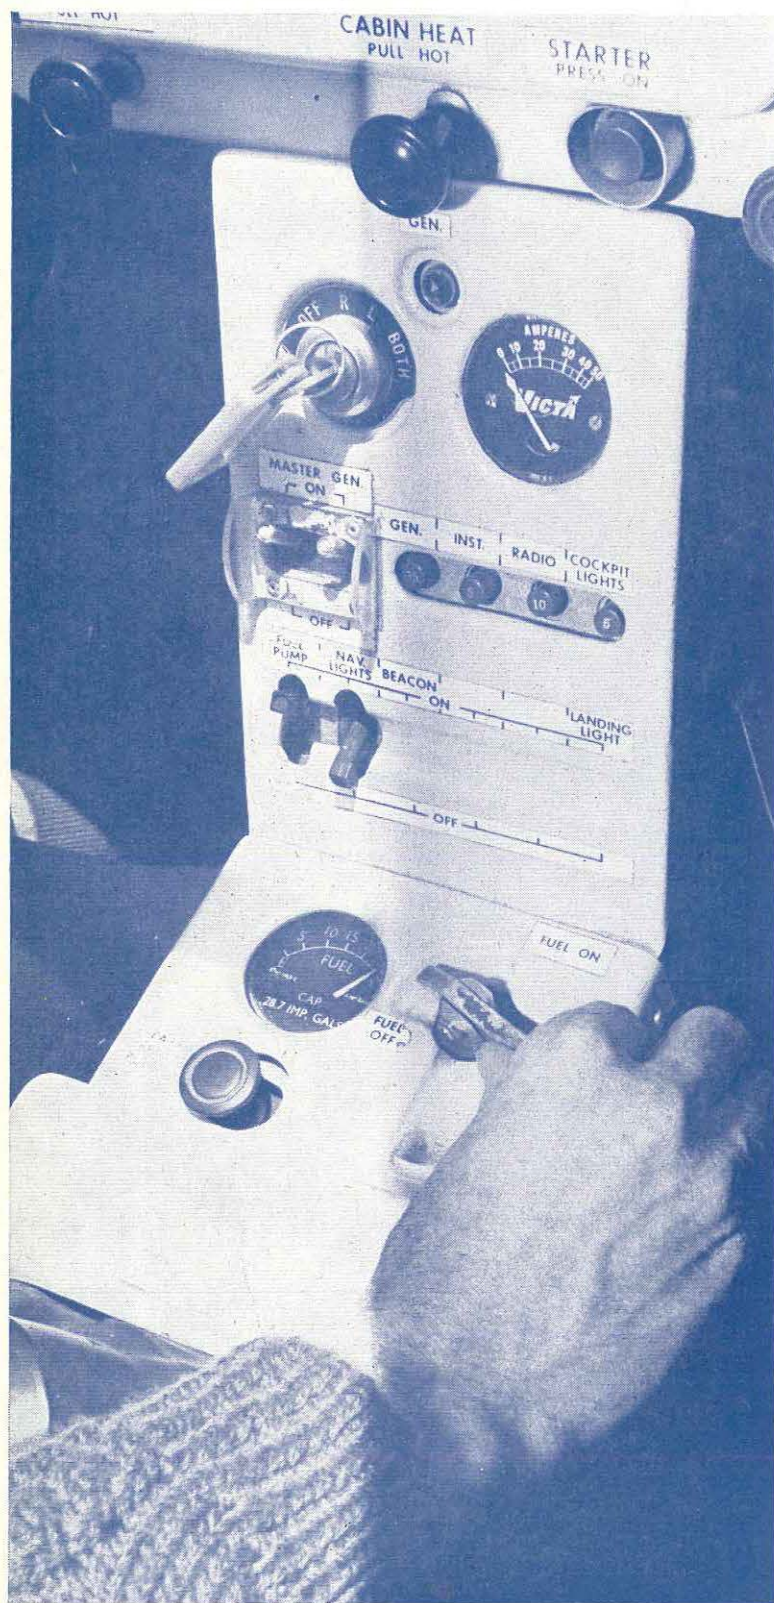
WHILE taking off from Runway 24 at Jandakot Airport, Western Australia, the engine of a Victa Airtourer suddenly lost power at a height of about 200 feet. The pilot quickly completed a trouble check, but the engine did not respond and he was committed to a forced landing. The only suitable area within gliding distance was the over-run of Runway 30, and the pilot headed towards it, turning off the switches as the aircraft descended. The aircraft struck the ground heavily just to the right of the over-run, rolling the port main tyre off its rim but sustained no other damage. Neither the pilot nor the passenger was injured.

Because of a deteriorated moulded rubber seat in the fuel cock, sufficient fuel was able to flow through the cock in the "off" position to run the engine at low and medium power. It was only when full power was applied and sustained during the take-off that the engine lost power from fuel starvation.
