# AVIATION SAFETY DIGEST

DEPARTMENT OF CIVIL AVIATION AUSTRALIA

No. 67 MARCH, 1970  
DEPARTMENT OF CIVIL AVIATION, AUSTRALIA

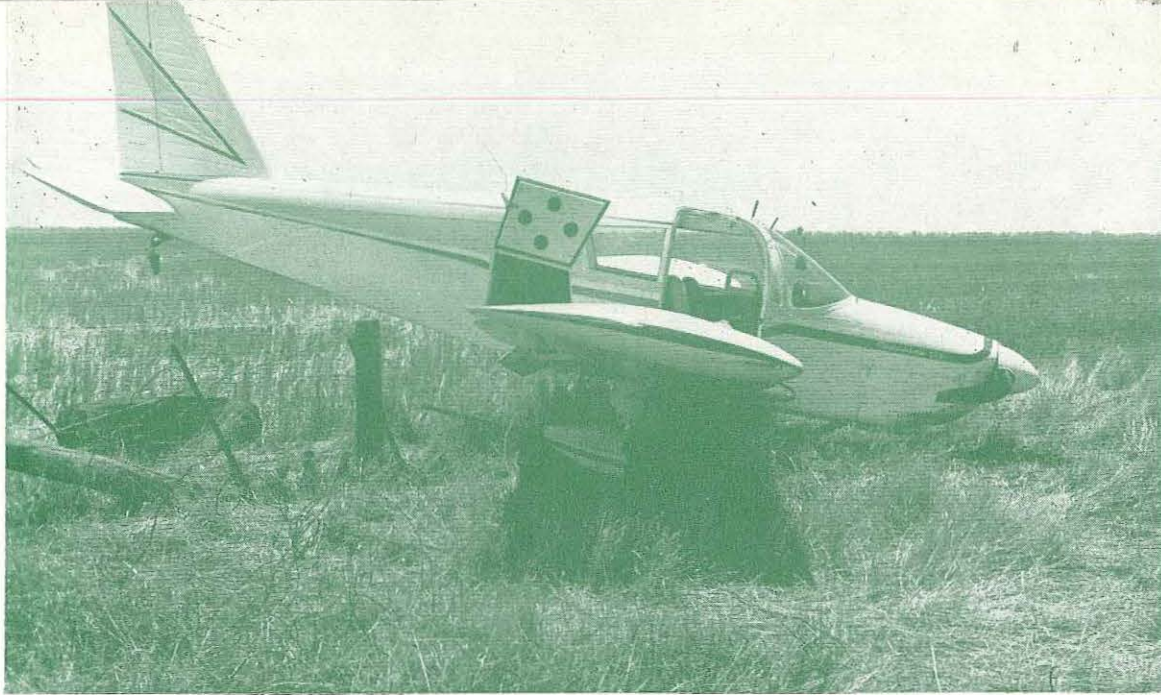
Examination of the area being used for the landing showed that, when allowance was made for the position and height of the power line in accordance with the published requirements for authorised landing areas, the position of the threshold should have been 400 feet beyond the boundary fence over which the aircraft was approaching. This "displaced threshold" would still have left a sufficient length of run in the paddock for the operation of a PA.28-235 in the existing conditions. As the pilot intended to park the aircraft near the approach end of the strip however, he was attempting to

Above: General view of the area showing relative positions of power line and landing strip.  
Below: The accident site looking in direction aircraft was landing. The repaired power line can be seen in the upper foreground of the picture.

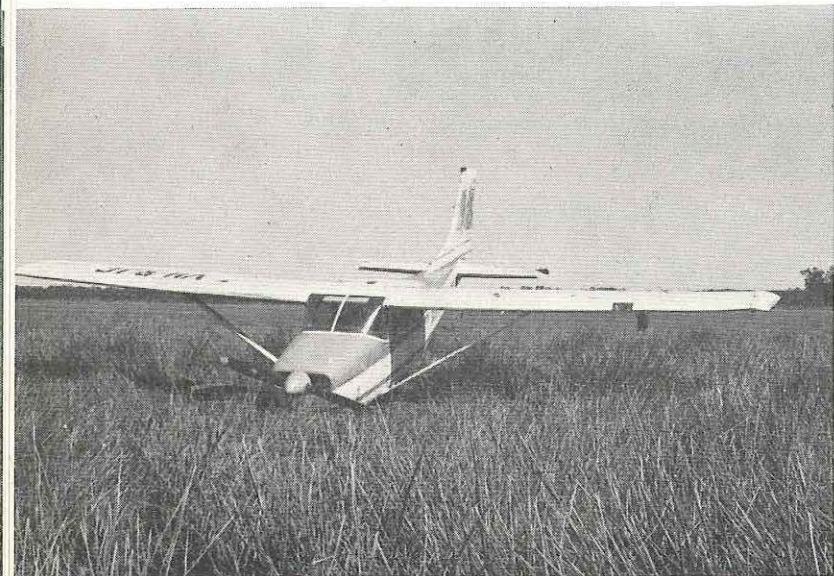
**I**N Northern Queensland, a Cessna 205 had been chartered to pick up three passengers from a station property. The commercial pilot who was rostered to make the flight had been informed by his chief pilot that the strip was about 3,000 feet long with reasonably good approaches.

After an uneventful flight, the pilot arrived at the strip and his three passengers embarked. They proved to be two very big men and a third man of more than average weight. With the passengers on board the aircraft was only 25 lb. below its maximum take-off weight, but although the day was warm with an outside air temperature of 78°F (25°C), the pilot did not anticipate any difficulty in becoming airborne in the distance he believed was available.
