AVIATION SAFETY DIGEST

Number 72 Jan. 1971

DEPARTMENT OF CIVIL AVIATION
AUSTRALIA

TRAGEDY IN THE DARK

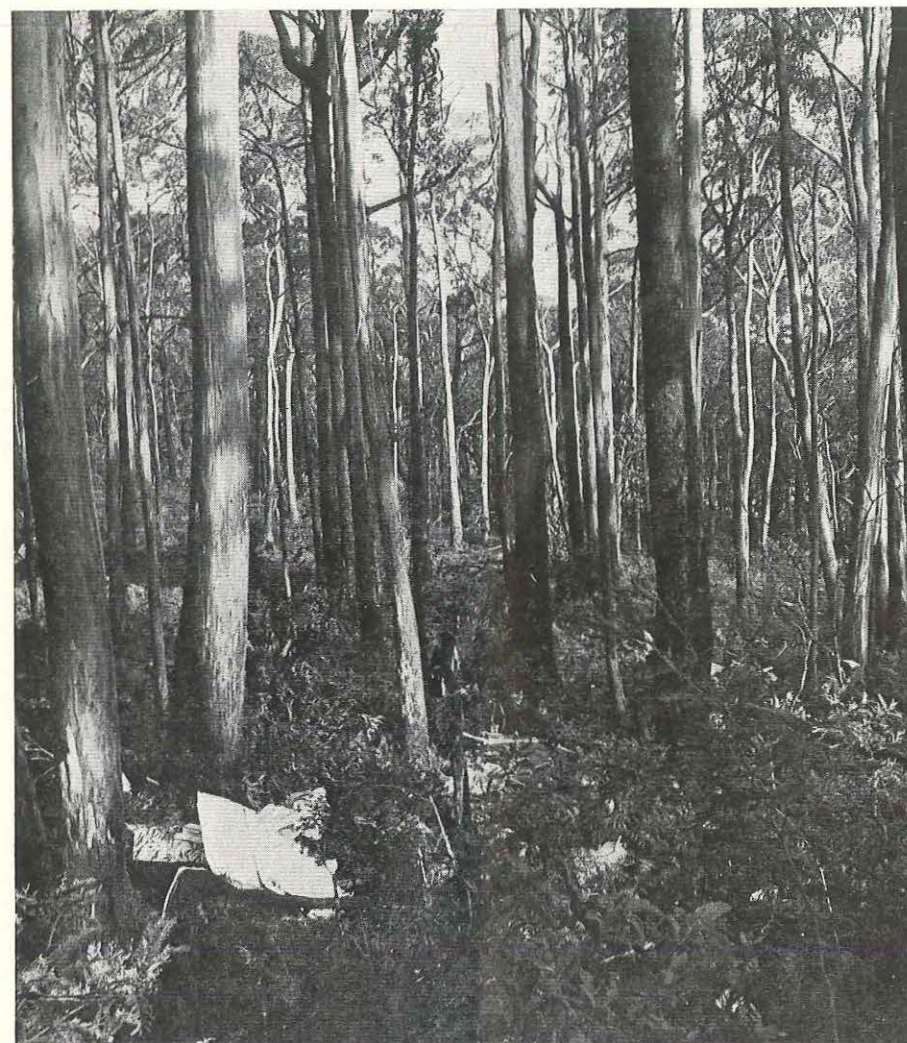
This page: View looking back in the direction from which the aircraft approached. A section of the wreckage lies in the foreground. The heavily timbered nature of the terrain and the dense undergrowth at the accident site are particularly evident in this picture.

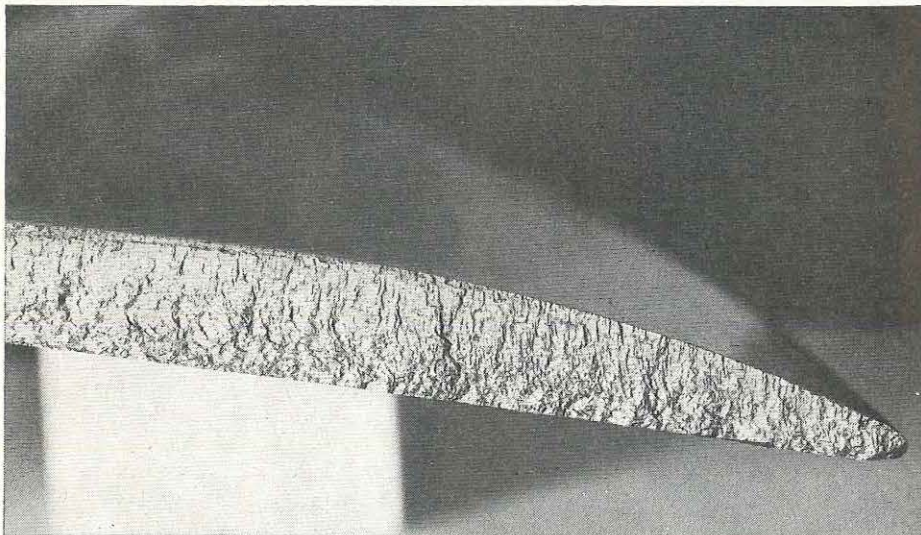
Bottom: Figure 3: Deep score marks caused by the use of a rasp on the leading edge of the Mooney's propeller blade, immediately inboard of the point of failure.

The photograph in figure 3 shows the results of unskilled attention to the propeller blade of the Mooney. The deep score marks caused by the use of a rasp are clearly evident. Such damage would be quite capable in itself, of initiating fractures in a propeller blade and, in any case, would ruin a blade which might otherwise have been returned to service after proper treatment. Although in this case the pilot had made some attempt to clean up the blade damage, it is quite clear he had not been instructed in the essential basic procedures or given any understanding of what he was trying to do.

The removal of stone bruises requires the use of fine files and should be completed with a final polish by a very fine emery cloth. The work should be accomplished in such a way that the indentation is smoothly blended into the blade contour and the area should be repolished as nearly as possible to the original high finish of the blade surface. The area around the stone bruise should then be carefully examined with a 5X or better magnifying glass, to ensure that no cracking has occurred and that all pits at the base of the stone bruise have been removed. The sketches in figure 2 show recommended contours for the removal of stone bruises, and are as specified in propeller repair and maintenance instructions. Obviously however, there is a limit to the amount of material which can be removed from any blade without affecting its performance, balance or strength. The limits to which repairs of this nature can be conducted are generally prescribed in propeller manufacturers' manuals, and in no circumstances must these be exceeded.
