Number 75 July 1971

DEPARTMENT OF CIVIL AVIATION AUSTRALIA

AVIATION SAFETY DIGEST

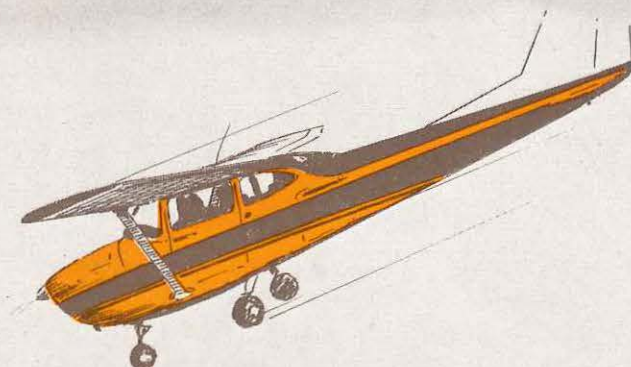
The inaccessibility of the crash site rendered a detailed examination of the wreckage extremely difficult, but it was evident that the aircraft had first struck the tree-tops at comparatively low speed in a level attitude. The impact had banked the aircraft sharply to the right,

The wreckage of the Cessna, lying on its starboard side, as first sighted from the air. The surrounding trees at the accident site are up to 70 feet high.

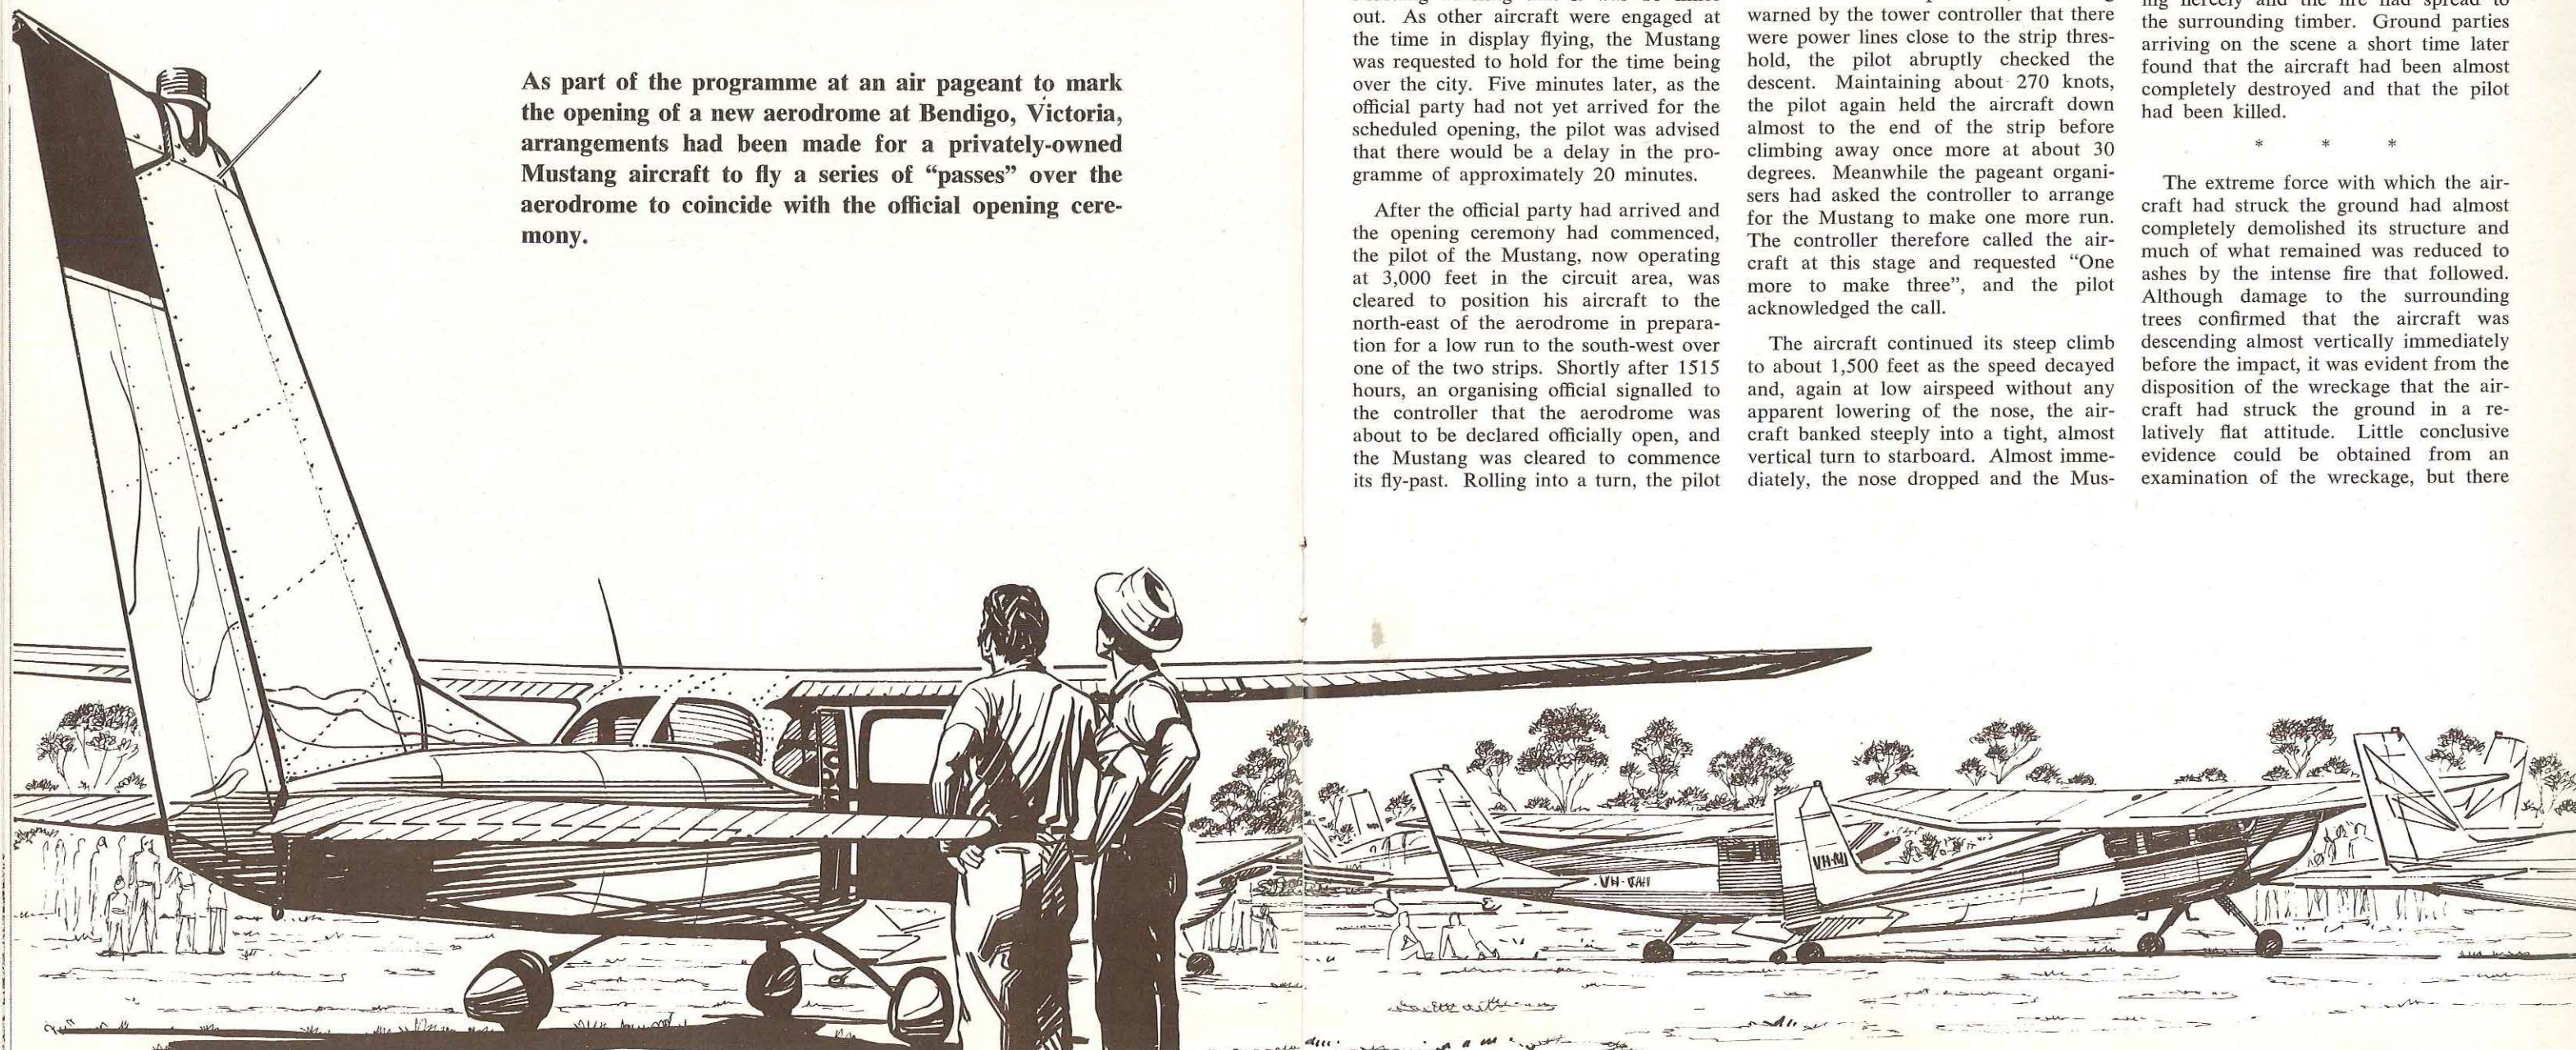
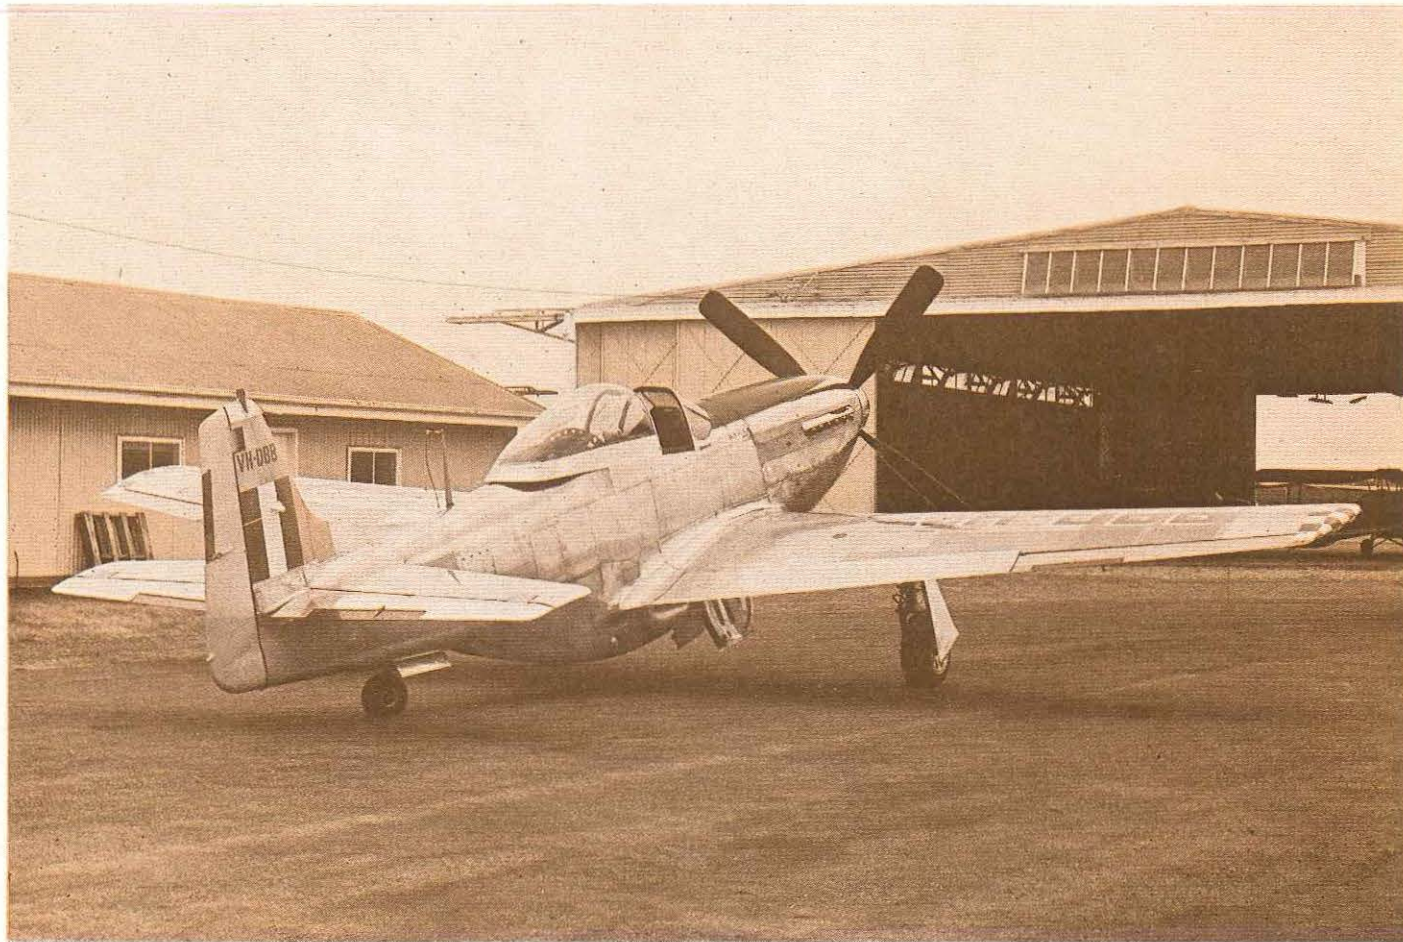
The extreme force with which the aircraft had struck the ground had almost completely demolished its structure and much of what remained was reduced to ashes by the intense fire that followed. Although damage to the surrounding trees confirmed that the aircraft was descending almost vertically immediately before the impact, it was evident from the disposition of the wreckage that the aircraft had struck the ground in a relatively flat attitude. Little conclusive evidence could be obtained from an examination of the wreckage, but there

was nothing to suggest any malfunction which might have contributed to the accident. The aircraft had been issued with its initial certificate of airworthiness only seven weeks before the accident and its conversion to civil airworthiness standards and subsequent routine maintenance had been carried out to a high standard virtually without regard to cost. Damage sustained by the engine and propeller, both of which were unaffected by the fire, clearly indicated that the engine had been operating at high power at the moment of impact. This fact was supported by the evidence of many witnesses, two of whom were experienced Mustang pilots who had watched and heard the aircraft operating normally and at high power during the display, and as it climbed away from the aerodrome for the last time.

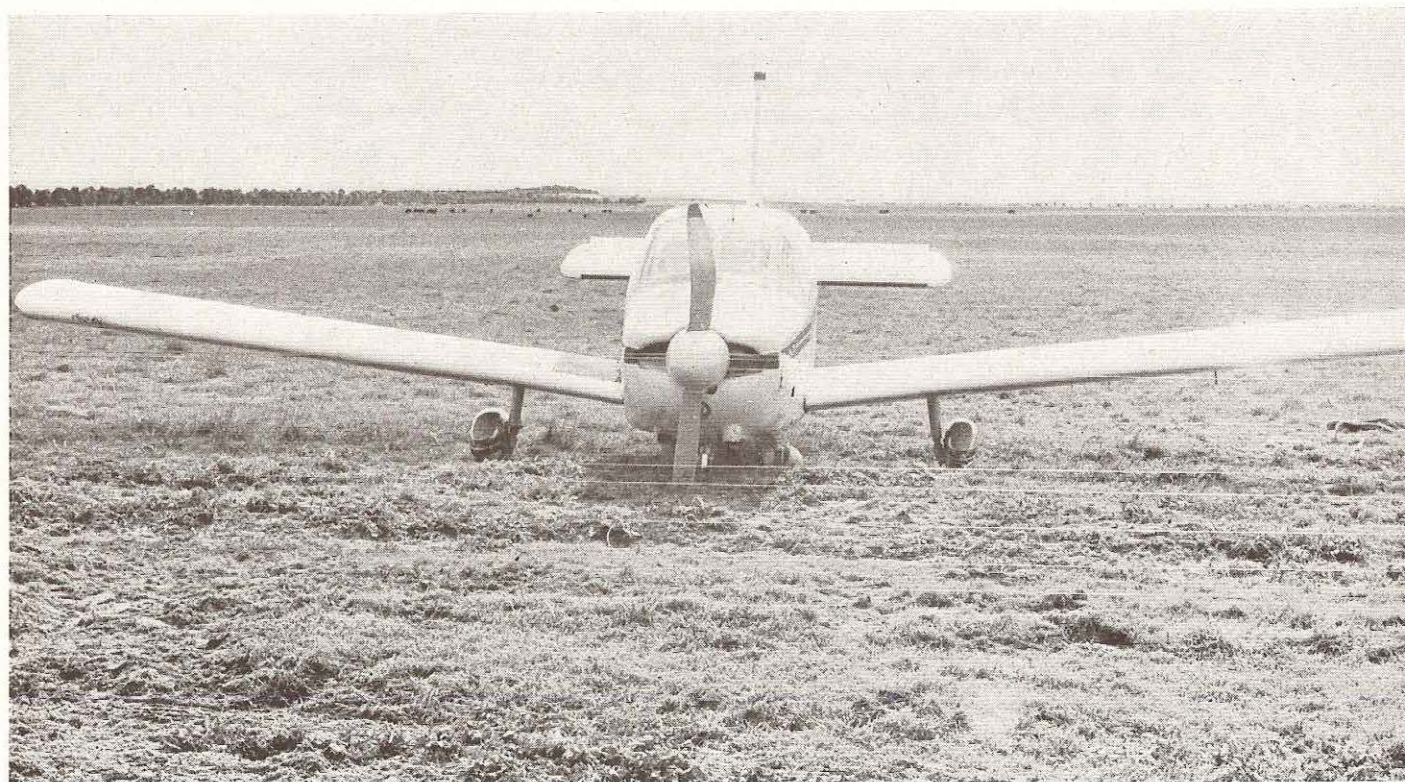
• THE ELUSIVE STRIP

The pilot of this Cherokee had planned a flight to a country property, allowing himself a margin of about 30 minutes before last light. The day was fine but overcast, and there had been some rain in the area.

It was found that the pilot was totally unfamiliar with the approach and take-off safety speeds specified in the landing and take-off performance charts contained in the aircraft's flight manual. The landing area he selected was quite satisfactory providing minimum approach speeds were used, and had the pilot adopted a proper precautionary-type approach at reduced speed, there is little doubt that the accident would have been avoided.

This accident is by no means an isolated case. Rather, it is but one of many that have occurred in recent years. It is surely a wise precaution when landing in paddocks, particularly those in which the surface conditions are not well known to the pilot, to touch down and stop in as short a distance as can safely be achieved. In this way the chances in hitting some unseen obstacle or over-running the selected landing area are obviously reduced to a minimum.

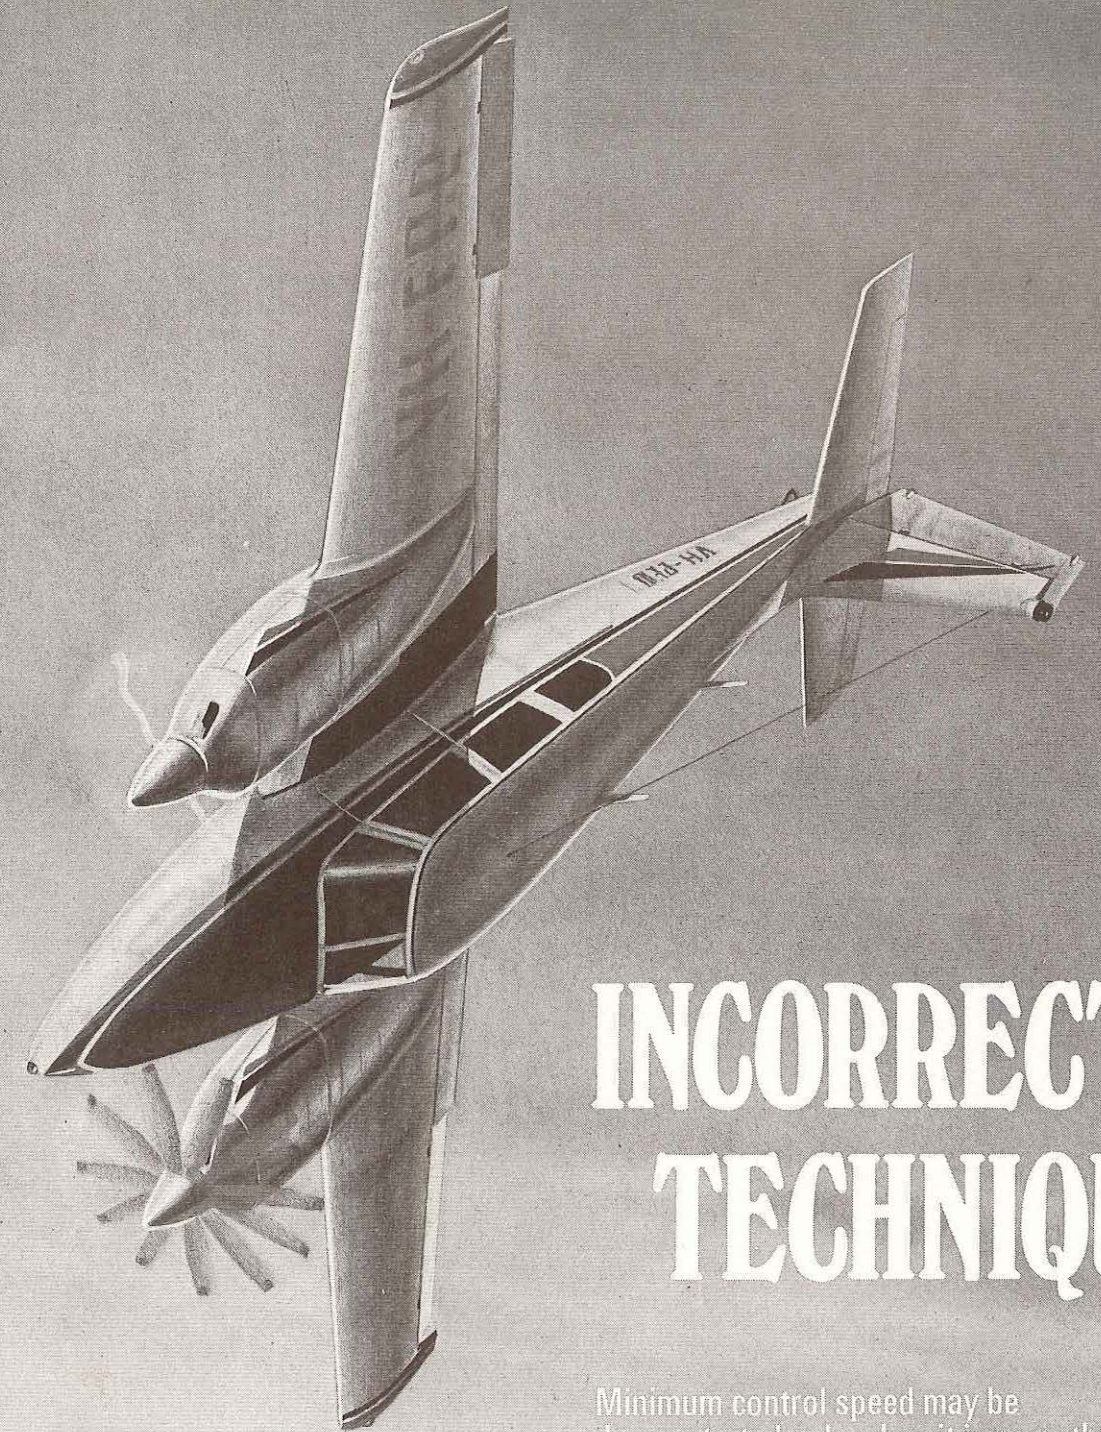
INCORRECT TECHNIQUE?

Minimum control speed may be demonstrated only when it is more than five knots above the stalling speed for the aircraft's configuration. Even then —

(See Flight Instructor's Handbook Exercise 21)
