AVIATION SAFETY DIGEST

No. 76 September • November 1971

DEPARTMENT OF CIVIL AVIATION AUSTRALIA

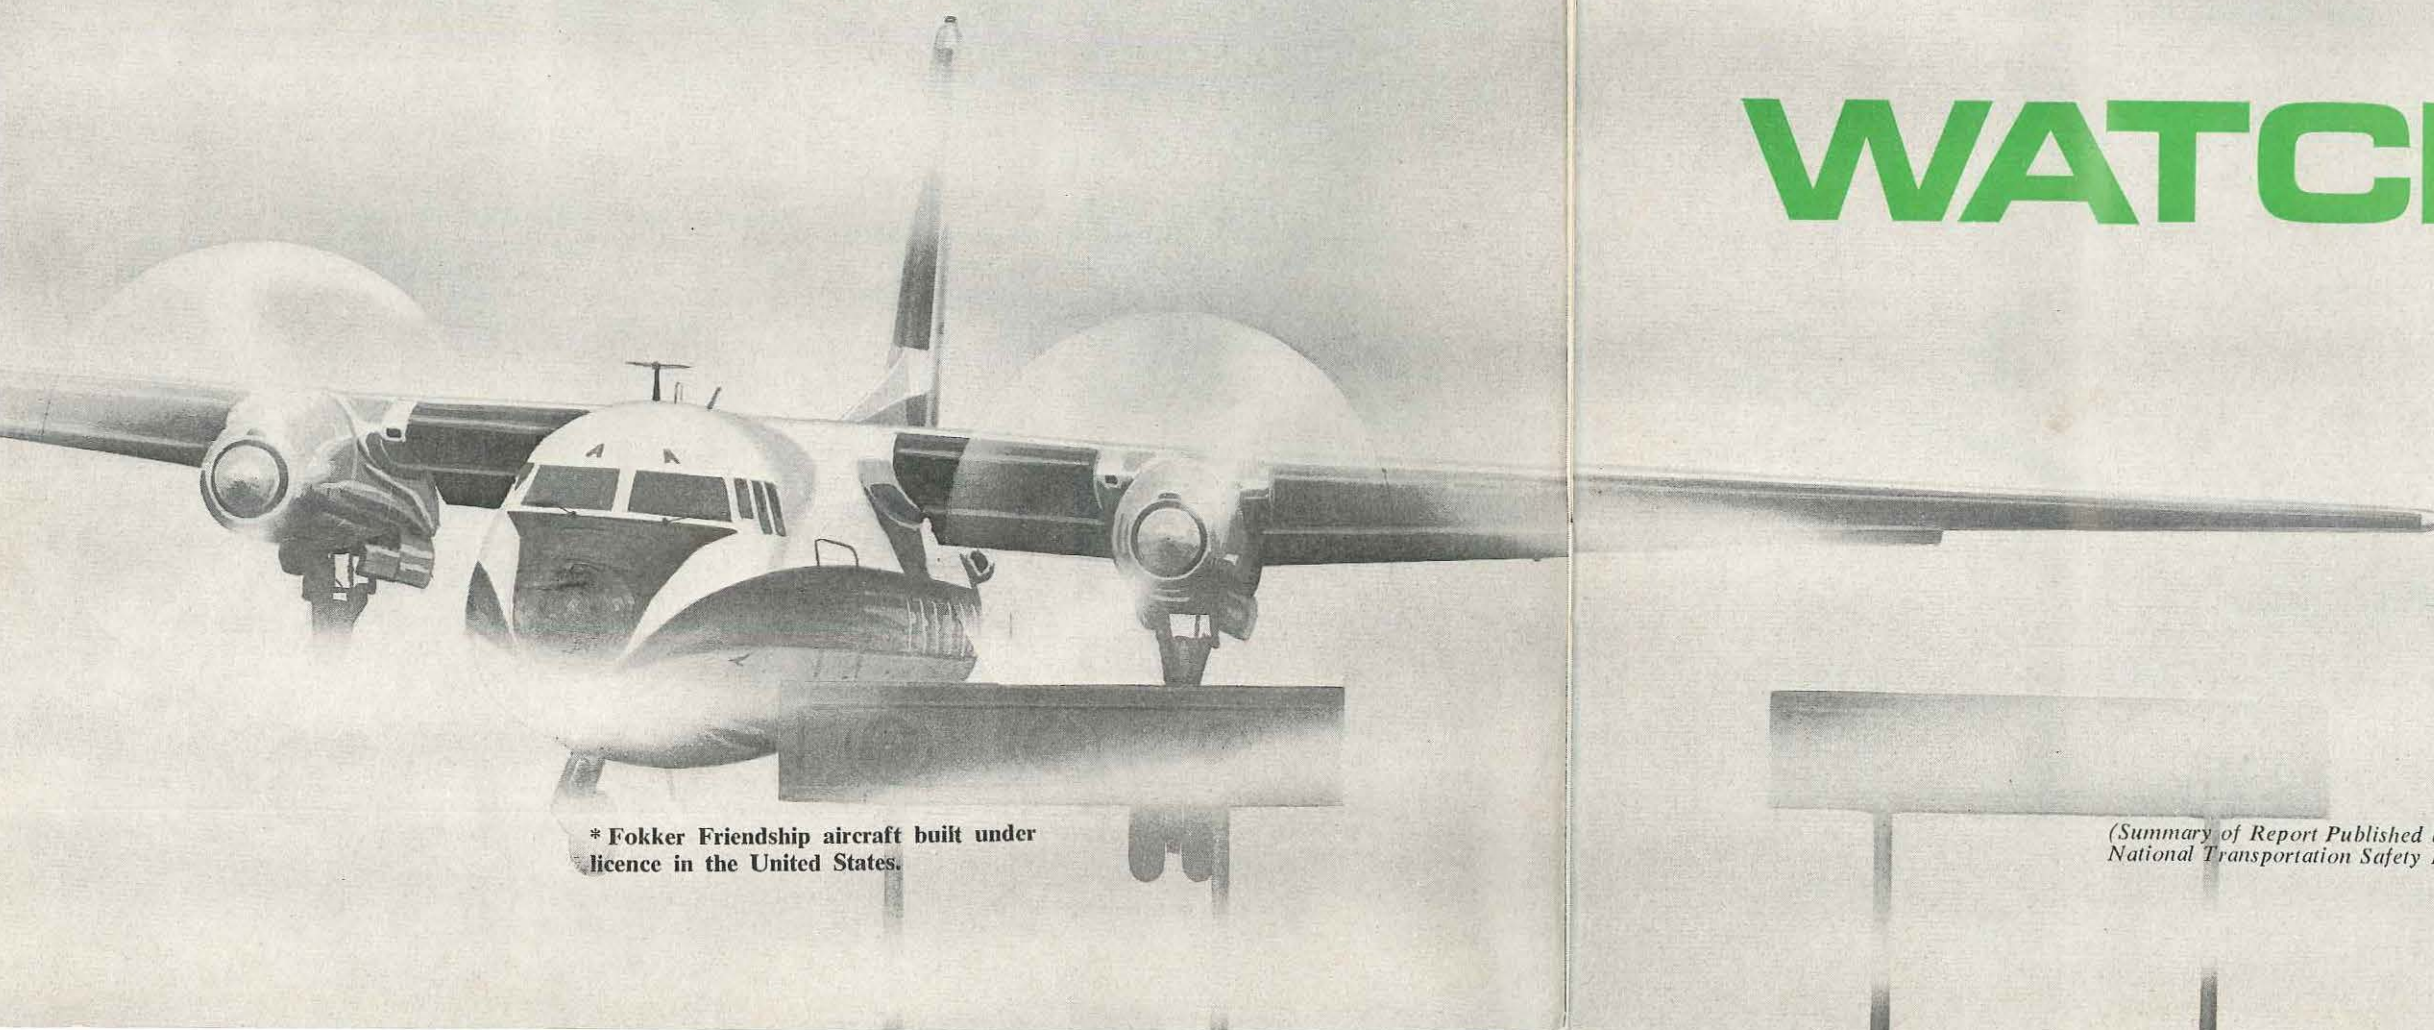
While making a localiser approach to land in daylight at Charleston, West Virginia, U.S.A., a FH-227B* descended below the final approach path and crashed into steeply sloping ground short of the runway. All but two of the 32 occupants were killed and the aircraft was destroyed by impact forces and the ensuing fire. At the time a layer of fog obscured the runway threshold and part of the runway approach lighting system. Beyond the area of fog, visual conditions existed.

The major portion of the airframe and all control surfaces were found in the main wreckage area. There was no evidence of any failure or malfunction of the flight control system before impact,

and at the time the undercarriage and the flaps were fully extended. Both engines had separated from the aircraft at impact and were recovered in the main wreckage area. A detailed examination of both engines and propellers indicated that they were capable of normal operation before impact.

The Safety Board determined that the probable cause of the accident was an unrecognised loss of altitude orientation during the final portion of an approach into shallow, dense fog. The disorientation was caused by a rapid reduction in the ground guidance segment available to the pilot, at a point beyond which a go-around could not be successfully effected.

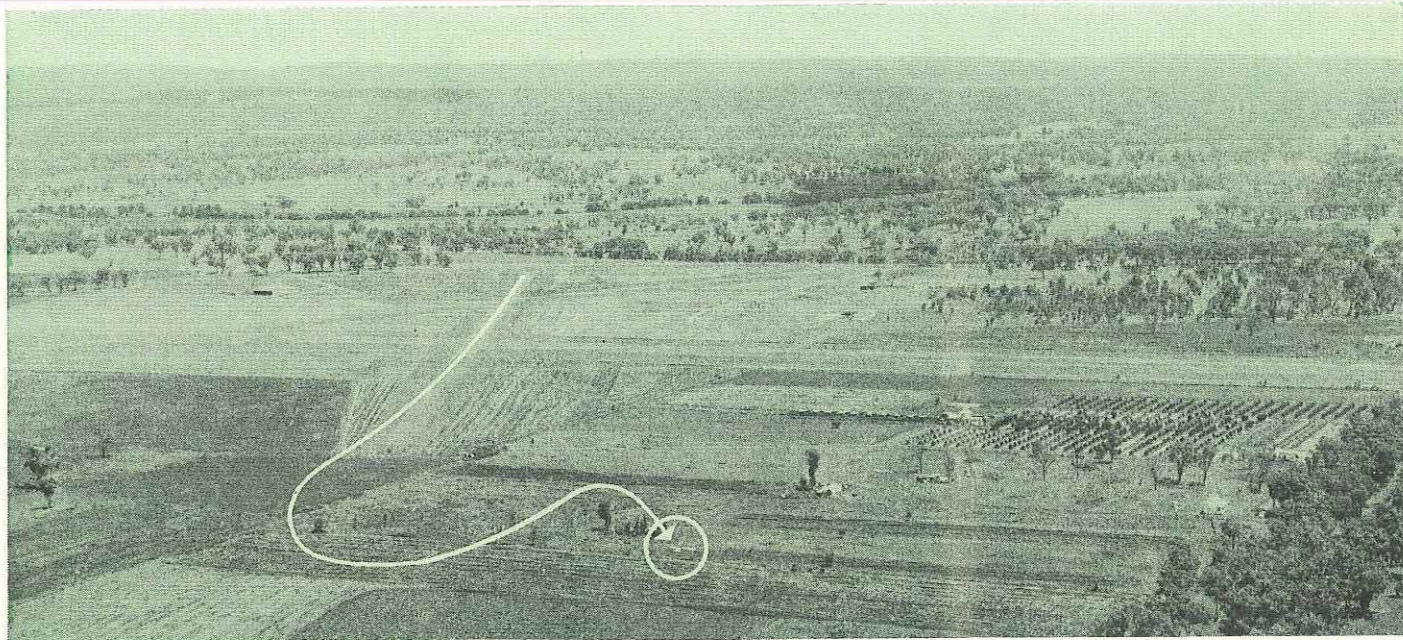
Aerial view of aerodrome showing direction of take-off and approximate flight path.

The probable cause of the accident was that the pilot, who was inexperienced on the type, lost control of the aircraft at a height which was too low to permit recovery. It has not been possible to establish the reason for the loss of control.

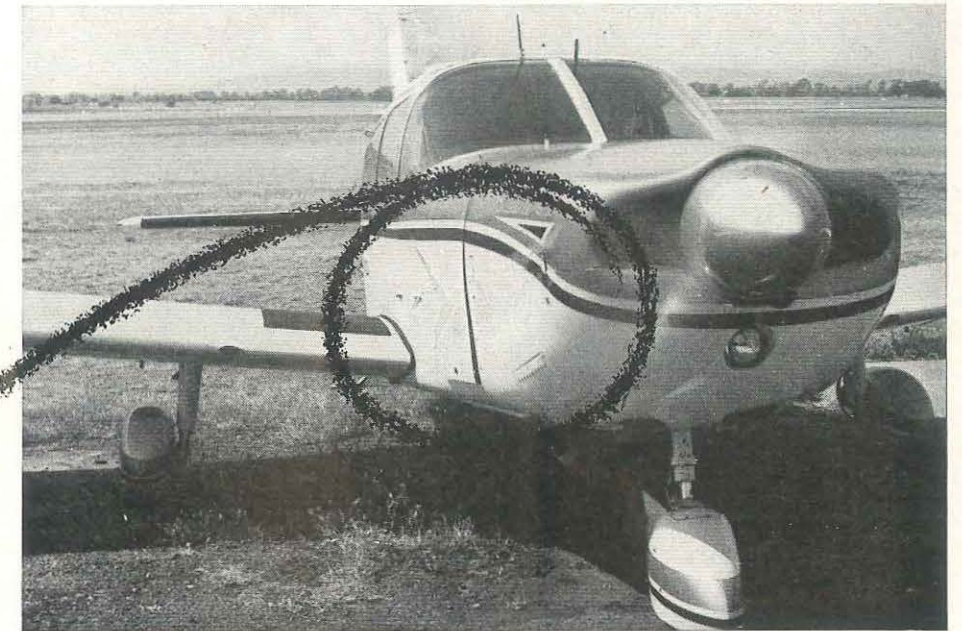
SOME time ago, the pilot of a Cherokee Six, about to touch down at a country airstrip, was startled to see the door of the nose luggage locker fly open. Almost immediately, there was a loud thump from somewhere outside the aircraft. After completing the landing and shutting down the engine, the pilot found that a 20 lb. gas cylinder had fallen from the nose locker when the door opened. The cylinder had punctured the skin of the starboard wing just ahead of the main spar, and then struck the tailplane, damaging the leading edge and both upper and lower skins. Extensive buckling of the rear fuselage skin had also occurred when the tailplane distorted under the impact.

The aircraft was an early model Cherokee Six and had a nose luggage door fitted with a key type barrel lock (see diagram). Inspecting the locker after the accident, the pilot found that although the door had opened, the tongue of the lock was still in the "locked" position. After he had "unlocked" the door, the pilot had no difficulty in closing it properly again, and he found that the door fitted quite firmly in the normal position.

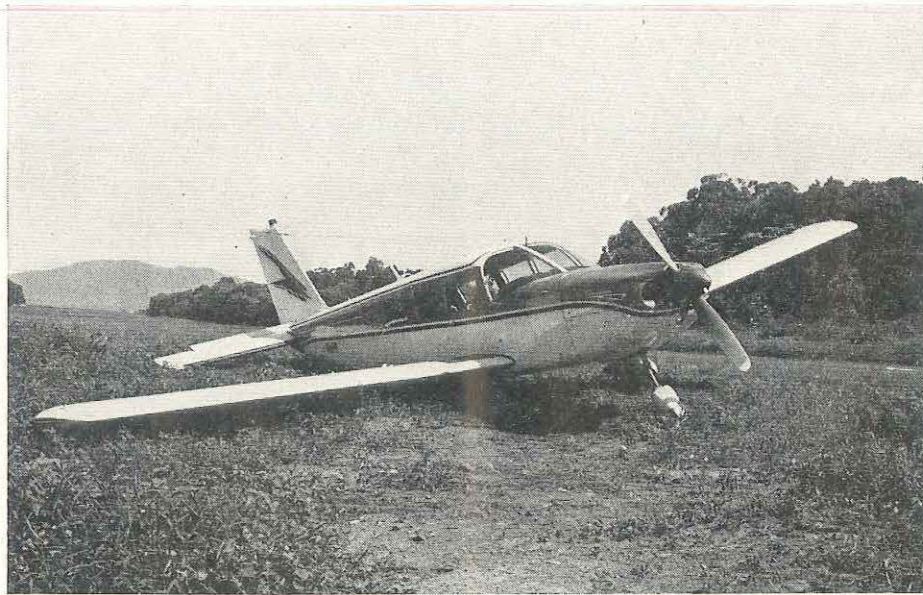
BEFORE landing at Dunk Island after a private flight from Cairns, the pilot of a Cherokee Six circled the strip several times to check the wind direction and the layout of the aerodrome. There was no wind and while he was circling and making up his mind in which direction he should land, he saw another Cherokee land into the south-east. He therefore decided to land in the same direction and carried out a left hand circuit with this intention. His final approach was steeper than normal and faster than recommended in the existing conditions, and after the pilot had rounded out, the aircraft floated for some distance. It touched down initially about a quarter of the way along the strip, but after striking a depression in the surface, became airborne again and touched down finally half way down the strip. The pilot applied the brakes but on the grass surface, the aircraft did not decelerate as quickly as he expected. When he saw that the aircraft was not going to stop within the confines of the strip, he turned to starboard slightly towards what appeared to be an extension of the strip. When the pilot saw that this area was not usable, he turned the aircraft back to port. By this time, however, the aircraft had passed beyond the markers of the strip and at low speed, the starboard wheel entered a depression and was wrenched off. The aircraft came to rest

on its starboard wing and, after turning off the fuel and switches, the pilot and his passengers quickly left the aircraft.

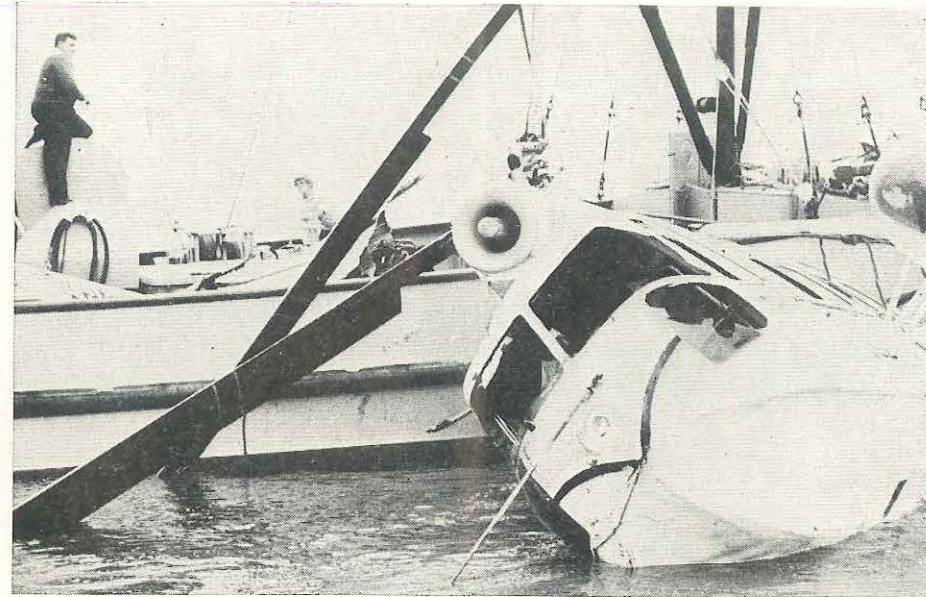
AT Lake Wellington, Gippsland, Victoria an amphibious S62A helicopter was engaged in a flying training exercise. Two highly experienced helicopter pilots were at the controls of the aircraft. The pilot flying the helicopter was doing so under the supervision of the other pilot, as part of his training for appointment as the company's check and training officer for this type.

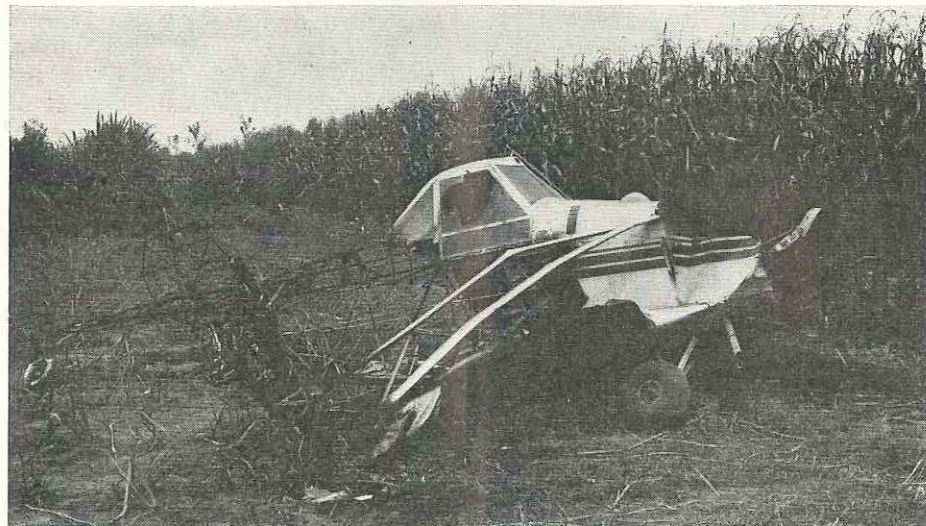
The manager made up his mind that if he found the area satisfactory he would straight away proceed with the spraying. Early the next morning he loaded the aircraft with chemical and flew to the cane-field where the farmer was working. After making a superficial inspection of the area, the pilot manoeuvred the aircraft into position, then descended steeply over trees towards the undulating crop to begin his first spraying run. As he did so, the pilot looked momentarily away from his line of flight to see what the farmer was doing, and the aircraft flew into the crop. The pilot was unable to regain control, and the aircraft crashed in an adjoining paddock and caught fire. The aircraft was destroyed and the pilot suffered severe burns.

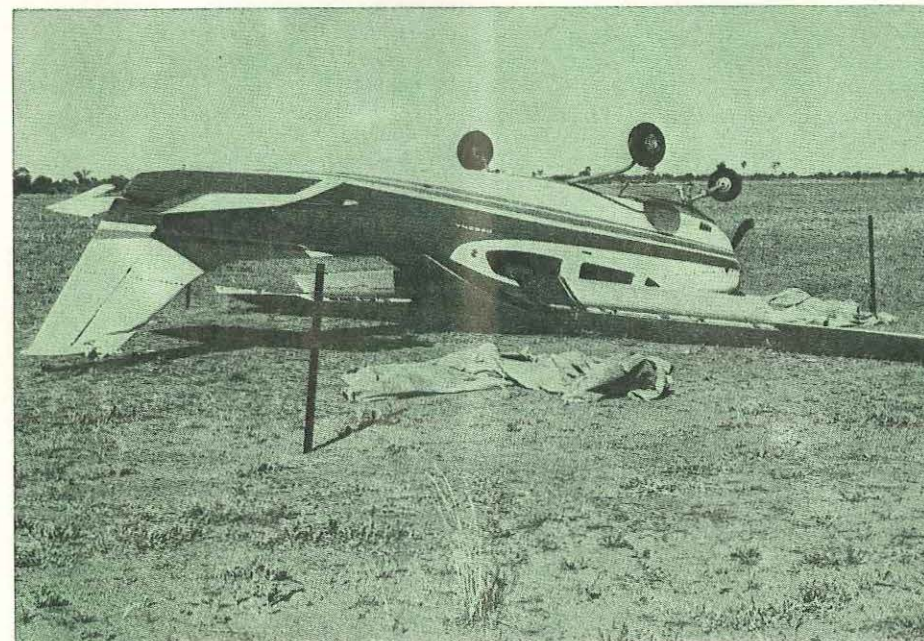
After turning on to final approach, the pilot found that the light had faded badly, though the sky remained bright. The pilot had difficulty in distinguishing the strip from the neighbouring area and although he did not realise it, the aircraft's final approach path was displaced about 100 feet to the left of the strip. As the aircraft touched down, the undercarriage struck a rabbit warren forming a mound of earth about two feet high which the pilot had not seen. The aircraft ballooned high into the air, floated for over 300 feet, then sank heavily on to the ground again. The nose-wheel collapsed, the aircraft skidded on its nose for a short distance and then somersaulted on to its back.

The aircraft was substantially damaged but the pilot escaped injury.

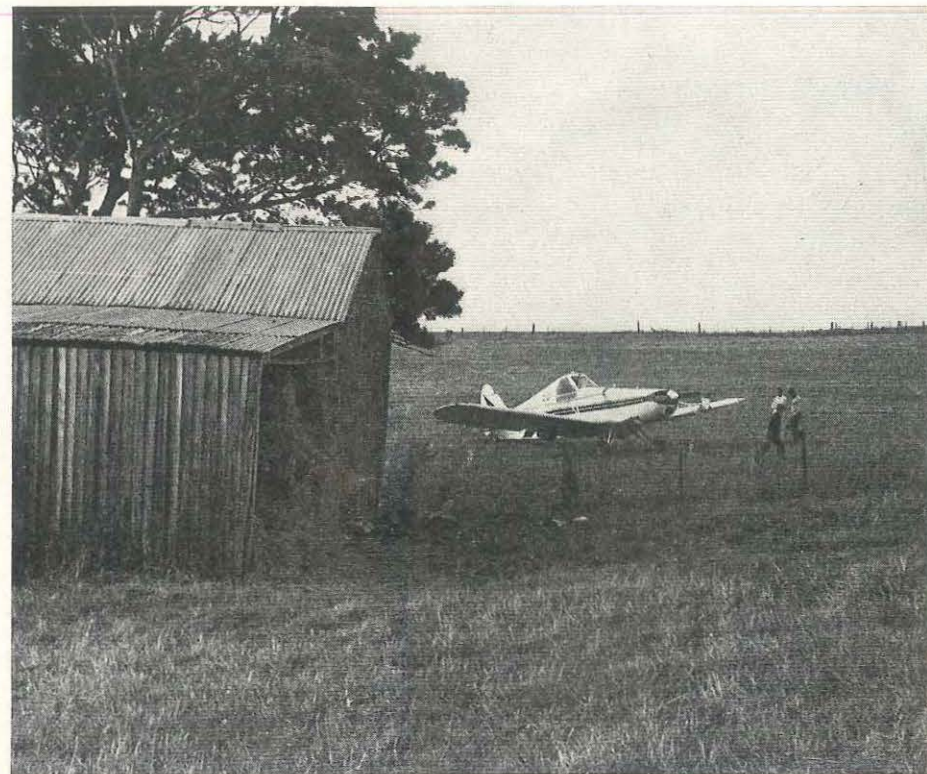
IN Tasmania, a Piper Pawnee was engaged in spreading superphosphate over hilly and moderately timbered terrain in which the cleared areas were fenced into small paddocks only about 100 yards square. While making a procedure turn at the end of one spreading run at a height of about 100 feet, the aircraft's engine failed completely. The pilot carried out a quick trouble check, then tried to position the aircraft for a forced landing uphill in a field less than 400 feet in length, which lay ahead and to the right of the aircraft's position. The aircraft struck a barbed wire fence at the approach end of the field and, as it touched down, the pilot applied the brakes fully and used the slope of the ground to assist in ground looping the aircraft to the right.

The wings and tail plane had been damaged when the aircraft struck the fence but, apart from the failure of the tailwheel fork during the ground loop, the aircraft sustained no further damage. Despite the fact that the fuel tank contents gauge showed that eight gallons remained, the aircraft's fuel tank was found to contain only one pint of fuel.
