Number 78 March 1972

DEPARTMENT OF CIVIL AVIATION AUSTRALIA

AVIATION SAFETY DIGEST

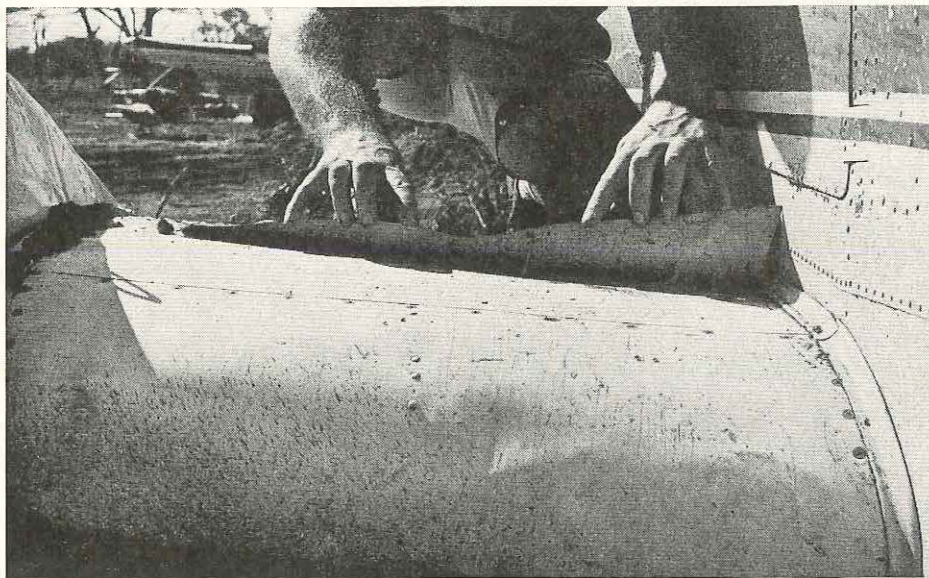
Top: View of accident site showing the aircraft as it came to rest with the port wing and tailplane torn off. The wheel tracks in the foreground are those of the salvage vehicle.

Bottom: The forward edge of the non-slip walkway showing its separation from the upper surface of the wing. The resulting turbulent airflow over the tailplane was probably responsible for the vibration which alarmed the pilot.

access panels, or other sections of the airframe were missing, and apart from impact damage, the engines and propellers should have been capable of functioning normally. But on the starboard wing inboard of the engine nacelle, the non-slip walkway, which is normally secured to the upper surface of the wing with adhesive, had separated from the wing at its forward edge. It seemed likely that this section of the wing-walk, protruding into the slipstream, could have created a turbulent airflow over the starboard tailplane and caused the vibration experienced by the pilot.

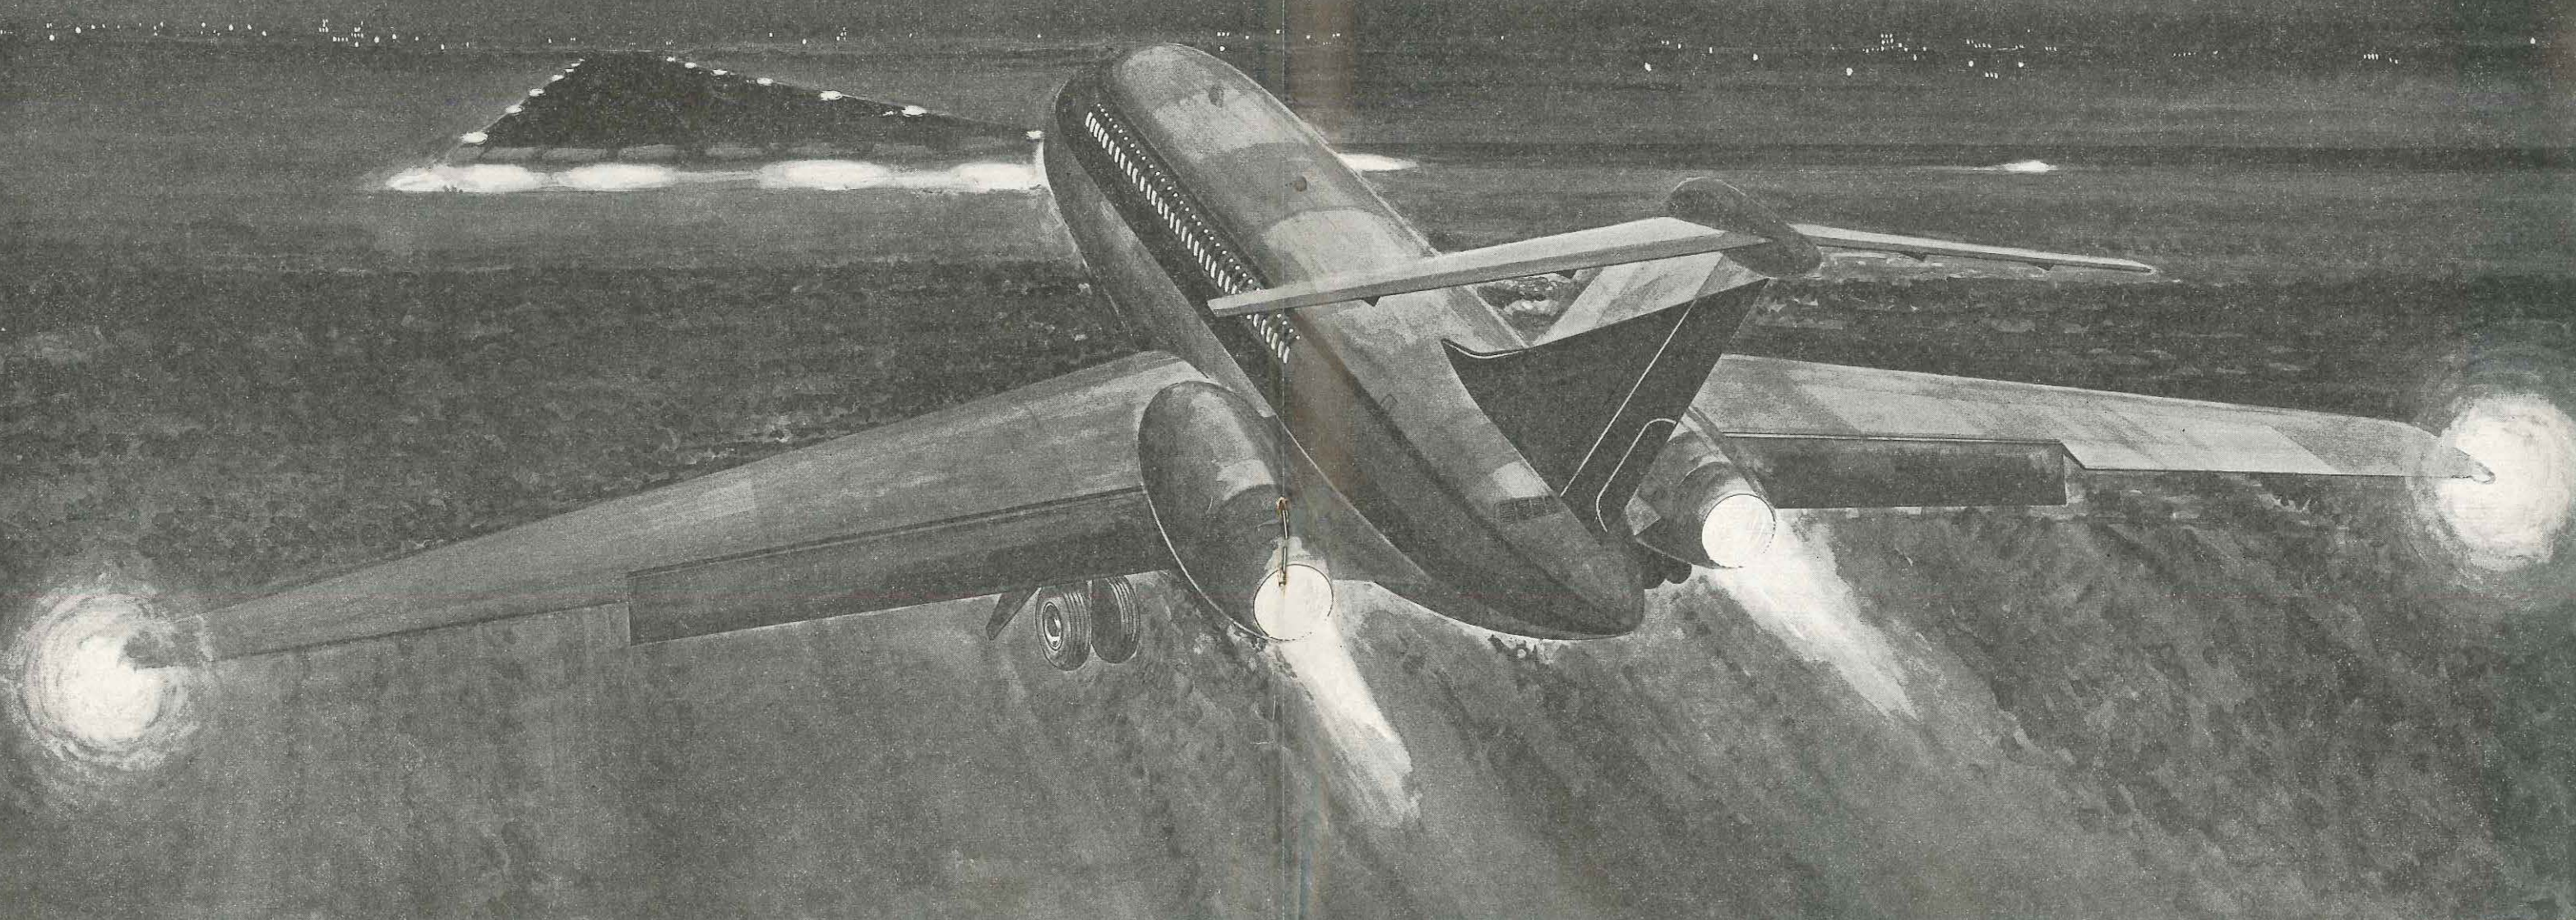
Examination of the aircraft showed that the fuselage had buckled and fractured symmetrically immediately aft of the wing, between fuselage stations 737 and 794. The tailcone rested on the runway and its underside had been worn flat with heat discoloration visible on both sides. There was no apparent damage to the undercarriage or its supporting structure but both port undercarriage tyres had flat spots, which had penetrated the casings, worn on them.

The loads and forces necessary to cause the failure sustained by the fuselage were analysed by the manufacturer, and it was concluded that the increase in effective sink rate, resulting from the landing on the upward slope, was the primary cause of the damage. If the aircraft had landed on the level runway at the same actual rate of sink, it would probably not have been damaged.

The DC-9 with its back broken as it came to a stop on the runway.

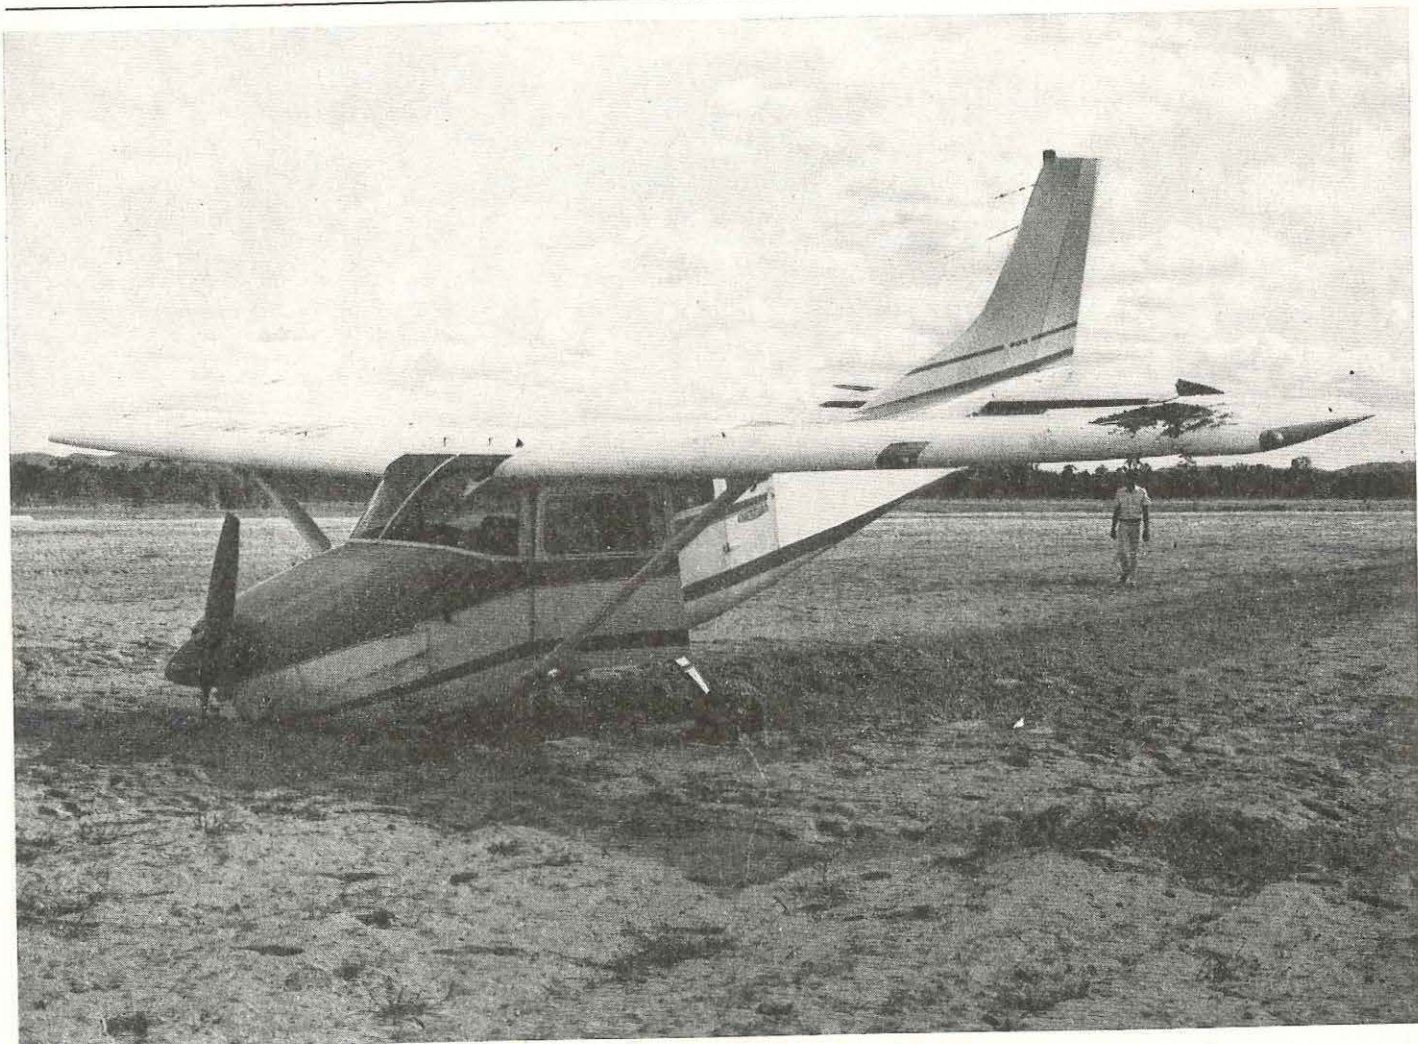
THIS Cessna 205, owned by a north Queensland cattle station, was being flown by a jackeroo employed by the station, who held a private pilot licence. The pilot departed late in the afternoon to fly two of the station's directors to Cairns, where they were to catch a south-bound airline flight. The flight was expected to take two hours and the aircraft's ETA at Cairns was 19 minutes before last light. The pilot had flown the route many times, and as the weather had been fine all day at the station, he did not obtain a forecast before taking off. However, when he called Cairns from 50 miles out, he learnt that the coastal weather was under the influence of a moist south easterly stream, and that there was low cloud and showers on the ranges. The pilot reported that if he was unable to reach Cairns, he would divert to Mareeba. As the aircraft approached the Great Dividing Range from the west, the weather progressively deteriorated, making it necessary for the aircraft to divert from track a number of times to remain in VMC. More time was lost in an attempt to penetrate the Kurunda Gap and it was not until 1814 hours, nine minutes before last light, that the pilot reported he was diverting to land at Mareeba. At 1822 he reported in the circuit area at Mareeba but shortly afterwards lost sight of the aerodrome in the darkness and rain. He was unable to locate the aerodrome again and hurriedly selected a ploughed field for a precautionary landing while it was still light enough to see. The aircraft touched down normally, but after running parallel with the furrows for about 500 feet, the nose undercarriage dug into soft soil and snapped off. The three occupants were shaken but otherwise unhurt.

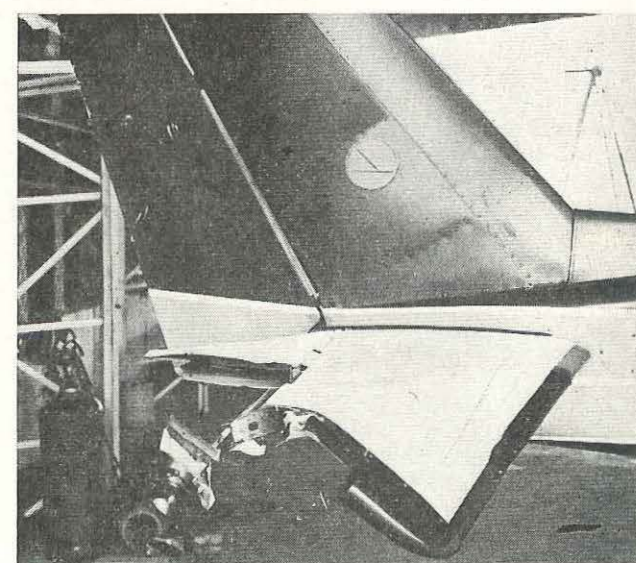
Although the pilot of this Slingsby Skylark was experienced in winch launching, he was undertaking only his third flight in this type of glider.

The wind was light and variable and when he was ready and slack had been taken up in the cable, the pilot called for full power and the winch launch began. The glider left the ground after a short run and after climbing to 60 feet the pilot assumed the full climbing attitude at the recommended speed of 55 knots. Meanwhile the winch driver, after commencing the launch, believed there was a malfunction in the winch and, thinking the glider was still on the ground, he de-clutched the winch and closed the throttle. Realising that the glider has lost power from the winch, the pilot lowered the nose and pulled the cable release knob, but the glider sank rapidly with insufficient forward speed. The pilot attempted to flare the aircraft for the landing but it struck the ground heavily in a flat attitude, breaking its back. The pilot was not injured.

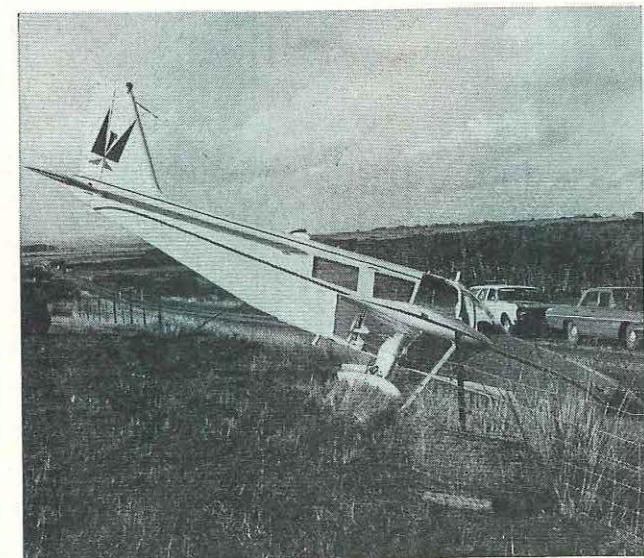
Arriving over an unattended airstrip from which he intended to conduct superphosphate spreading, the pilot of this Piper 'Pawnee' saw that sheep were grazing on the landing area. As his loader driver had obviously not arrived, he made a very low run to clear the sheep from the strip. Near the end of the run the aircraft struck two sheep, substantially damaging the starboard undercarriage assembly. The pilot completed a circuit however, and then landed the aircraft with very little additional damage.

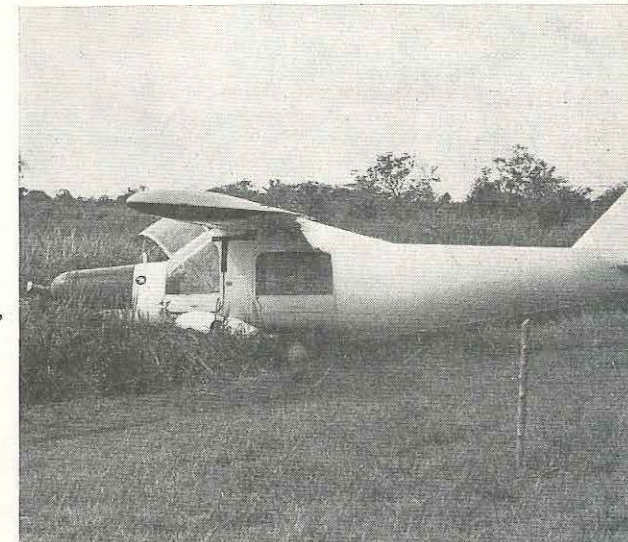
Entering the circuit area at Kunjingini, New Guinea, the pilot of this Dornier positioned the aircraft for a landing into the north. After turning on to final approach and lowering 35 degrees of flap, the pilot saw there was a horse grazing in the shade of a tree about half way down the western side of the strip. The horse was not moving and the pilot considered it would be safe to continue the landing. Lowering full flap he made a normal touchdown, but after the Dornier had rolled a short distance, the horse suddenly turned and bolted straight at the aircraft, striking the propeller and starboard undercarriage leg. The aircraft swung to the right, and before the pilot could regain directional control, it ran into a ditch on the eastern side of the strip. Both undercarriage legs were torn backwards, but the three occupants were not injured.

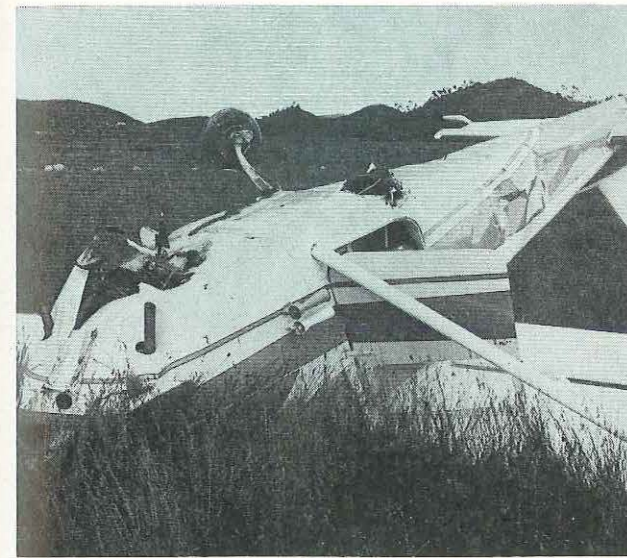
Unaware that the single runway at Zeehan, Tasmania, was only 140 feet longer than required by the type of aircraft he was flying, the pilot of this Cessna 172D crossed the threshold at about 100 feet and touched down with less than half the runway length remaining. The pilot applied the brakes but then realized he would not be able to stop. He attempted to go around but there was insufficient distance left in which to become airborne, and the aircraft overturned after striking a low earth embankment 22 feet beyond the end of the runway. The pilot sustained minor injuries.

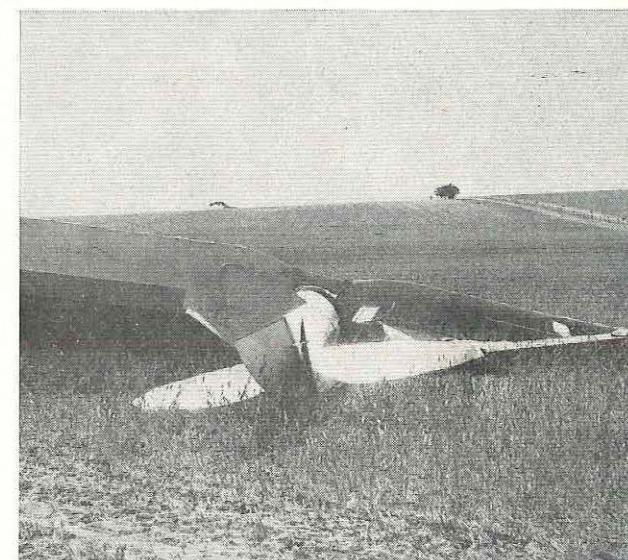
The pilot of this Tiger Moth had previously reported that recovery from spins to the right was more prolonged than from the left, and the rigging of the aircraft had been, checked and both ailerons and a strut replaced.

After climbing to 5,000 feet the pilot spun the aircraft and recovered several times but, believing the recovery from a right hand spin was still taking longer than it should, he climbed back to about 3,600 feet and again placed the aircraft in a spin to the right. When the pilot applied full left rudder to recover, the aircraft continued to spin, and after two further rotations, the pilot moved the control column forward progressively, still holding on left rudder. When this also seemed unsuccessful, he held on left aileron, then tried rocking the control column backwards and forwards, and finally applied power. The aircraft still did not recover, and continued to spin in a nose-down attitude until it struck the ground. The pilot was seriously injured.

Examination of the wreckage did not disclose any defects, and although the pilot later demonstrated the correct spin recovery technique during a flight test, it was concluded that, possibly because of the effects of the prolonged spinning, he had not sustained the complete technique for spin recovery.
