AVIATION
SAFETY
DIGEST

A MATTER OF TIME!

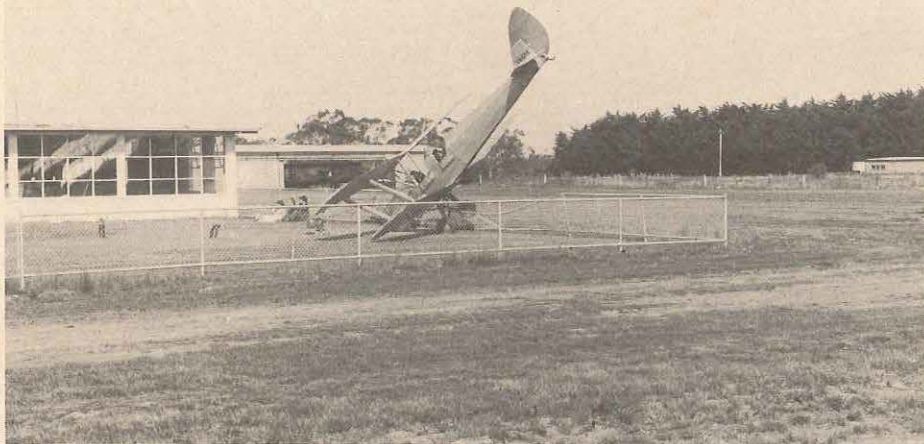
Left: "The fundamental safety measures for hand starting are frequently overlooked or disregarded." All the more embarrassing when it happens in front of the club-house!

Right: "The handle of the main pressure oil filter should be rotated two or three times before the first flight of each day."

Right: "Particular care is necessary when applying forward elevator control, with engine power, to go around from a touch-and-go landing" - this even includes experienced flying instructors!

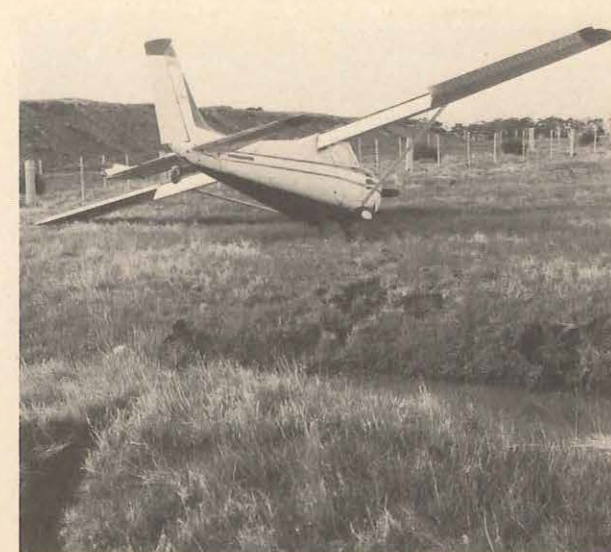
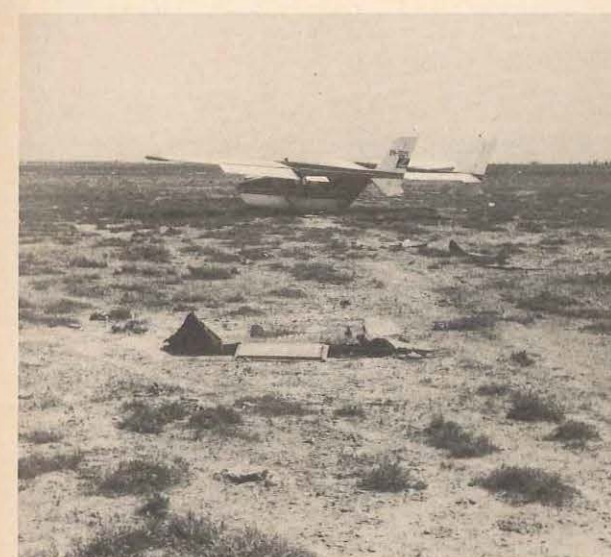
Before departing from Perth, Western Australia the pilot of a Cessna 337 carried out a short flight to familiarise himself with the operation of the auto-pilot. The aircraft was then refuelled to capacity and the pilot took-off for Newman. Landing at Newman some four hours later, the pilot decided to refill the auxiliary tanks only, as the fuel gauges indicated there was still 50 U.S. gallons in the mains. With an estimated fuel quantity of 81 U.S. gallons, and an endurance of four hours the pilot then departed for Marble Bar. En route to Marble Bar, the pilot in consultation with his passengers decided to continue to Broome, as he had calculated he still had sufficient fuel for the diversion, plus the mandatory 45 minutes reserve. However, when about 10 miles from Broome, the front engine failed because of fuel exhaustion and, as the aircraft had been flying just off the coast, the pilot turned towards the shore. Shortly afterwards, the rear engine also failed from fuel exhaustion, so the pilot selected a large paddock near a homestead and prepared for a forced landing. From the air, the pilot assessed the field surface as being rough, and decided to land with the undercarriage retracted. The touchdown was smooth but, just before the aircraft slid to a stop, it swung to the left and the belly cargo pack disintegrated. It was later discovered that the fuel quantity gauges were grossly inaccurate. The pilot had based his endurance calculations on these indications.

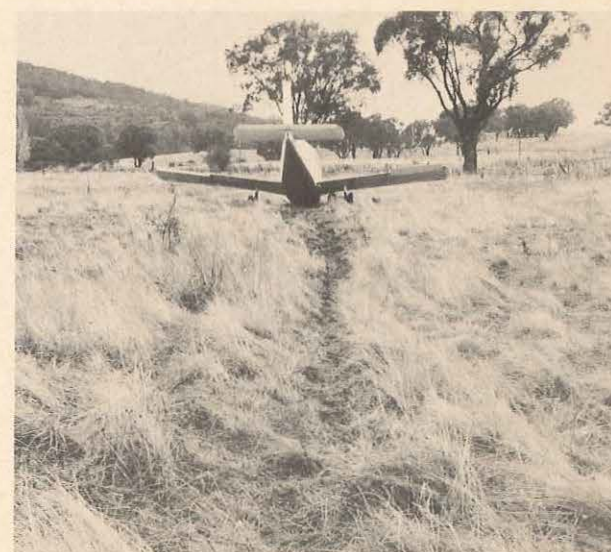
A commercial pilot had been engaged to make a charter flight from Bankstown to Griffith, N.S.W. in a Piper Cherokee. Arriving at the aerodrome early on the morning of the flight, the pilot obtained the relevant area forecast and completed a flight plan. The forecast indicated that a front was approaching Sydney from the south-west. After the passengers had boarded the aircraft, they departed in clear weather.

As the flight proceeded the weather gradually deteriorated, until over the Great Dividing Range the aircraft was flying through sleet and snow just below the cloud base, about 400 feet above the ground. By this time, the weather had also closed in behind the aircraft, and the pilot realised he was trapped in a valley, with cloud lying on the tops of all the surrounding hills. Rather than enter the cloud the pilot decided to make a precautionary landing and chose a field which he judged as suitable. In reality, the field was short and rough and soon after touching down the aircraft's nose leg collapsed. The aircraft slid to a halt on its main wheels and engine cowling, but all three occupants escaped without injury.

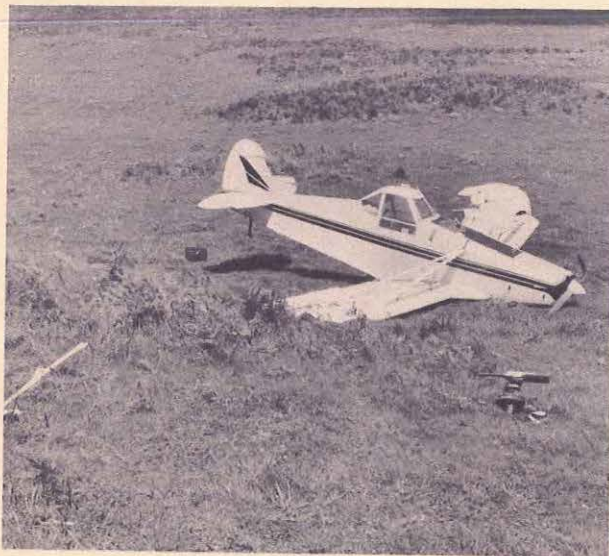
After completing an hour and a half of aerial spraying in Victoria, the pilot climbed the PA25 Pawnee to about 400 feet, so he could plan the clean-up run he was about to do. At this point, the engine faltered and the pilot immediately selected carburettor heat. This improved the running of the engine and after about 15 seconds he returned the selector to cold. Shortly afterwards, the engine faltered again, so the pilot pumped the throttle and reselected carburettor heat, but this time it did not restore power to the engine. He turned off the fuel and magneto switches, and began gliding towards the only clear area in his vicinity. The sloping terrain was undulating, with outcrops of rock and while trying to reach the selected landing area, first the wing tips, then the undercarriage, struck some rocky outcrops. Substantially damaged, the aircraft continued on down the slope, swung through 120 degrees, and eventually came to rest on its belly. The pilot vacated the aircraft uninjured. No fault could subsequently be found with the engine.

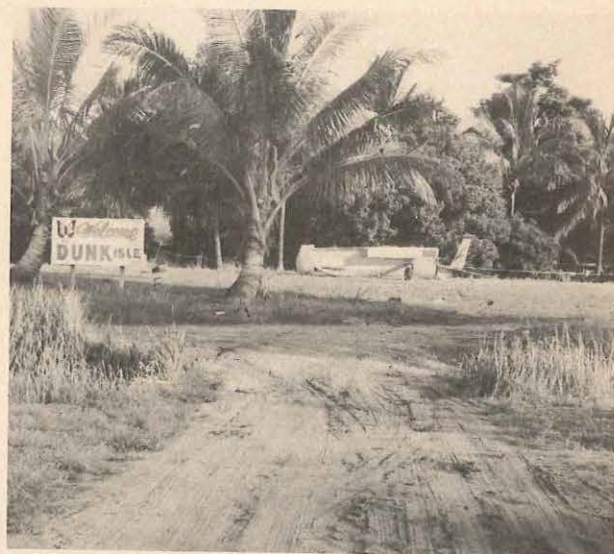
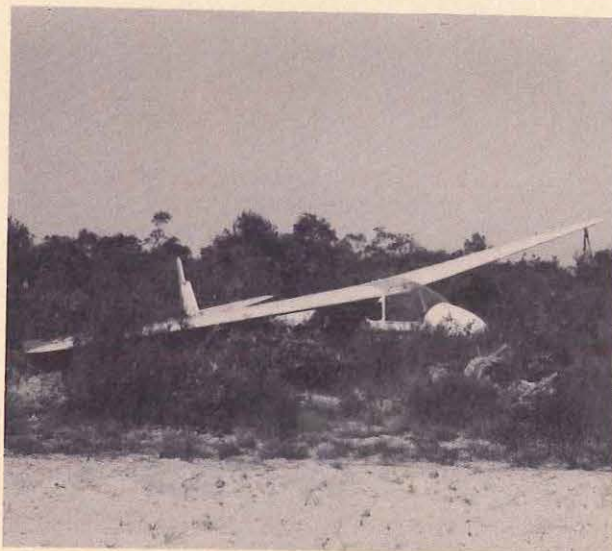
At Elliott gliding field, near Bundaberg Queensland, this ES 52 Kookaburra was winch launched to a height of about 1,000 feet. On board was an instructor and a student, and after releasing from the winch they continued in the same direction, attempting to find a thermal so the student could be instructed in the further effects of controls. When the glider had descended to 800 feet, without having located a thermal, the instructor decided they should return and land. By the time they had rejoined the circuit at the winch end of the runway, they were down to 600 feet and, as the wind was only light, the instructor elected to make a "down wind" landing. After the spoilers were opened, the glider sank quite rapidly, but when about mid-way down the runway, the instructor realised they were overshooting. At a height of about 100 feet he eased the nose up to reduce the speed to 45 knots and increase the rate of sink. But suddenly the glider stalled, dropped the starboard wing and began to turn in that direction. The instructor immediately recovered from the stall, but on touchdown the glider was still askew to the runway and ran off to the right into the surrounding bush. The occupants were not injured.

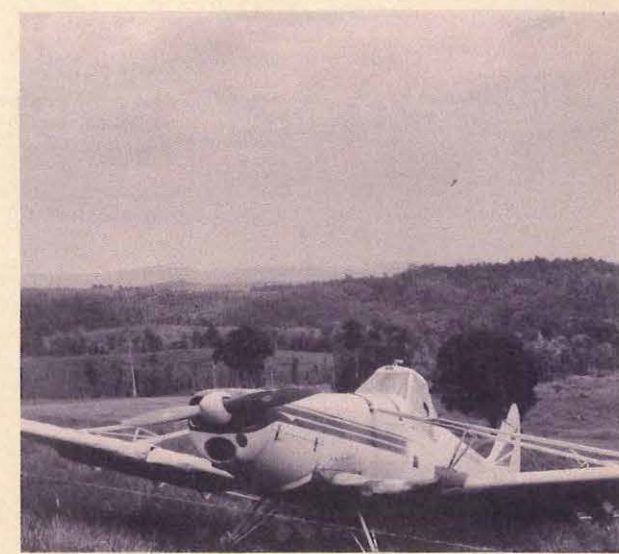
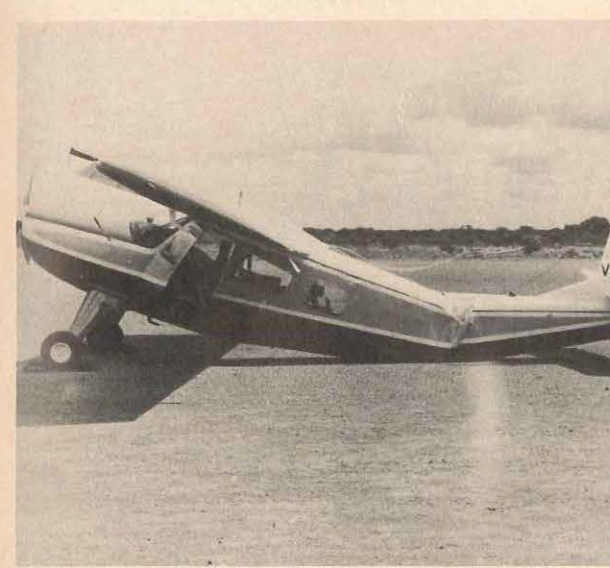
When does a heavy landing become an accident? Undoubtedly by this point!

The owner-pilot of this Helio Courier decided to carry out some circuit practice at a country aerodrome. The first two circuits were carried out without any particular problem using an approach speed of 55 knots and 30 degrees of flap. On each approach however, the pilot had noticed an unusual amount of lift, followed by a high rate of sink just before reaching the threshold of the runway, so on the third circuit he planned to touch down well beyond the beginning of the runway with the object of overcoming this effect.
