AVIATION
SAFETY
DIGEST

Number 90 1975
CONTENTS

LIBELLE

SHEDS WINGS IN FLIGHT

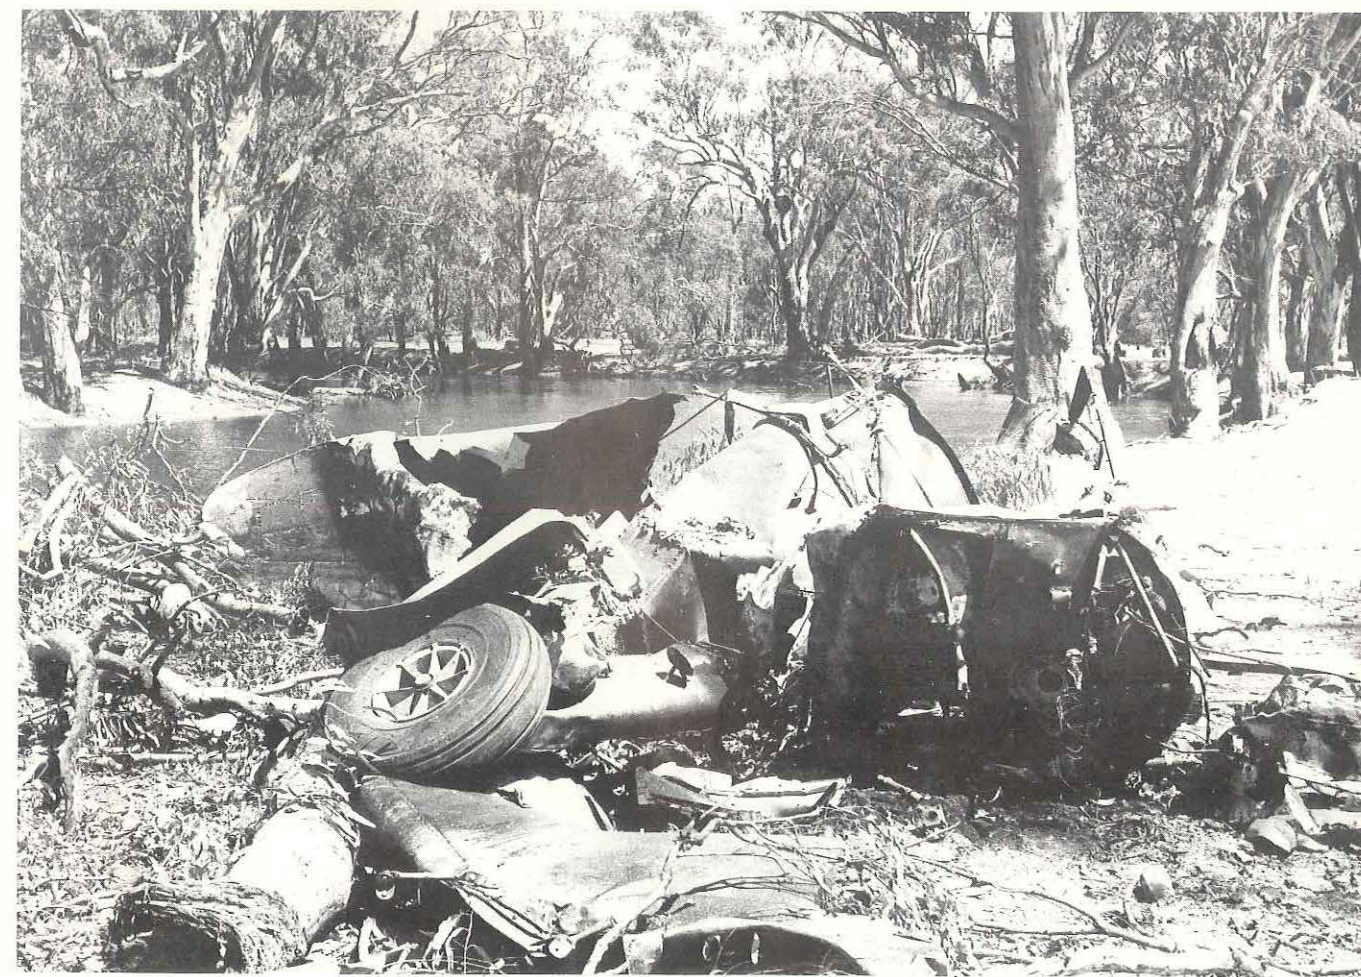
The burnt out wreckage of the Beaver as it came to rest on the river bank nearest the rice paddy being treated.

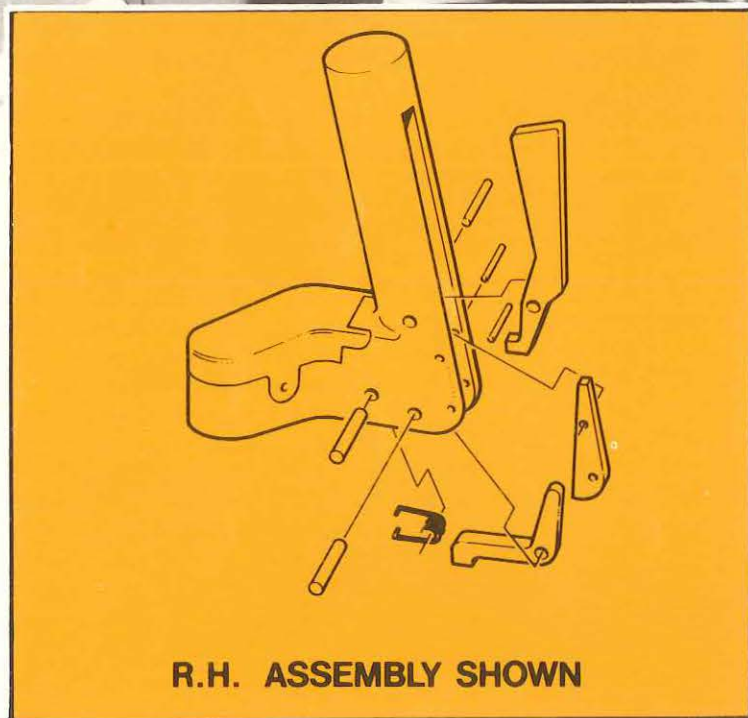
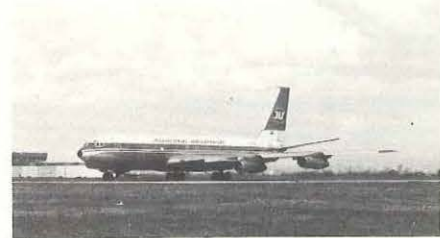
During the subsequent investigation, the co-pilot's sliding window, which had sprung open during the take-off, was examined. It was found that the roll pin, which secures the window handle to its shaft, was withdrawn about seven millimetres. The trigger lock bolt was worn, and the window adjusting rod shortened by one full turn. As well, there was excessive play in the window handle mechanism. The window was checked for operation and it was found that a force of 22 to 27 kg was required to lock the window, as against the normal force of about 20 kg. The spring-loaded trigger in the handle hung in a mid-travel position and the associated trigger lock bolt did not fully engage the lock plate hole. In this condition, though the window appeared to be in a closed and locked position, any pressure applied to the handle would disengage the trigger lock bolt, enabling the window to open.

take-off. The condition of the locking mechanism of the window was such that, to all outward appearances, the window was closed and locked. In fact however, the locking mechanism was out of adjustment and as a result, the locking bolt was not fully in place.

Top: View of starboard side of Boeing 707 cockpit showing co-pilot's sliding window and spring loaded trigger.

Inset Diagram: Exploded view of trigger mechanism.

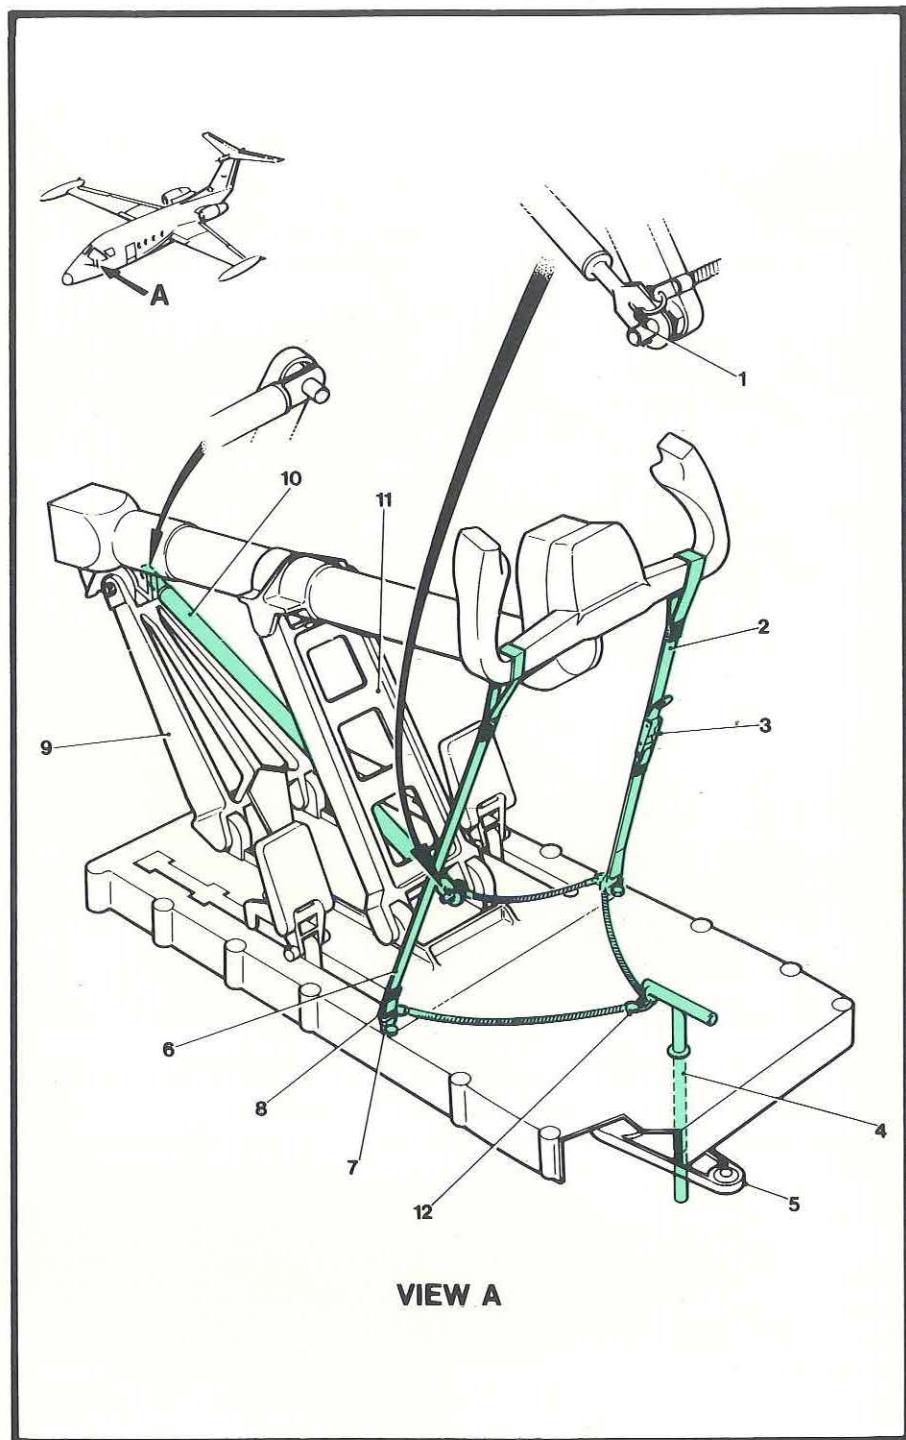
VIEW A

tain's control assembly was found to be bent in a manner consistent with the elevator gust lock strut having been in position at the time the aircraft collided with the railway line. There was no impact mark or other damage to account for the bend in this spigot. The control assembly on the first officer's side had broken up whilst in the neutral position, and the absence of impact marks on either set of control assembly stops indicated that they had not been 'hammered' at any time during the break up.

The aircraft's elevator controls are manually operated and of conventional pattern. Locking either set of cockpit controls locks the entire system. The gust lock system provides for locking the controls in the cockpit and consists of a pair of webbing straps, a 'T' shaped metal fitting, and a light alloy tubular rod which are normally connected together by cord. There is no interconnection between the gust locks and the thrust levers, and it is possible to obtain take-off power with the locks in place. When in use, the webbing straps are fastened over the control wheel horns to provide aileron protection, the rudder is held by inserting the 'T' shaped metal fitting through a hole in the cockpit floor, into a matching hole in the rudder mechanism, and the elevators are locked by a light alloy rod located on two spigots on opposite corners of the pantographic elevator control assembly. The manufacturer specified that the gust locks should always be fastened together.

Notwithstanding these instructions they were sometimes separated for ease of installation, and they were reported to have been separated on the aircraft involved in the accident. When installed as the manufacturer intended, the complete gust lock system hinders access to the pilot's seat sufficiently to provide a safeguard. However this hindrance is provided by the aileron straps and it is lost when the elevator gust lock, disconnected from the rest of the apparatus, is installed on its own. It was noted that if the elevator gust lock is dislodged from its bottom spigot only, the control column can be moved fully

forward, but fouling of the aircraft structure by the lock strut prevents any degree of rearward movement.
