AVIATION
SAFETY
DIGEST

Number 91 1975

AUSTRALIAN DEPARTMENT OF TRANSPORT

A TRAGEDY of ERRORS

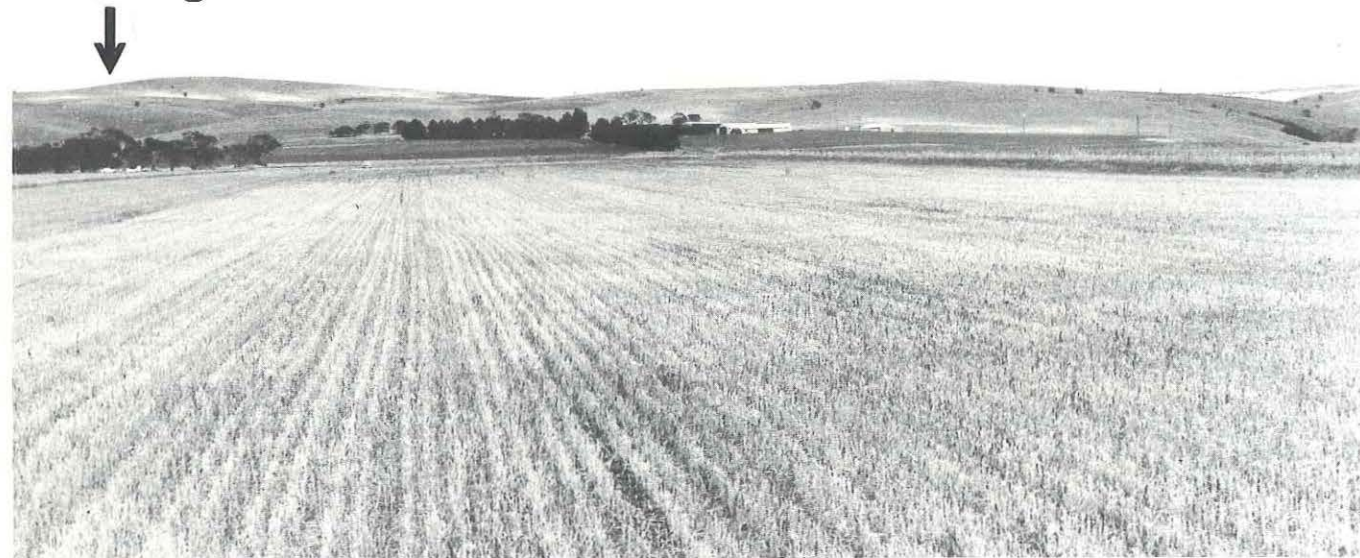
Wreckage

Examination of the wreckage did not reveal any defect in the aircraft or its systems which could have contributed to the accident, and it was apparent that the engine was developing full power throughout the take-off run until the moment of impact.

The pilot was unaware until afterwards that the port wing tip had scraped the ground after the aircraft had become airborne initially. Nevertheless, the intermittent sounding of the stall warning at this time, followed almost immediately by the aircraft's heavy impact with the ground, obviously should have indicated a stalled or semi-stalled condition at a dangerously late stage in the take-off. Abandoning the take-off at that point, would probably have resulted in only minor damage as the aircraft slid into the fence, or was deliberately ground-looped to avoid it.

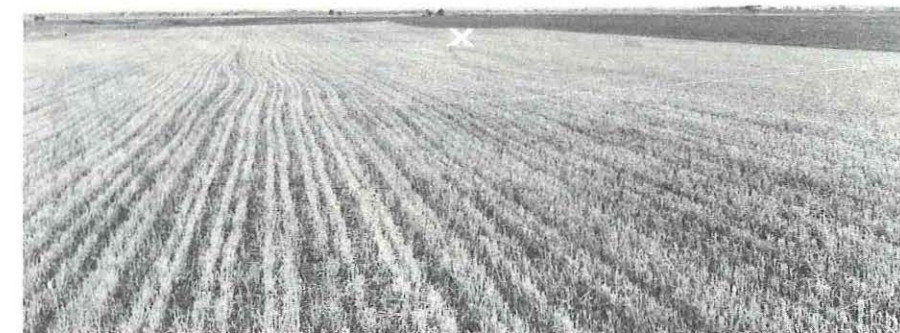
Take-off commenced here

Probably the most significant aspect of this accident is that it contains yet another tragic lesson on the wisdom of using all the available length for take-off. On this occasion there was no reason whatever why the pilot could not have taxied right to the end of the cleared area of the crop and used the full 915 metres available. Instead he began the take-off from a point where the distance to the upwind fence was only a little over half the total length.

In deciding not to use the full distance, the pilot's judgment was influenced by his belief that the upslope on this portion of the strip would have degraded the aircraft's performance. In actual fact, he would have gained 425 metres of strip and, as the increase in upslope over this length was only a quarter of a degree, the effect would have been small indeed compared to the benefits of using the full distance. Had the pilot done this, there is no reason why the aircraft should not have comfortably cleared the boundary fence and the trees beyond.

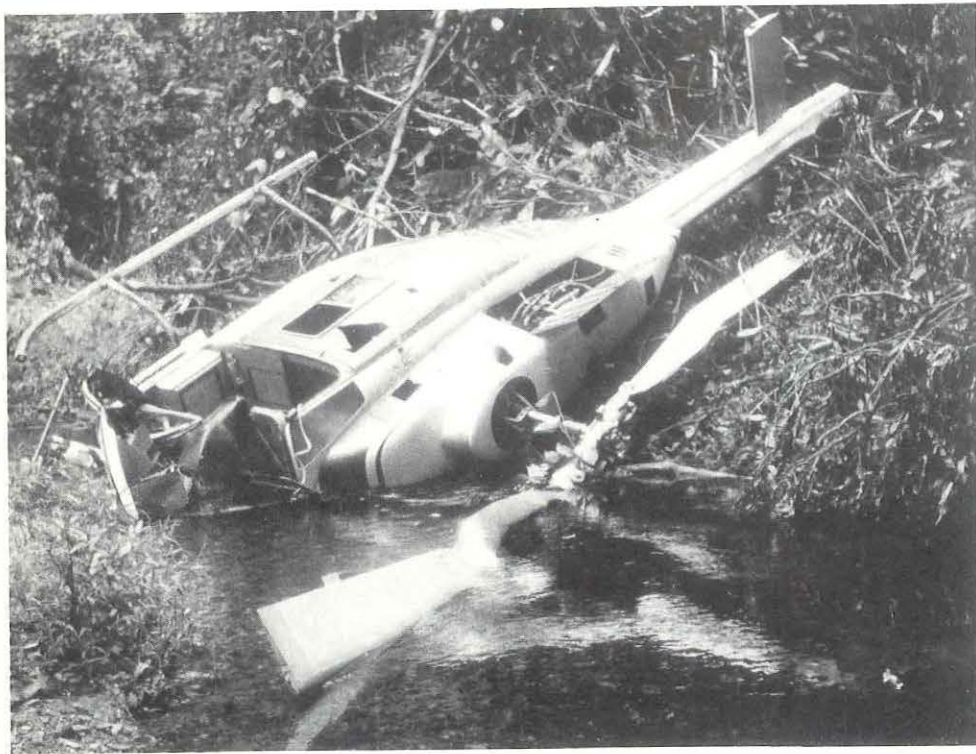
Examination of the wreckage failed to reveal evidence of any defect or malfunction which could have contributed to the accident. At the moment of impact, the aircraft was in a climbing configuration. The height of

Opposite page: The remains of the burnt-out fuselage suspended in the dense undergrowth.
