AVIATION
SAFETY
DIGEST

Number 92 1975

AUSTRALIAN DEPARTMENT OF TRANSPORT

CONTENTS

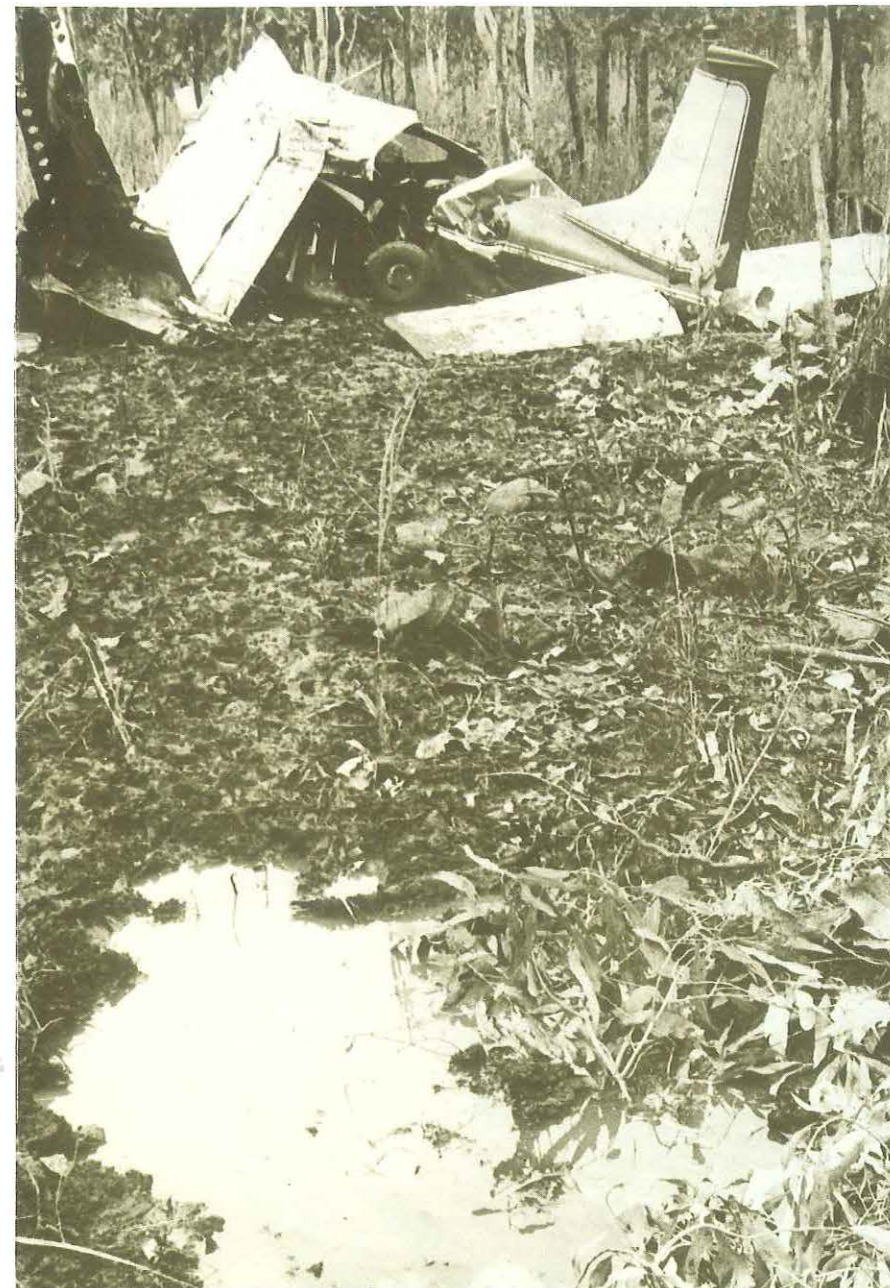
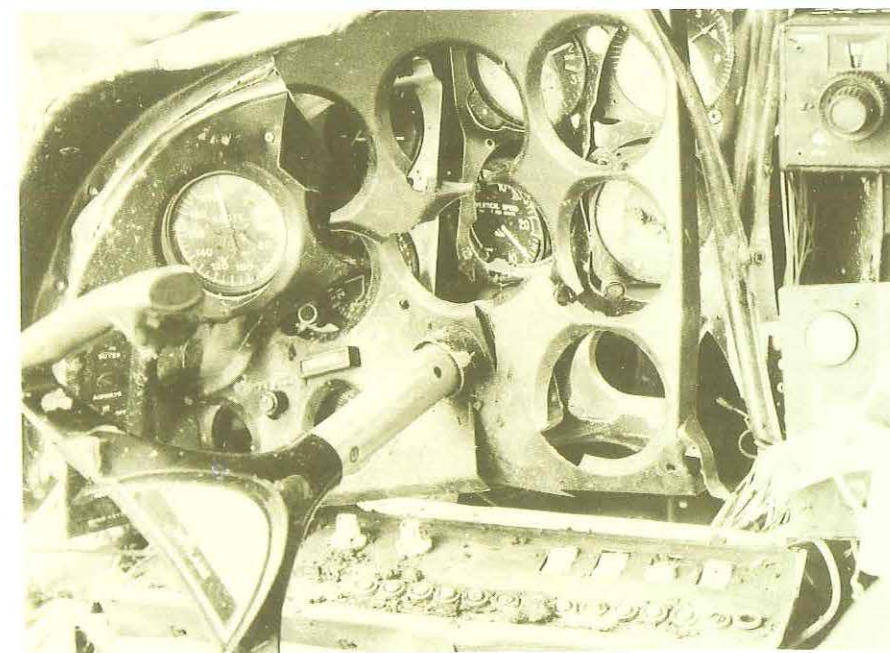
Above: The initial impact crater and the very short distance which the wreckage slid is indicative of the steep angle at which the aircraft struck the ground.

Below: Damage to the aircraft's instrument panel provides a further impression of the force of impact.

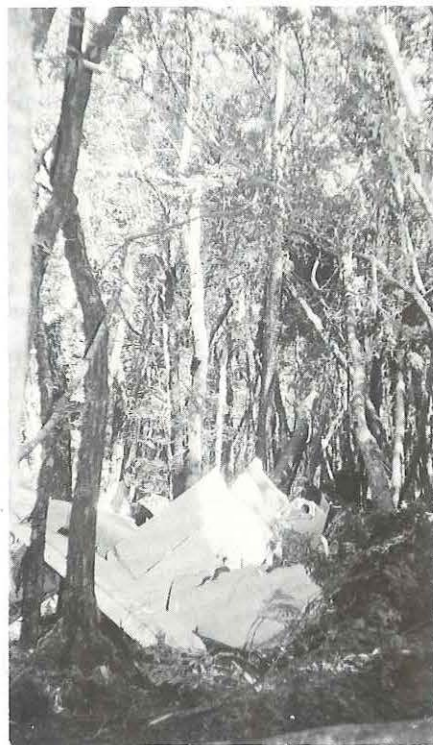
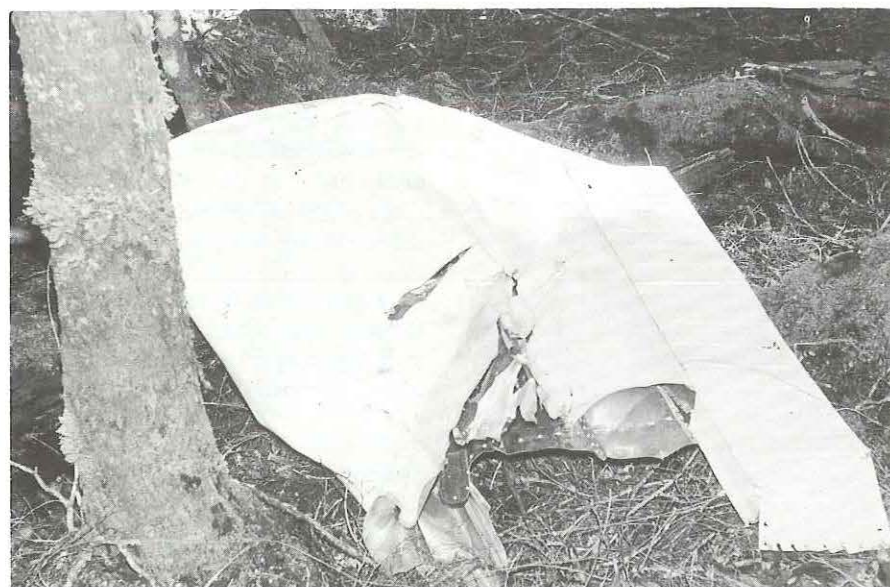
Two metres of the outer section of the port wing was found 30m down the slope from the main wreckage, and an impact mark on its leading edge showed that it had struck the trunk of a tree at a high angle of attack. A tree with its top snapped off was identified nearby.

Above and Left: The dense forest in which the pilot was forced to land is apparent in these two photographs. More difficult terrain in which to make a forced landing can scarcely be imagined.

Below Left: The outer section of the port wing, torn off as the aircraft descended into the trees, was found 30 metres from the main wreckage.

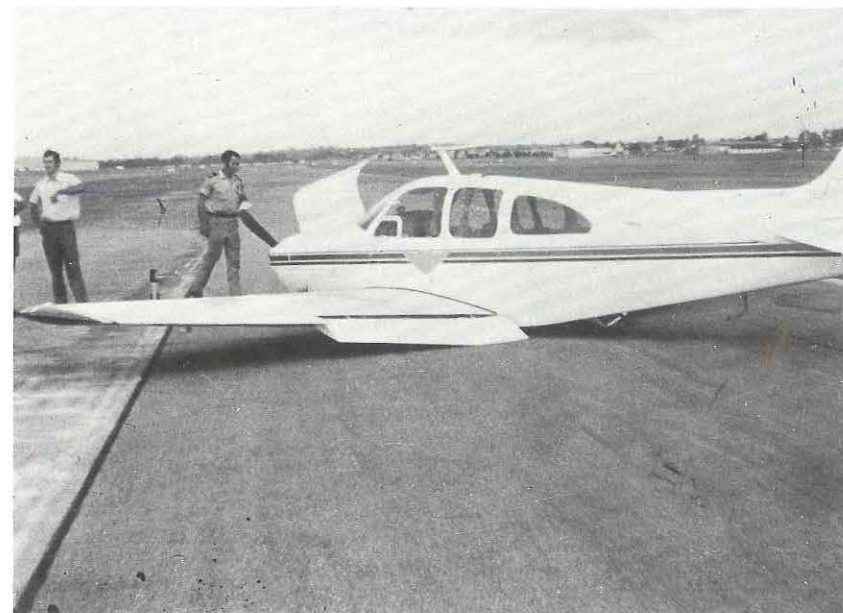
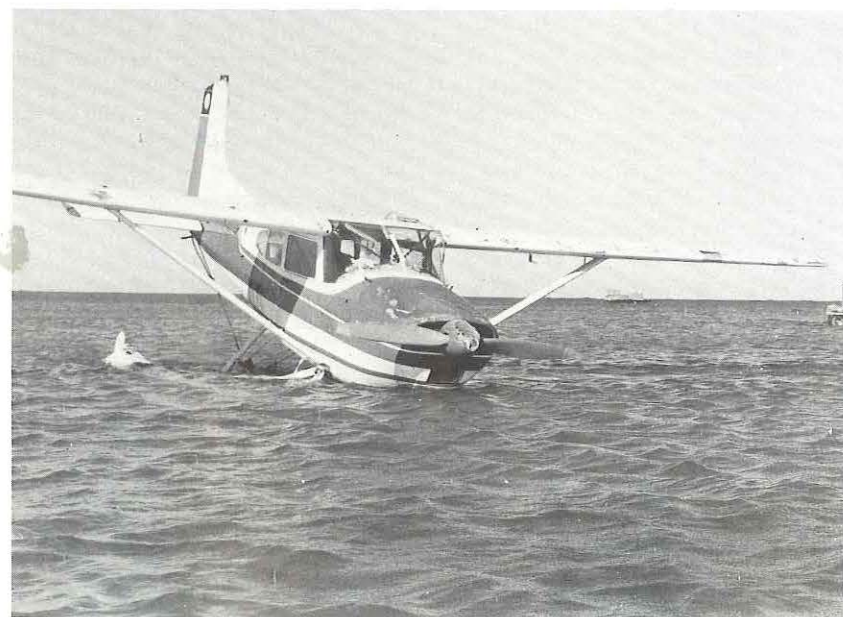
rapidly, coming to rest inverted in about a metre of water. Fortunately the cabin area remained intact and was not immersed, and a boat was quickly on the scene. After some difficulty in releasing the passengers, who were suspended in their seat belts, the aircraft was safely evacuated. The aircraft was substantially damaged by impact forces and sustained further extensive damage as a result of salt water immersion.

But whatever the reason for the pilot's error in the unusual and somewhat different cockpit checks he was obliged to perform, the fact remains that the amphibian's undercarriage was lowered or was down for alighting when it should have been UP. In this condition an accident of some sort was bound to occur on touchdown — yet a further variation on the extensive theme of 'undercarriage trouble' for the Department's computer 'memory'!

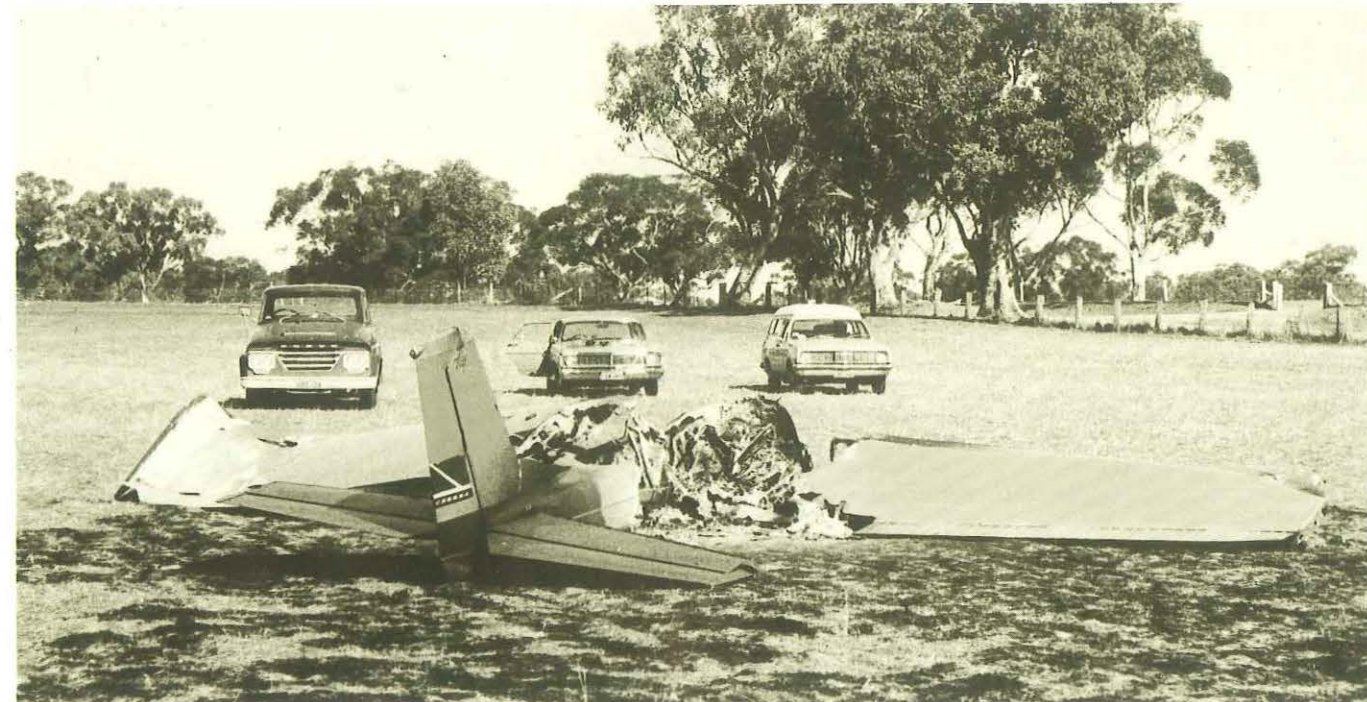
- The pilot, having previously selected take-off flap, increased the setting to **full** flap in the course of the take-off, apparently in an attempt to improve the aircraft's performance.

The gutted wreckage of the Cessna 150. It is possible that the power line and rising terrain in the background affected the pilot's judgement.

This situation, which was further compounded by the aerodynamic blunder of attempting to use an excessive amount of flap during the climb, would have produced a condition where the aircraft's drag was greater than the thrust being produced by the engine, even at full power. As a result, the speed decreased, the aircraft squashed and lost height. Finally, when the angle of attack had reached the critical point, the aircraft stalled at a height from which recovery was not possible, even though in each case the pilot lowered the nose.

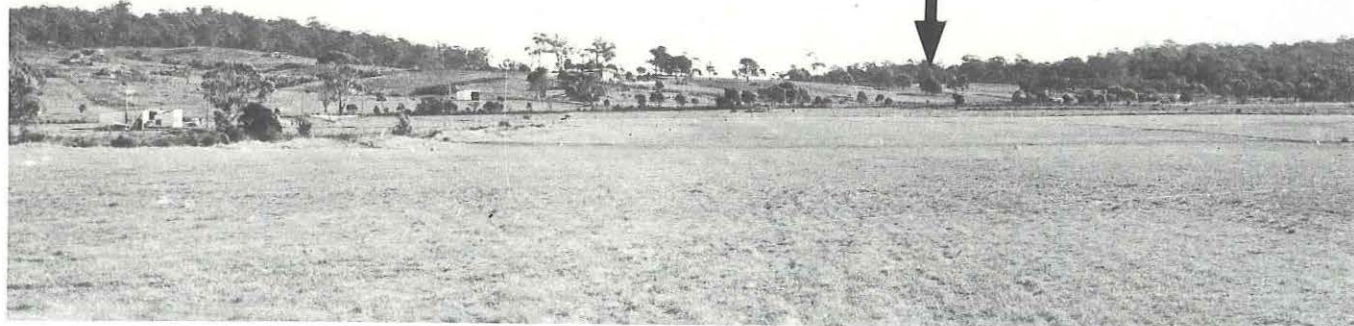
The remains of the Victa Airtourer involved in the other very similar accident.

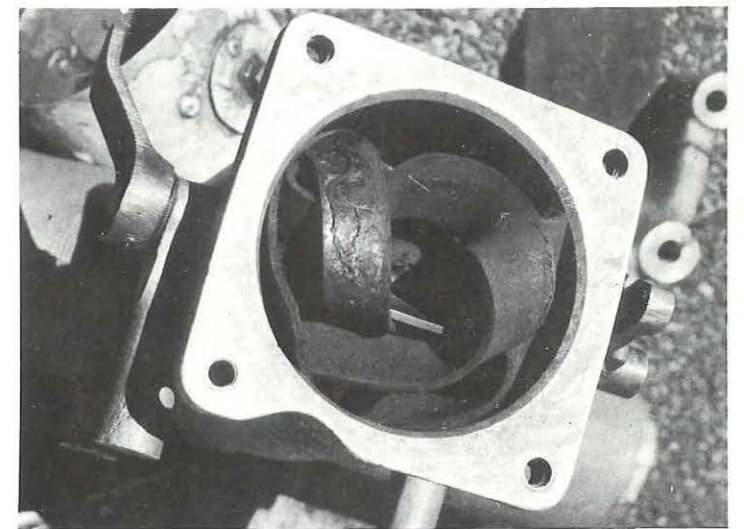
Examination of the engine and its accessories revealed that the air box and expander assemblies of the air induction scoop in the lower engine cowling were not bolted together. The two retaining screws were missing, as was the neoprene gasket that fits between the two parts. The gasket was later found in the induction manifold, wrapped around the throttle butterfly as shown in the picture.

It was not possible to determine whether the retaining screws had been omitted or simply just not tightened properly the last time the aircraft was serviced. The original air box fastenings had been replaced with screws and anchor nuts, and in view of the difficulty that would be experienced in tightening the screws while holding the lower engine cowling in position, it

seems likely that the screws were inserted but not correctly tightened. This is supported by the fact that the neoprene gasket remained in position for some 30 hours following the servicing. Once the retaining screws fell out however, engine vibration and movement of the cowling would have caused the cement adhesive on the neoprene gasket to break away. This would have allowed the gasket to be drawn into the in-

take manifold and foul the throttle butterfly, causing the sudden loss of power.
