AVIATION
SAFETY
DIGEST

Number 93 1975
CONTENTS

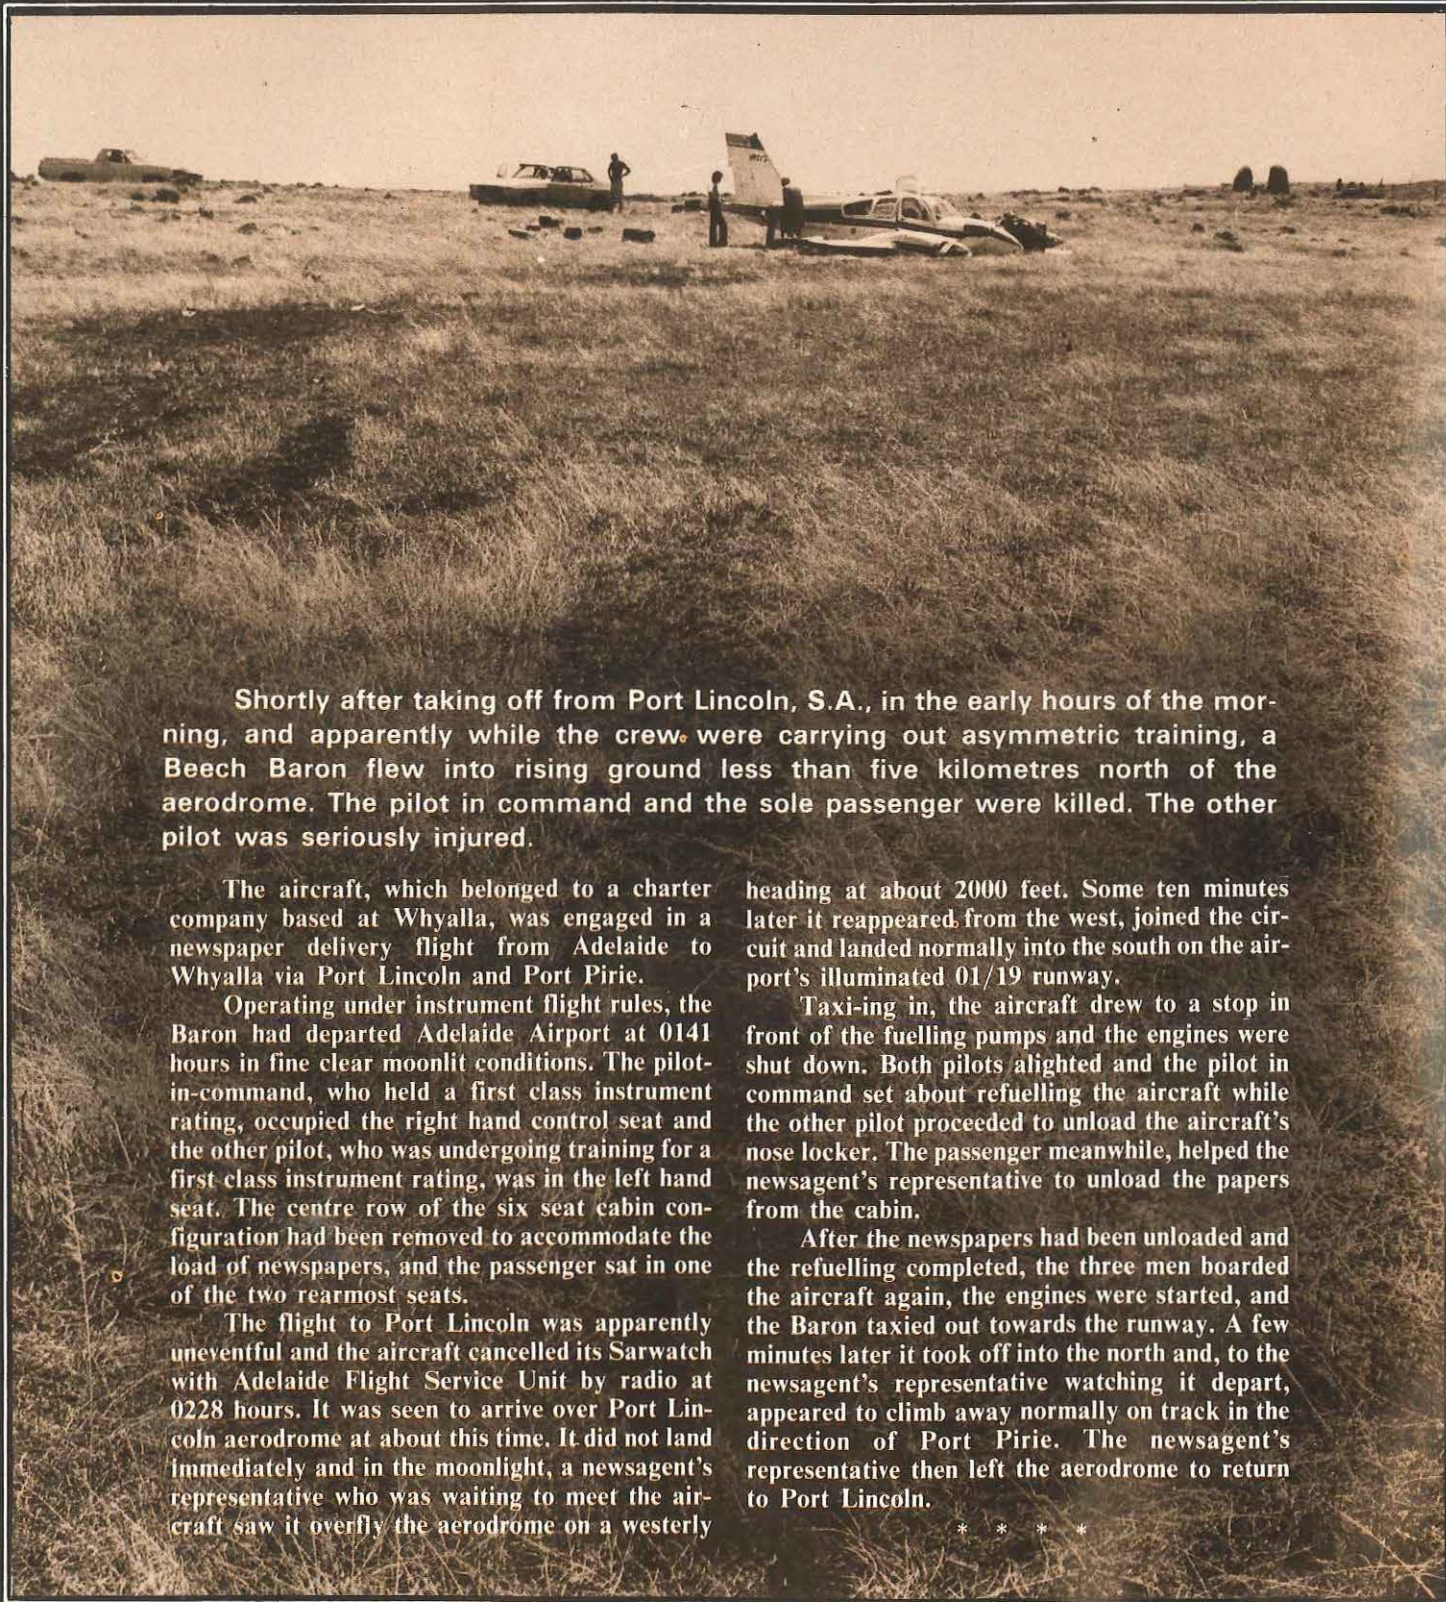
Though at first sight the aircraft appeared to have suffered comparatively little damage for an accident of this type, closer inspection showed that the underside of the fuselage had been badly damaged and torn by contact with the numerous small boulders which littered the hillside.

Left: General view of aircraft as found. The chart obscuring the port windscreen panel can be seen still in position. Note the surprisingly intact appearance of the aircraft for this type of accident.

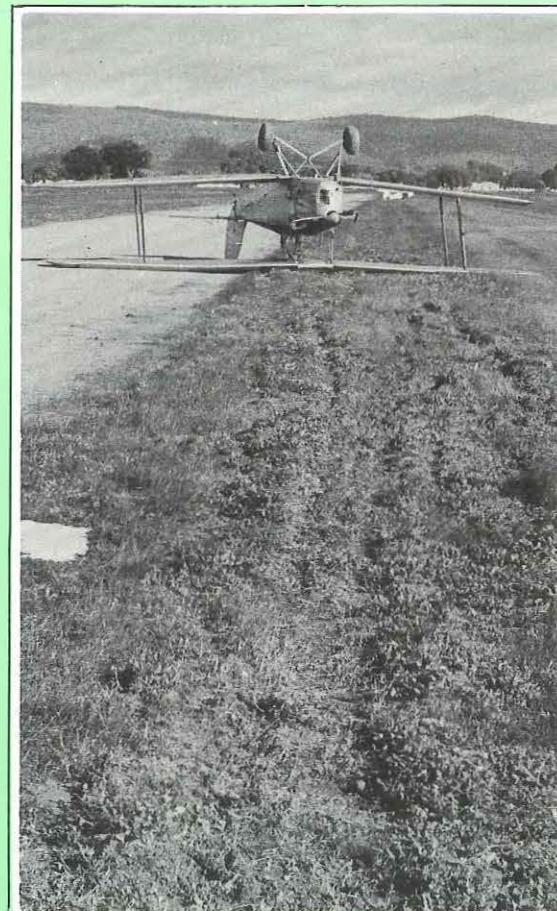
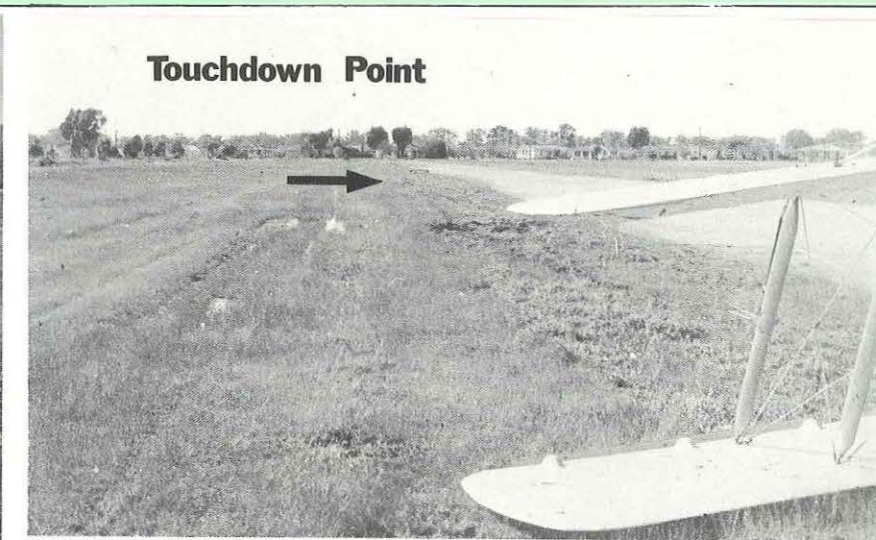
Both occupants were restrained in their seats by their safety harness and managed to release their buckles and lower themselves to the ground. Fortunately neither of them was injured. As can be seen from the photographs the aircraft itself had sustained only relatively slight damage.

The accident itself resulted from the pilot's attempt to land the aircraft on an area that was unsuitable. Though he had made a circuit before landing he had overlooked several warning signs. Firstly there was a large white plaster-board cross on the grass, adjacent to the windsock. The cross had been put out some time before by members of the local aero club when extensive rain had rendered most of the landing area unusable. Secondly, numerous pools of water lying on the grassed areas of the strip were clearly in evidence. Only the gravelled 12 metre wide, centre section of the strip remained relatively firm and dry, while the surrounding grassed area was completely waterlogged. The worst affected were the edges of the marked strip, adjacent to the gravelled section, where the aircraft landed. These had recently been graded and were particularly soft.

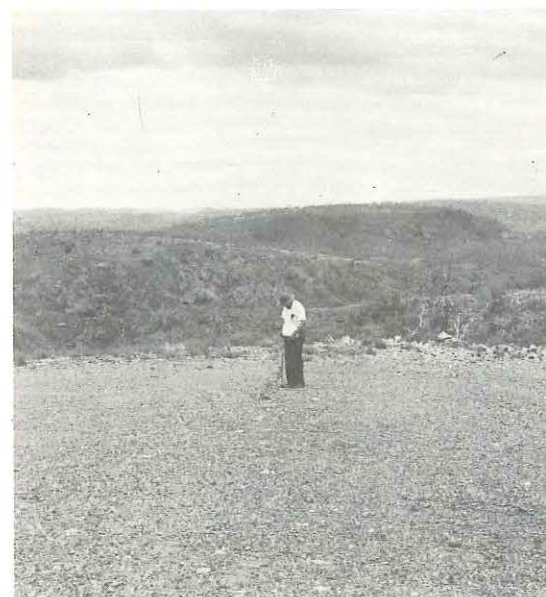
ground, the airspeed, which had been fluctuating, suddenly dropped, and the aircraft sank rapidly. The pilot did not increase power, but instead quickly reached for the flap lever and lowered the remaining third stage of flap. In his haste, the flap mechanism apparently failed to positively engage the third stage-detent, and when the pilot released his hold on the lever, it sprang back to the second stage position. As best he could the pilot attempted to flare the aircraft for the touchdown, but it struck the ground very heavily 25 metres short of the threshold, dislodging the port landing wheel. Bouncing violently three times, the Cherokee finally settled on to the strip 110 metres in from the threshold, then swung to the left off the prepared surface on to rocky ground. Both the port and nose undercarriage legs collapsed, allowing the

port wing, nose, and propeller to strike the rough ground and sustain severe impact damage.

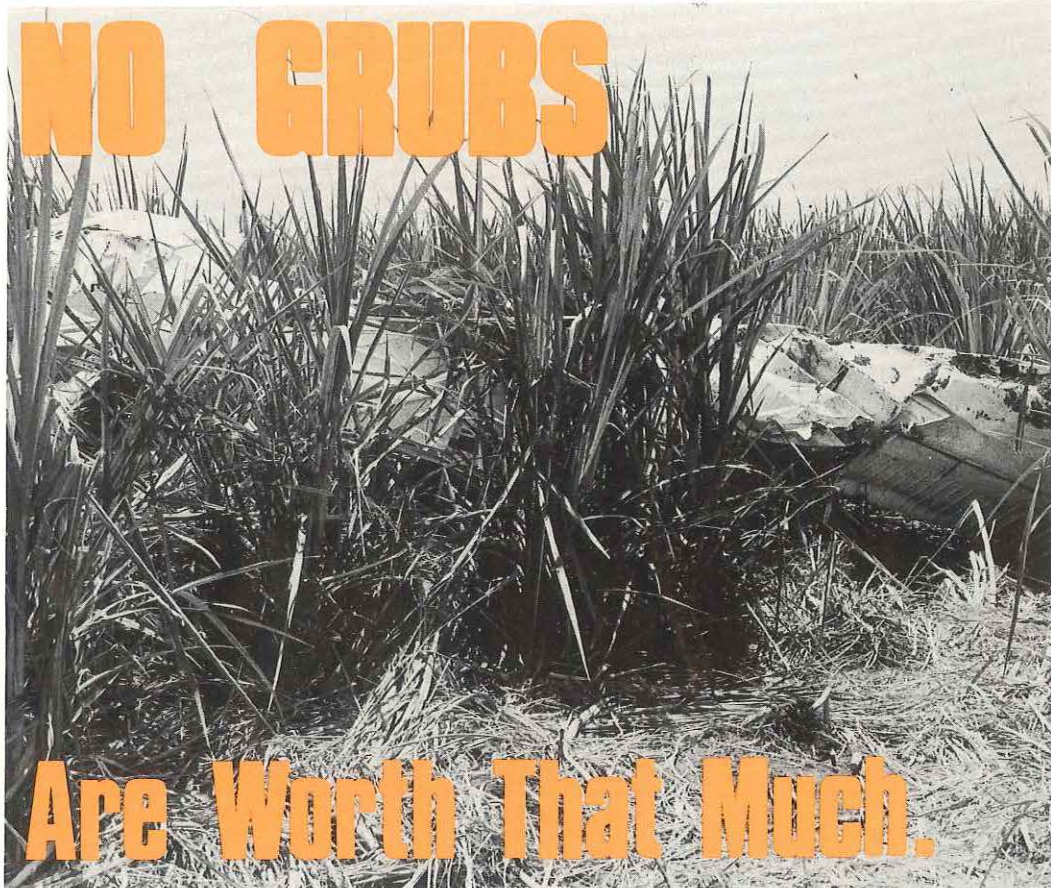
produced by a break in the crop caused the starboard wing to dip, and the wing-tip entered the top of the tall cane. The aircraft swung off its flight path to the right, losing what little height it had, and flew into the crop of tall cane. Sliding sideways, the aircraft struck the ground and the undercarriage collapsed. The port wing-tip dug in, and the Agwagon flipped over on to its back.

Fortunately the pilot was unhurt and was able to scramble out of the relatively undamaged cockpit unaided. The Agwagon itself was a write-off.
