Department of Transport - Australia

Number 101 1978

Aviation Safety Digest

Disastrous Indecision	2
You — and Low Level Jet Routes	5
What Can Go Wrong — Will!	7
Cherokees Collide Head-on	8
Ooops!	10
Eyesight is Precious	11
A Nasty Situation	12
'What! You Threw Away the Ripcord?'	14
It's Good Advice For Us, Too!	17
The Wrong Side of the Power Curve	18
A Close Call!	19
Dust Devils and Aviation	20
Ask For Help — While You Still Can!	22
The Breath of Life	23
Counting Sheep?	24
Incredible!	25
Recognising and Handling Dangerous Goods	26
Your Role in Search and Rescue	28

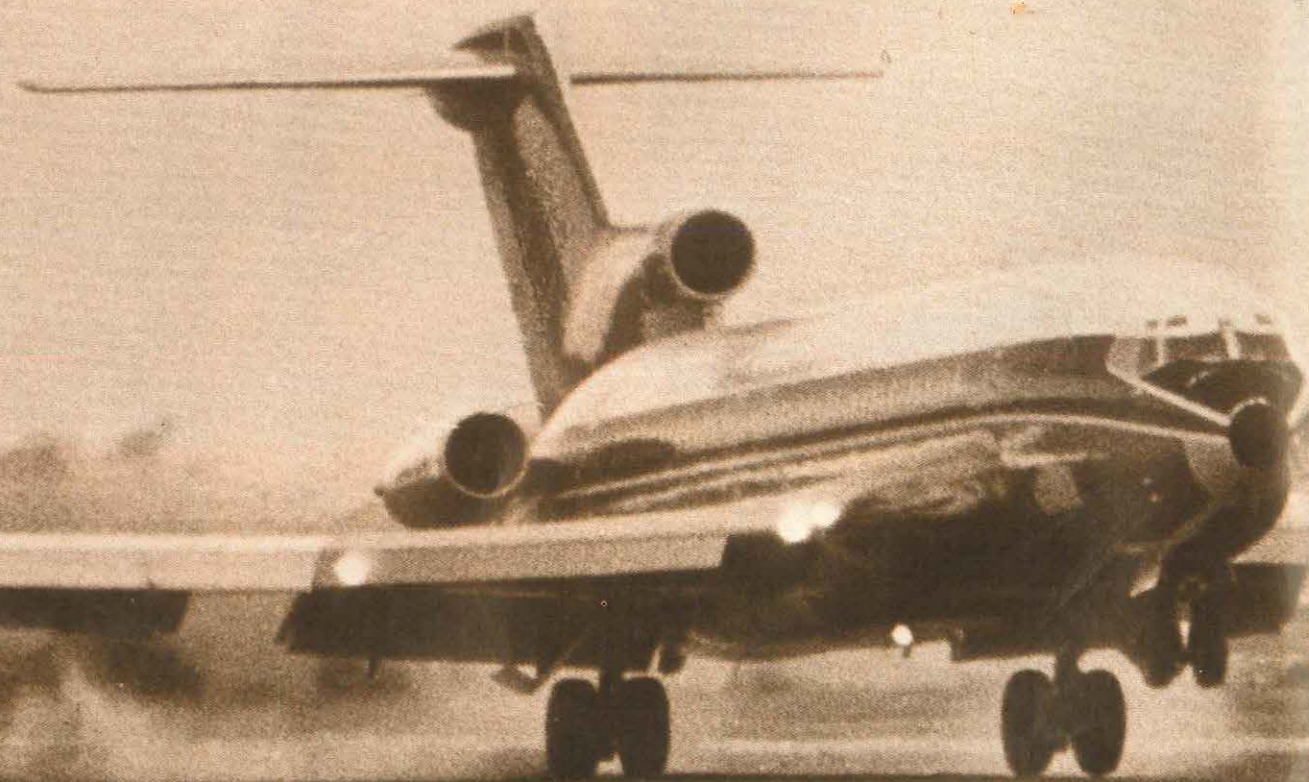
DISASTROUS INDECISION

The investigation confirmed that the engines had in fact responded to the movement of the thrust levers, which had been advanced in accordance with a laid down 'two-step' procedure to allow the engines to stabilize at 1.4 EPR. Thus from the time the captain decided to go-around, it would have taken six to seven seconds for the engines to accelerate to take-off power.

During at least part of this time the aircraft would have continued to decelerate. Analysis of Boeing 727-100 performance data shows that from the initiation of full power during a touch-and-go, more than 580 metres of runway is required to lift-off, while another 240 metres is needed to reach an obstacle-clearance height of 35 feet. In addition, the 'two-step' advance of the power levers can lengthen the take-off roll by as much as 150 metres. These figures compare with a stopping distance of about 520 metres using maximum wheel braking and other available braking devices.

The Board therefore concluded that a successful go-around could not have been executed when the captain attempted to do so, but that using maximum braking and spoilers, he should have been able to stop the aircraft on the runway and certainly within the confines of the runway over-run.

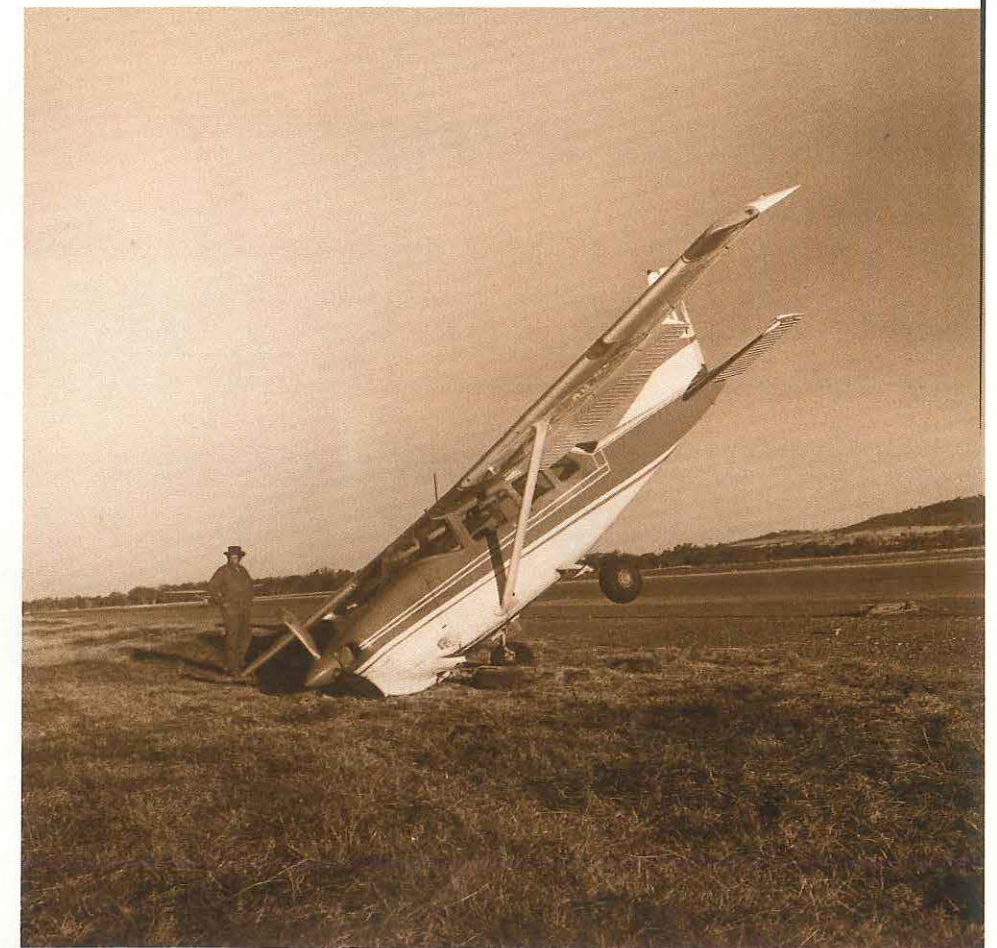
WHAT CAN GO WRONG - Will!

As the bundles of newspapers carried in the aircraft were not restrained against movement in any way, it is likely that, during flight, a bundle of newspapers slipped forward until it was resting against the stowed right rudder pedal. In this way, pressure was applied to the right brake, causing the aircraft to veer to the right after touchdown. This in turn led directly to the need for the pilot to take corrective action, and the subsequent loss of control when he applied full power.

Both the Cessna 206 and 207 are widely used to carry cargo, some of which is often loaded into the space made available by removing the right-hand front seat. This accident shows the potential hazard of placing freight near the stowed rudder pedals — it also emphasises again the importance of properly restraining such freight.

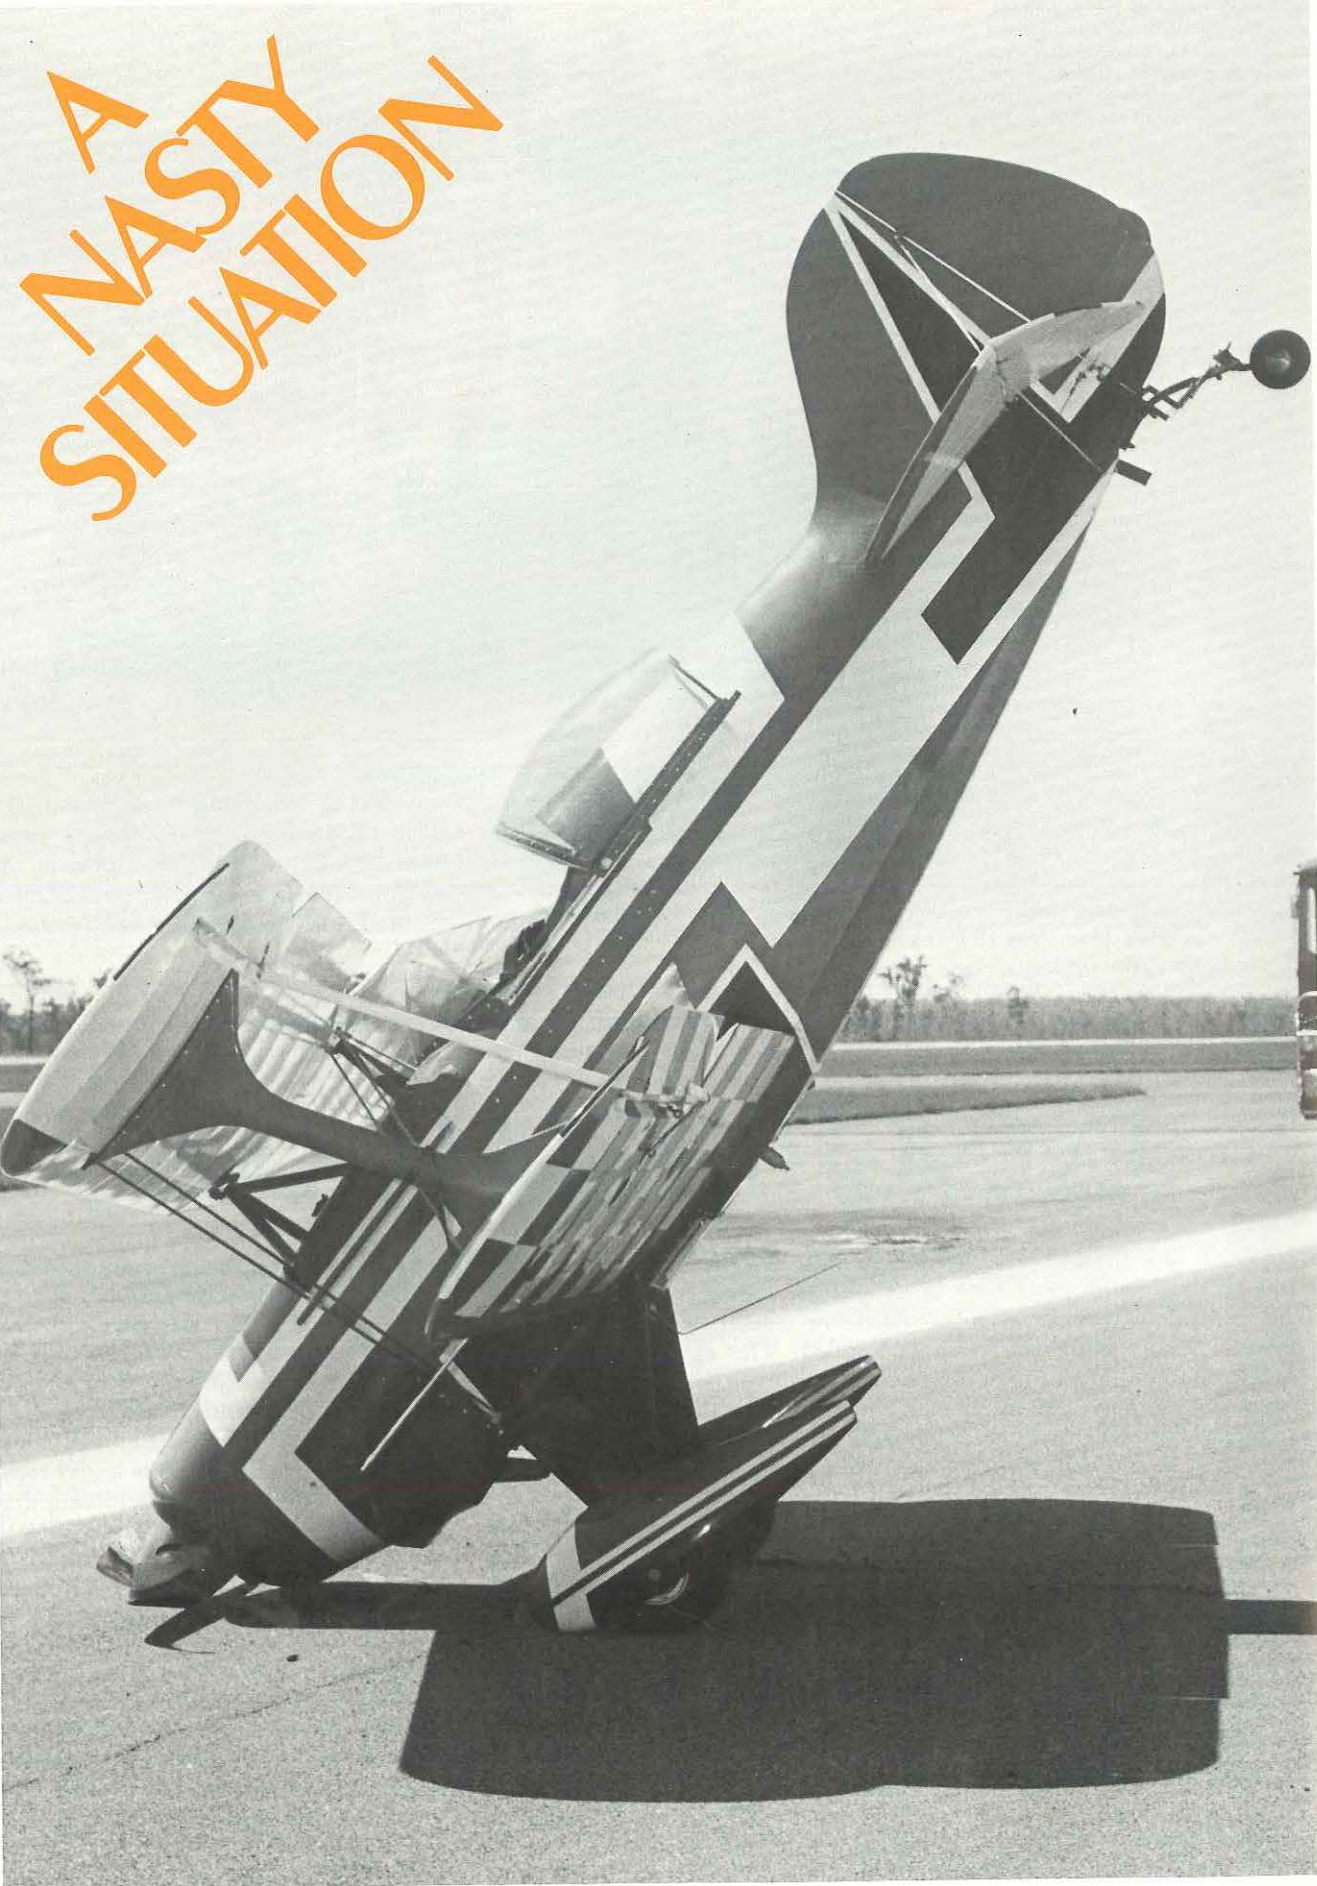
Instantly, I realised the rudder cable had given way. Believing at first the cable itself had parted and fearing the right cable would be pulled beyond my reach, I instinctively reached forward and grabbed the loose end before applying left rudder to recover. By this time the aircraft had rotated just over 360 degrees and I pulled out of the dive between 1000 and 1200 feet using elevator and aileron control. I took a moment to settle down, and then called Darwin Tower to tell them of my predicament. They alerted the emergency services and cleared me to land on runway 11. I had taken up a northerly heading across the airport and, while continuing on a wide left circuit, I had wrapped the loose rudder cable around my wrist and hand. By pulling on the cable, I was able to obtain some measure of right rudder control.

The right rudder pedal, with its toe brake, had shot forward with such force when the cable let go that it had dented the firewall and was now beyond my reach. So I knew that on landing, I would have no directional control once the slipstream effect on the rudder had diminished. Because of its tail-wheel undercarriage and very short fuselage, the Pitts requires maximum concentration and constant application of brakes to keep straight after touchdown, irrespective of the wind direction. It was unfortunate that the prevailing weather conditions would compound my problems, as the wind was gusting. I decided to carry out a powered approach at minimum speed.

Both rudder cables were removed from the aircraft, which had flown only 65 hours since new, for more detailed examination. The cables have similar eye fittings at each end and these were measured and compared with other sample end splices. It was found that, while the copper sleeves used to form the eyes were the correct type for 3.2 mm (1/8 inch) cable, all four end splices had been formed with a pressing tool appropriate to a cable diameter of 4 mm (5/32 inch). Thus the sleeve had not been properly compressed and the resulting clamping action was insufficient to provide a splice of adequate strength. During a series of laboratory tests, the rear end of the left rudder cable pulled through the sleeve when a load of 280 kg was applied. It appeared from marks on the fittings that the splice which failed in flight would have been significantly less effective than the one which failed on test. A correctly pressed sleeve withstood a load of 1090 kg without any sign of slipping.

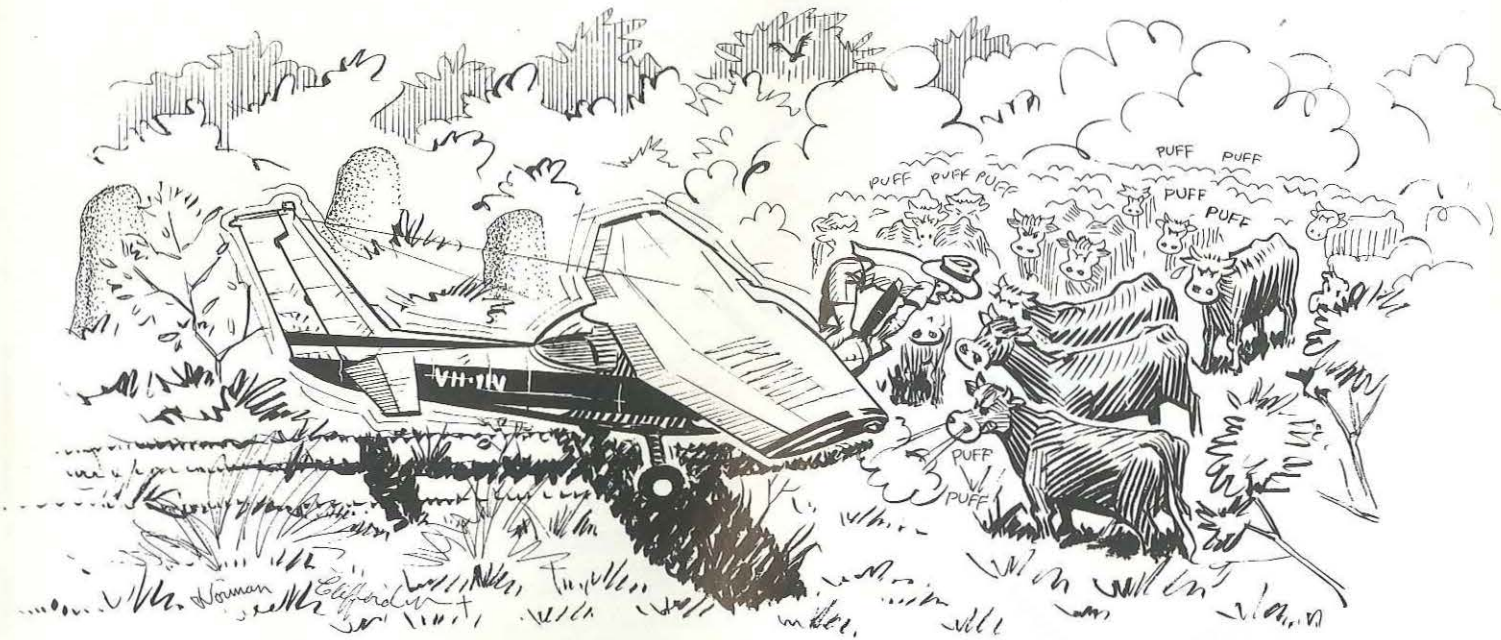
The pilot therefore decided to use his own technique of making the aircraft's engine backfire by switching the magnetos on and off. As he was doing so however, the lock nut which holds the switch in place on the panel came off, and the magneto switch fell out on to the floor — in the off position, with the key out of the lock, and with the aircraft only about 50 feet above ground!

These two examples of failed plastic distributor gears testify to the consequences of deliberately causing an engine to backfire.
