# Aviation Safety Digest

# Solitary waves and low-altitude wind shear in Australia

# Engine failure on takeoff

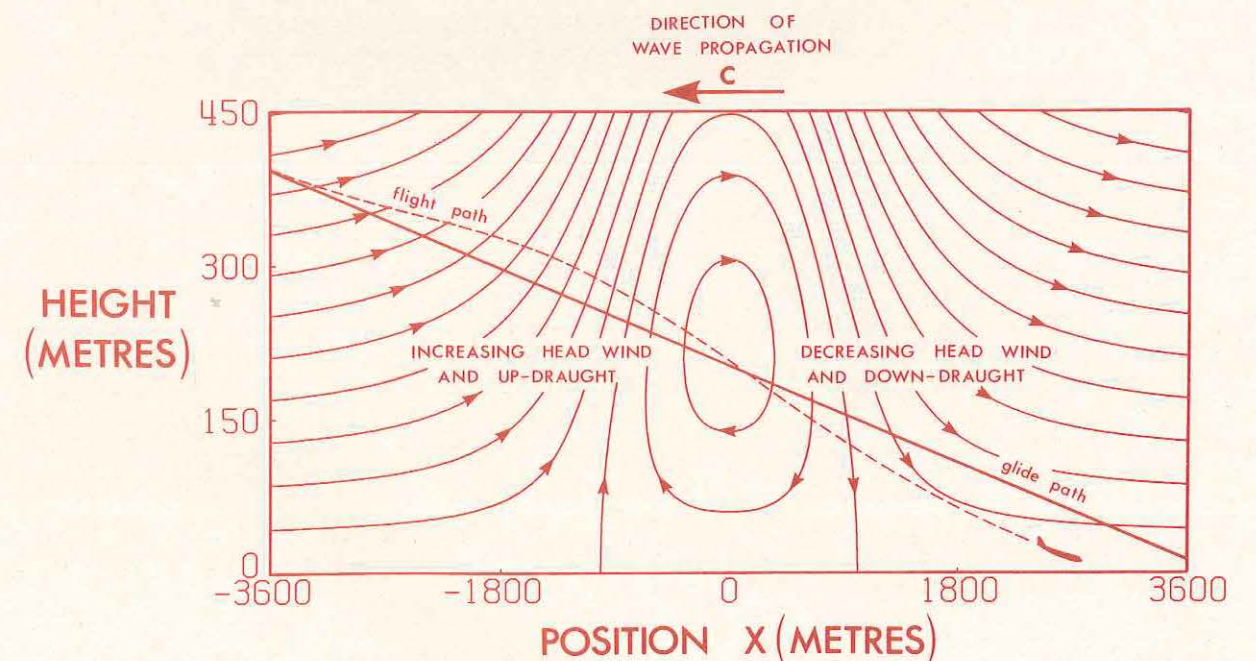
The complex, rapidly varying wind shears produced by large amplitude boundary layer solitary wave disturbances can affect the performance of aircraft in a variety of ways. Perhaps the most serious situation occurs when an aircraft unexpectedly encounters a solitary wave disturbance from the front during the critical final approach stage (see Figure 3). In this case

the aircraft is initially displaced above the glide path under the positive influence of increasing head winds coupled with the up-draught along the leading edge of the disturbance. This brief period of positive lift is followed by a sudden loss of lift as the aircraft penetrates the region of rapidly decreasing head winds and down-draught along the trailing edge of the wave. In most circumstances, the normal reaction of a pilot to the initial increase in lift during final approach would be to decrease air speed in an attempt to return the aircraft to the standard glide path; this action, coupled with the sudden loss of performance along the trailing edge of the wave, could leave the aircraft dangerously close to the ground in a potentially disastrous runway undershoot situation. This particular behaviour pattern — a temporary period of positive performance followed by a sudden loss of lift — is characteristic of many low-altitude wind shear accidents. In a similar manner, an encounter with a solitary wave from the opposite direction during the approach stage could lead to runway overshoot conditions.

**Figure 3.** Illustration of the possible behaviour of an aircraft leading to runway undershoot during a head-on encounter with a large amplitude solitary wave on final approach. Maximum horizontal winds occur at the centre of the disturbance near the surface.

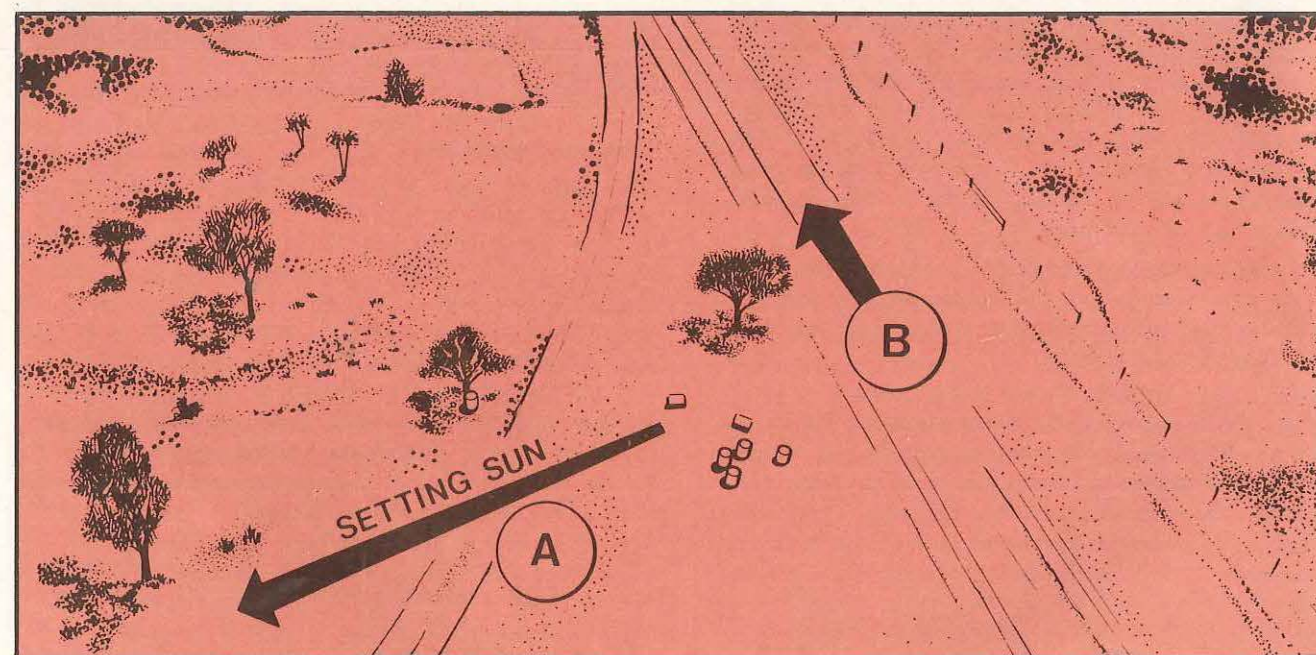
Helicopter was parked at A, C172 at B, heading 350 as indicated by arrow.
