Reduced braking effectiveness during landing involving Boeing 737-800, VH-VOP

Christchurch, New Zealand | 11 May 2015

ATSB Transport Safety Report
Aviation Occurrence Investigation
AO-2015-046
Final – 18 September 2018

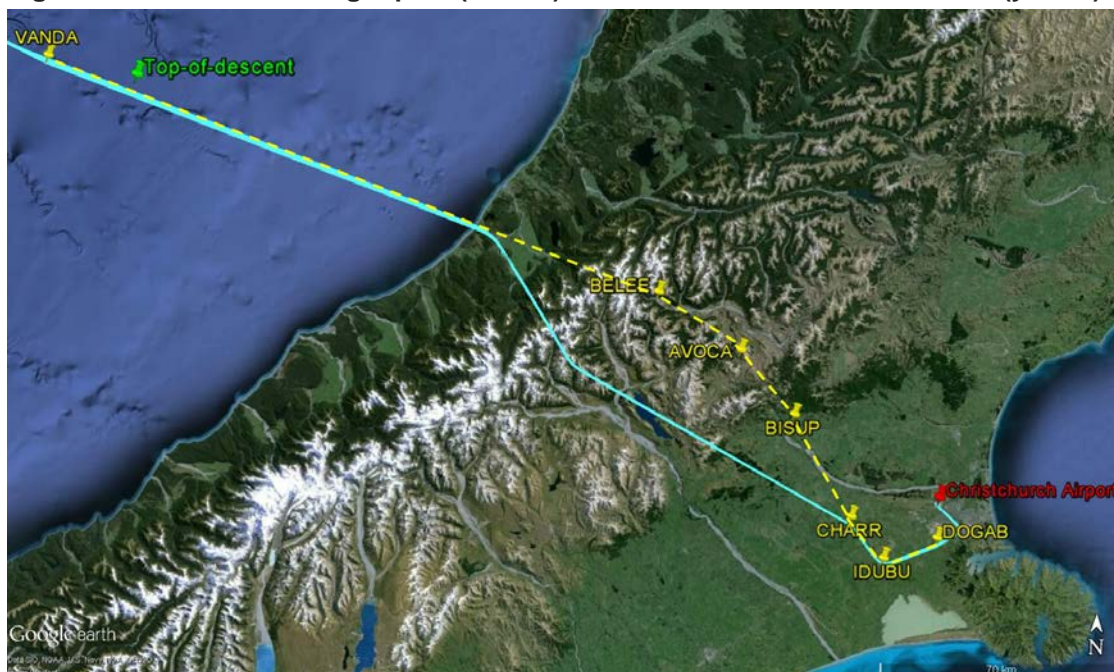
Figure 1: VH-VOP actual flight path (in blue) and BELEE 1 Charlie arrival route (yellow)

At 1146, the crew of VOP established contact with Christchurch Area ATC on a different frequency from the A320 crew. The crew advised ATC that they were at waypoint ‘VANDA’ (Figure 1) maintaining FL 390 and were in receipt of ATIS X. ATC began to clear the crew to descend for the ‘BELEE 1’ arrival but then asked them to standby. Shortly after, ATC advised the crew that ATIS Y was now available with a visual approach to runway 29 and that there were ‘quite a few changes from the previous, you want to have a listen’. About 1 minute later ATC contacted the crew and advised they were cleared to descend to FL 160 for the ‘BELEE 1 Charlie’ standard arrival route for runway 29 (Figure 1). The crew acknowledged the clearance and responded ‘Velocity 160’, inadvertently transposing their cleared flight level for their call sign. ATC then confirmed their call sign as ‘Velocity 134’ and advised that ATIS Y was current with a QNH⁷ of ‘993’. The crew acknowledged the QNH and requested the surface wind, which was reported as 250° at 12 kt, maximum 18 kt. The crew recorded these details on the take-off data card.

Having been notified of the change in runway-in-use, the crew commenced their preparations for the revised approach. Also around this time, the crew noted weather ahead on the aircraft’s weather radar at waypoint ‘BELEE’, requiring a track deviation.

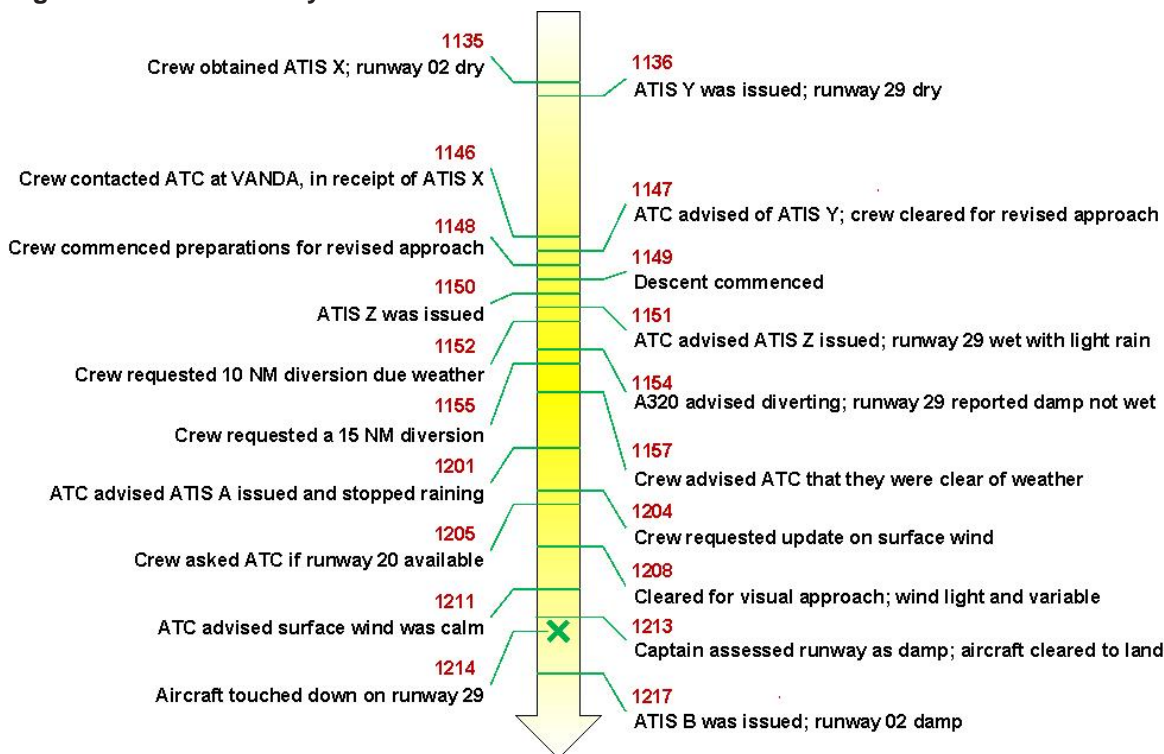
Figure 2: Timeline of key events¹²

ground engineer who had also observed the significant amount of water spray. The engineer stated that water seemed to pool in that area of the runway when it rained. The captain and FO had not previously been aware of any tendency for water to pool on that runway. The FO conducted a visual inspection of the aircraft's tyres with an engineer to see if any reverted rubber was present; none was detected. Figure 2 provides a timeline of the key events leading up to the incident.

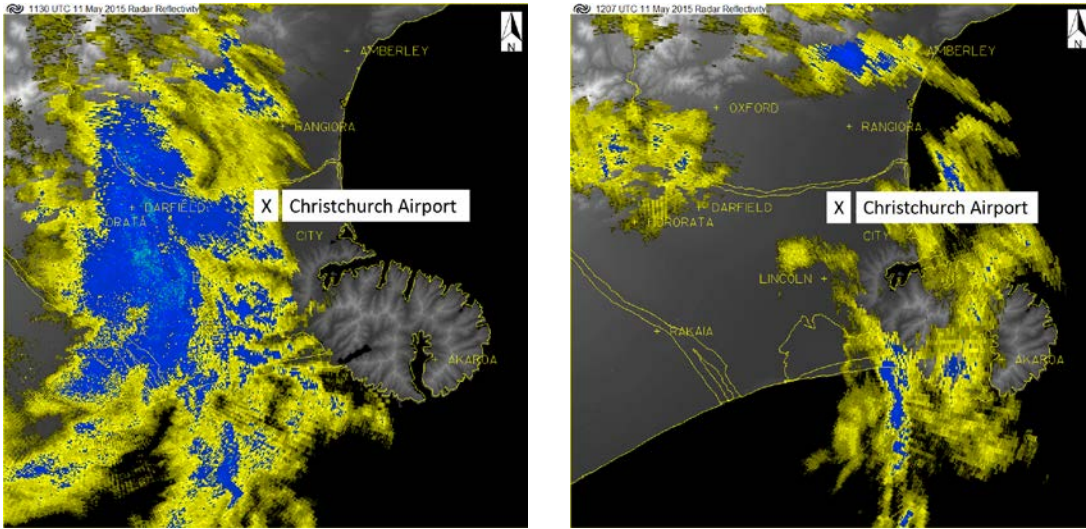
Figure 3: Weather radar showing rain passing overhead Christchurch Airport

Image shows light (yellow) to moderate (blue) rain passing overhead Christchurch Airport between 1130 (left) and 1207 (right); VOP touchdown was at 1214. Source: MetService, annotated by the ATSB

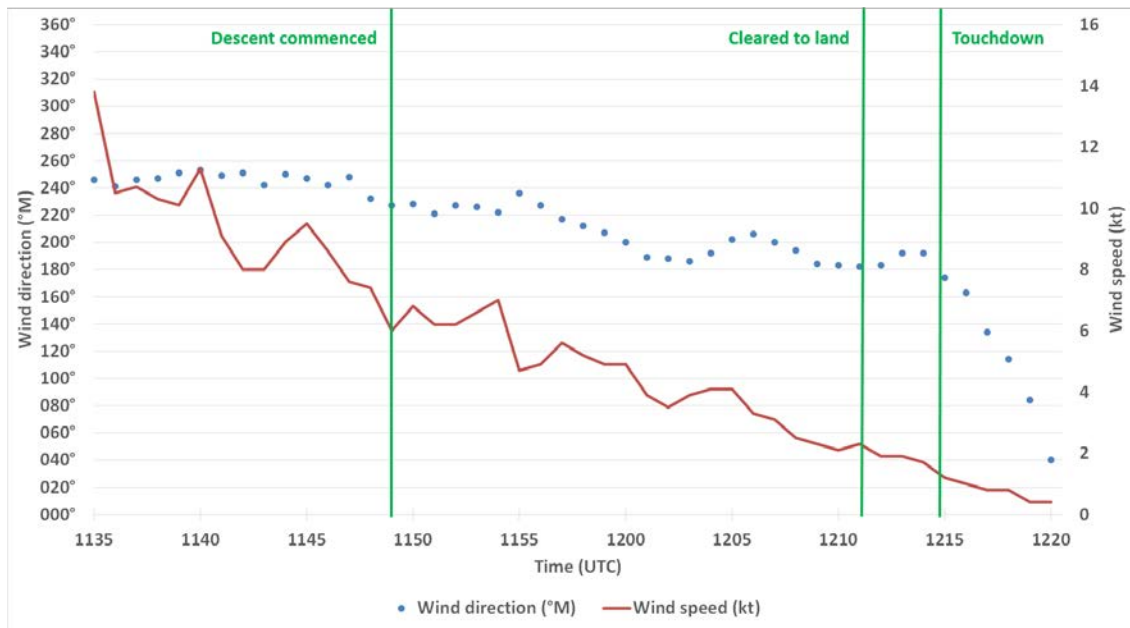
Figure 4: Christchurch Airport one-minute interval wind data between 1135 and 1220

Christchurch Airport had four anemometer (wind) sensors located 1,000 ft from each runway end. MetService provided the ATSB with one-minute interval data recorded by the automatic weather station, which captured temperature and wind data. The temperature at the time of landing was 12 °C. A graphical depiction of the changing wind (° Magnetic)¹⁶ between 1135 and 1220 is shown in Figure 4.

Images shows the changing wind speed (in red) and direction (in blue). Source: MetService, modified by the ATSB

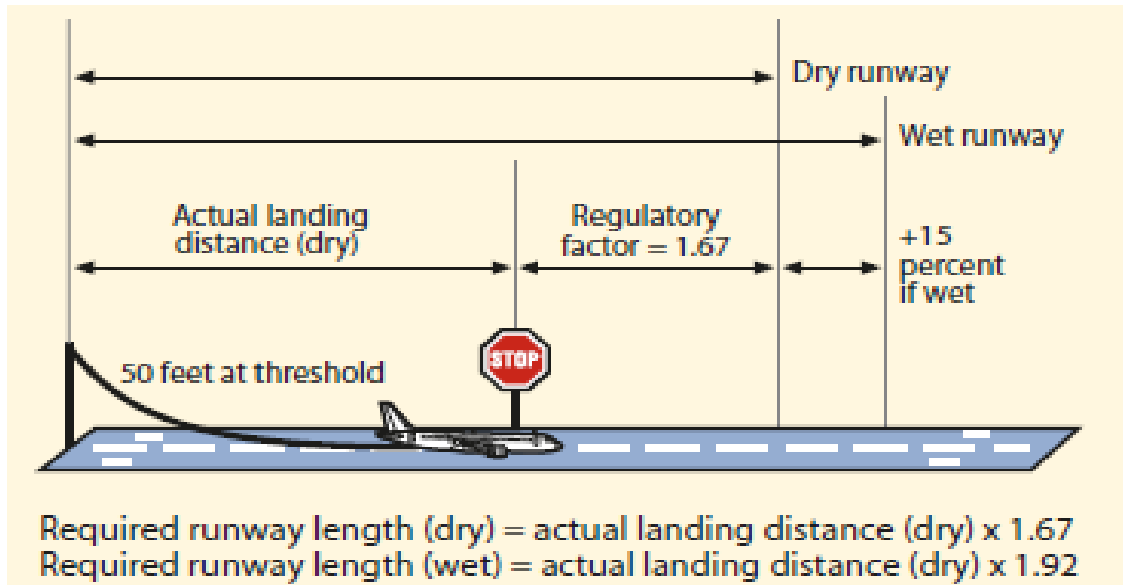
Figure 10: Graphical representation of certified landing data and the safety margins for a dry and wet runway

³² The requirement for a wet runway is based on the distance computed to meet the dry requirement and then increased by a factor of 1.15.

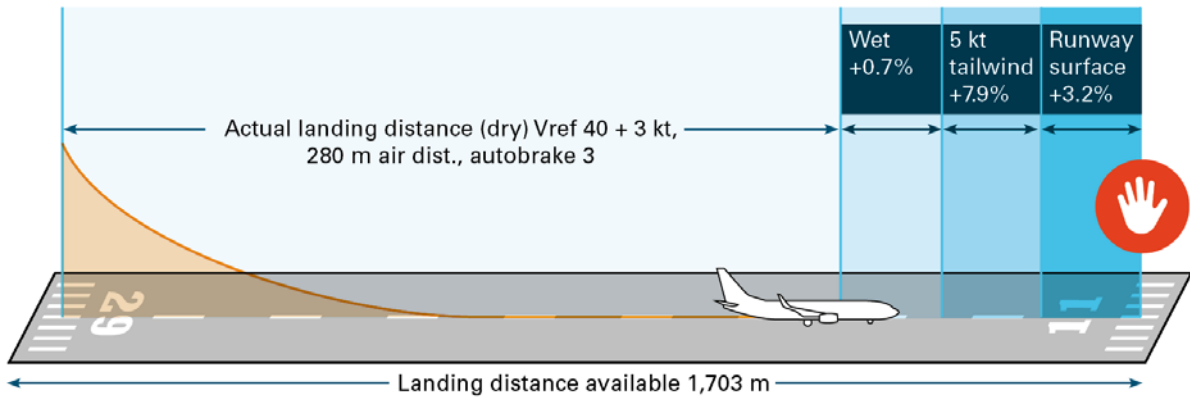
Figure 15: Effect of environmental conditions on the actual landing distance (not to scale)

As previously discussed, the crew were of the understanding that there was nil wind and the runway was damp (dry). The ATIS current at the time of landing indicated that the runway was wet and there was a 3 kt headwind, but Boeing later determined that there was a 5 kt tailwind. While the difference in wind component between the ATIS and that established by Boeing could not be resolved, environmental factors can have a significant effect on aircraft landing performance. In this case, as shown in Figure 15, the wet runway and 5 kt tailwind accounted for a 0.7 and 7.9 per cent increase respectively in the actual landing distance. The remaining distance between this, and when VOP was stopped, was attributable to the additional effects of the runway surface conditions (3.2 per cent). Combined, these environmental conditions resulted in about a 12 per cent increase to the actual landing distance.

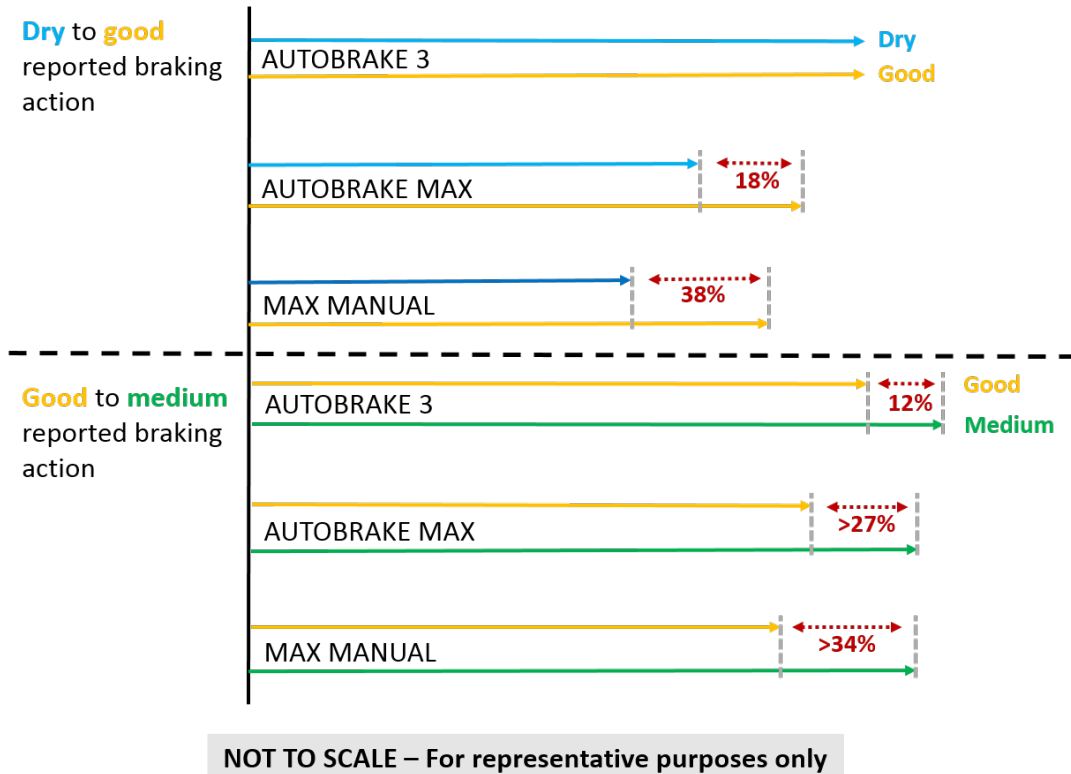
Figure 16: Comparison of QRH landing distances when the runway conditions are underestimated

If the runway conditions were reported ‘dry’ and this was used to calculate the QRH landing distance, when in fact the conditions were wet ‘good’ reported braking action,⁴⁴ for AUTOBRAKE 3, the difference would be negligible (less than 1 per cent). However, if AUTOBRAKE MAX or MAX MANUAL braking were used, the landing distance for the actual conditions would be 18 per cent or 38 per cent (respectively) greater than the landing distance calculated for the reported conditions (Figure 16). Similarly, if the conditions were reported wet ‘good’ reported braking action but were actually wet ‘medium’ reported braking action, for AUTOBRAKE 3, the difference would be about a 12 per cent increase. For AUTOBRAKE MAX and MAX MANUAL braking, the difference would be an increase of at least 27 per cent and 34 per cent respectively.

Image shows a comparison of QRH landing distances when the runway conditions are underestimated between 'dry' to 'good' and 'good' to 'medium' reported braking action. Source: ATSB

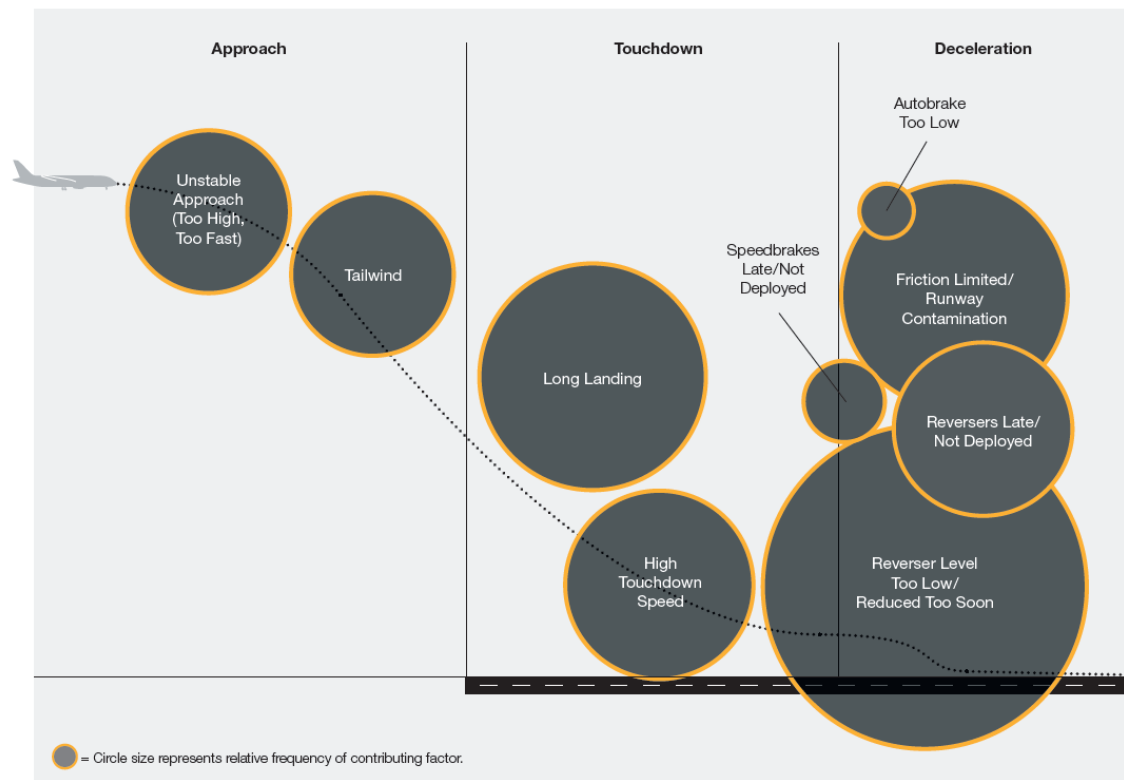
Figure 18: Factors in landing runway overruns

- [Boeing](#) analysis of event data between 2003 and 2010 showed that 68 per cent of runway landing overruns occurred after a stable approach, 55 per cent touched down within the touchdown zone, 90 per cent landed on an other-than-dry runway and 42 per cent landed with a tailwind of 5 kt or greater. The analysis emphasised that a runway overrun was frequently the result of more than one contributing factor occurring simultaneously. Figure 18 shows the common factors in runway overruns during landing. The size of the circle represents the relative frequency the item was a contributing factor to the overrun.
