Grounding of *ABFC* *Roebuck Bay*

Henry Reef, Queensland, on 30 September 2017

ATSB Transport Safety Report
Marine Occurrence Investigation
335-MO-2017-009
Interim – 9 October 2018

Interim factual report

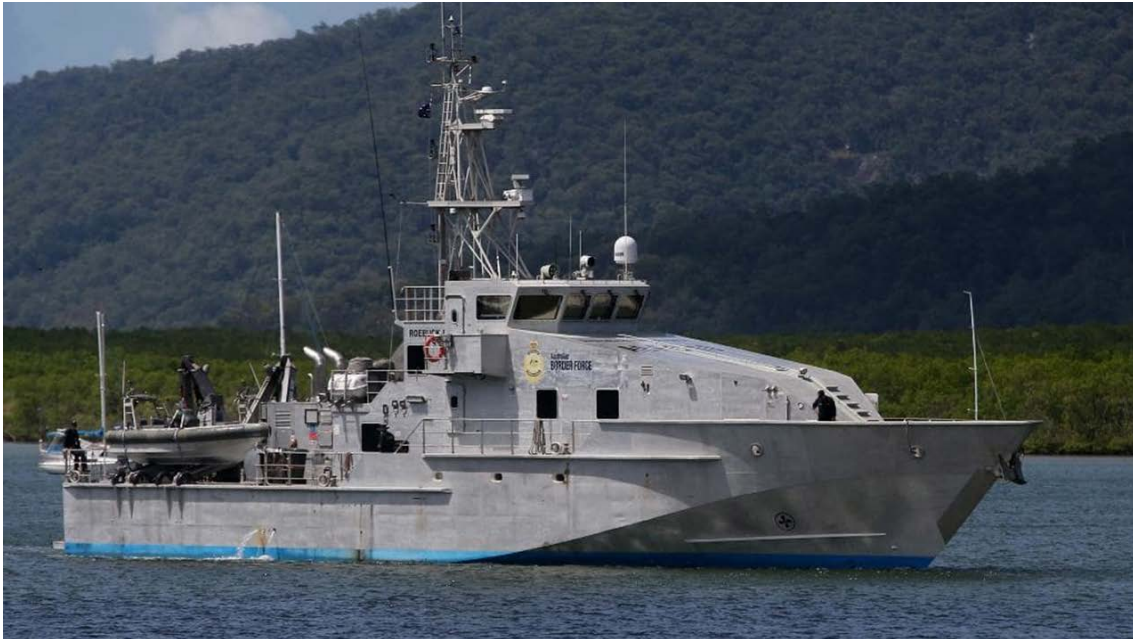
Figure 1: ABFC *Roebuck Bay*

On 11 September 2017, the 38 m long ABFC *Roebuck Bay* (Figure 1) was alongside in Cairns, Queensland undergoing a routine crew change prior to commencing a 3-week patrol. Over the next 2 days, the cutter was prepared for the patrol with several start-of-patrol and pre-departure checks being completed by the cutter's various departments. As part of these checks, the navigation officer completed the electronic chart display and information system (ECDIS) start-up checklist, the navigation pre-departure checklist and the bridge departure checklist.

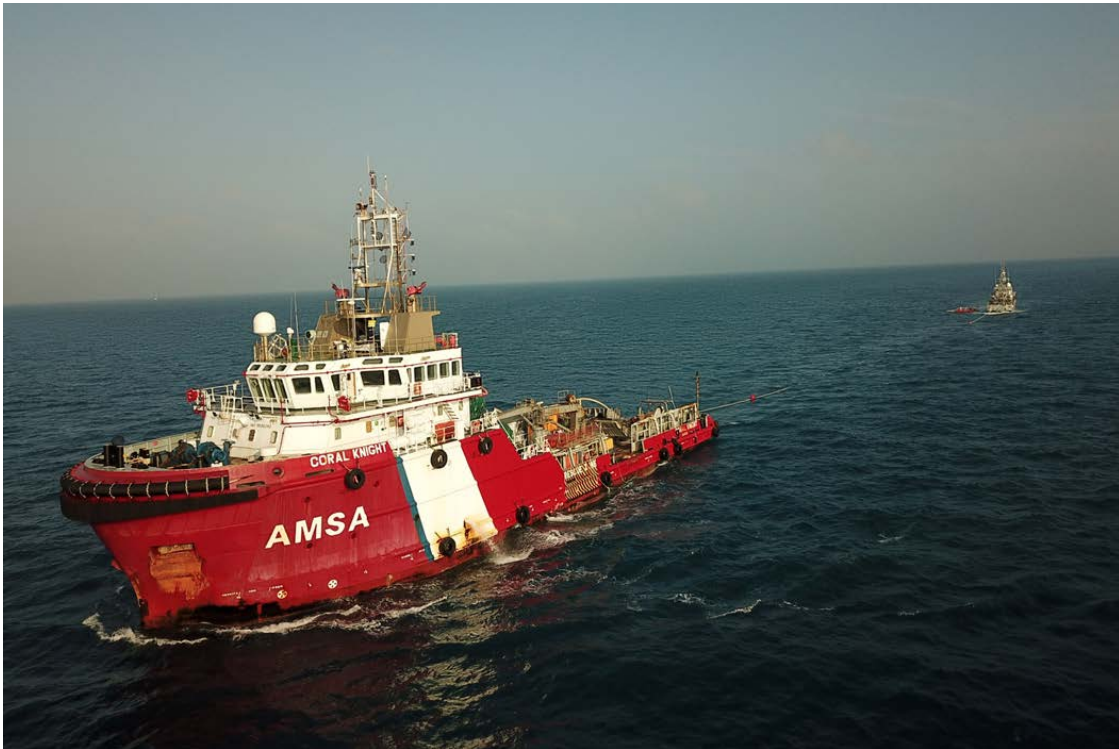
Figure 7: ABFC Roebuck Bay under tow by Coral Knight

At about 2200, with the weather deteriorating to south-westerly winds at 20 knots and 2 m seas, a decision was made to commence towing *ABFC Roebuck Bay* immediately. By 2254, *Coral Knight* had weighed anchor and at about 2307, *Coral Knight* commenced towing *ABFC Roebuck Bay* in the general direction of Cairns. Regular rounds were conducted to inspect and pump affected spaces on board the cutter and shortly after midnight, all non-essential personnel were transferred to *Coral Knight*. The tow proceeded at an average speed of about 3.5 to 4 knots (Figure 7) and by midnight on 1 October, the tow had passed through LADS passage (Figure 3). Regular SITREPs were provided by *Coral Knight's* master at roughly 3-hour intervals to all involved parties including AMBOC, AMSA and ABF interests.
