# Derailment of freight train 1501S

Near Dry Creek, South Australia | 28 July 2017

**ATSB Transport Safety Report**  
Rail Occurrence Investigation  
RO-2017-008  
Final – 31 October 2018

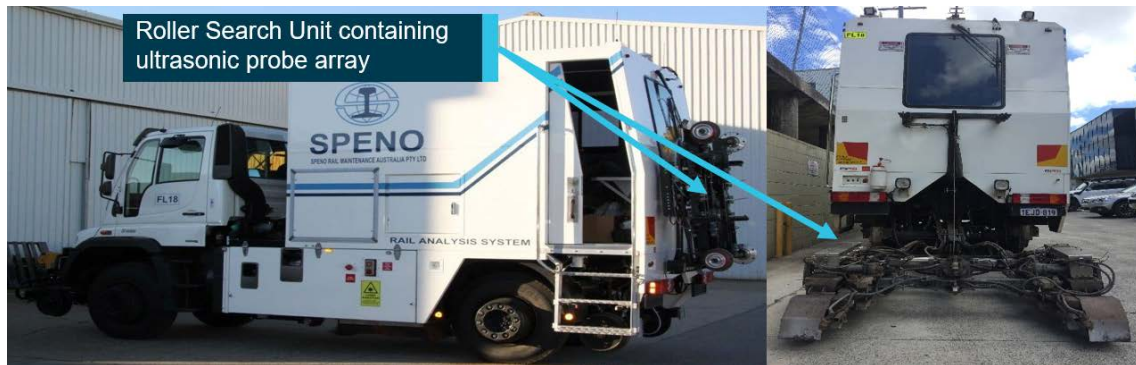
**Figure 5: FL-18 (RFAS-2100) rail analysis system (main test vehicle)**

The rail testing process typically involved the operation of two on-track vehicles. For this type of operation, a main test vehicle (Figure 5) would conduct continuous testing where the ultrasonic operator would interpret, mark and log ultrasonic events displayed on the test vehicles display monitors. Automatic paint guns sprayed a white paint mark on the gauge side, rail web and foot of each rail when the system detected the presence of a defined event.
