Fall from height and serious injuries to crewmembers on board *Shanghai Spirit*

15 NM north-east of Port Alma, Queensland | 29 January 2017

ATSB Transport Safety Report
Marine Occurrence Investigation
328-MO-2017-001
Final – 21 February 2019

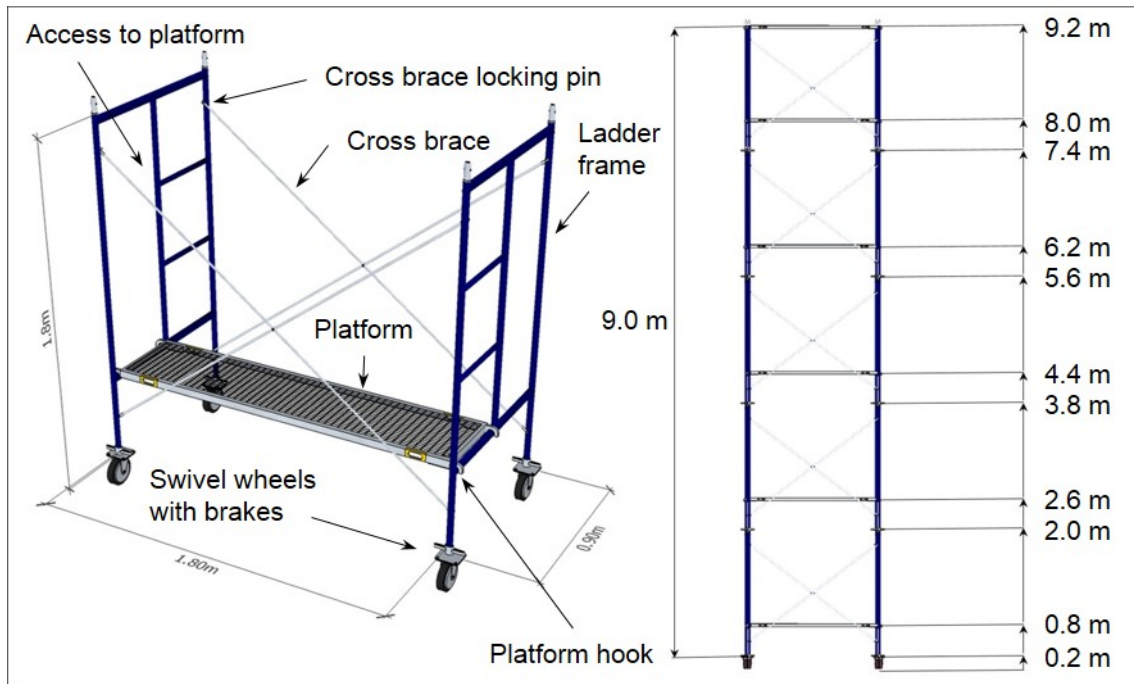
Figure 4: Scaffold construction components and dimensions

The mobile scaffolding equipment in use on board *Shanghai Spirit* was made of steel and was similar to other common types of mobile scaffold towers designed for use on stable, level surfaces. It was constructed of modular tiers placed one atop the next via inserts in each vertical leg. Each tier was 0.9 m wide, 1.8 m long and 1.8 m high. With five tiers fitted, the scaffolding had a height of 9.2 m. A single, half-width (400 mm wide) work platform was positioned on the lower cross bar of each tier with two in place on the uppermost (fifth tier) level (Figure 4).

At the base of the scaffold, rubber-tracked swivel wheels were fitted at each corner and allowed the structure to be moved (rolled) easily from position to position. These wheels could be locked to prevent unintended movement.
