# In-flight break-up involving Cessna 210B, VH-DBU

30 km NW Albany, WA on 24 October 2017

**ATSB Transport Safety Report**  
Aviation Occurrence Investigation  
AO-2017-103  
Final – 16 May 2019

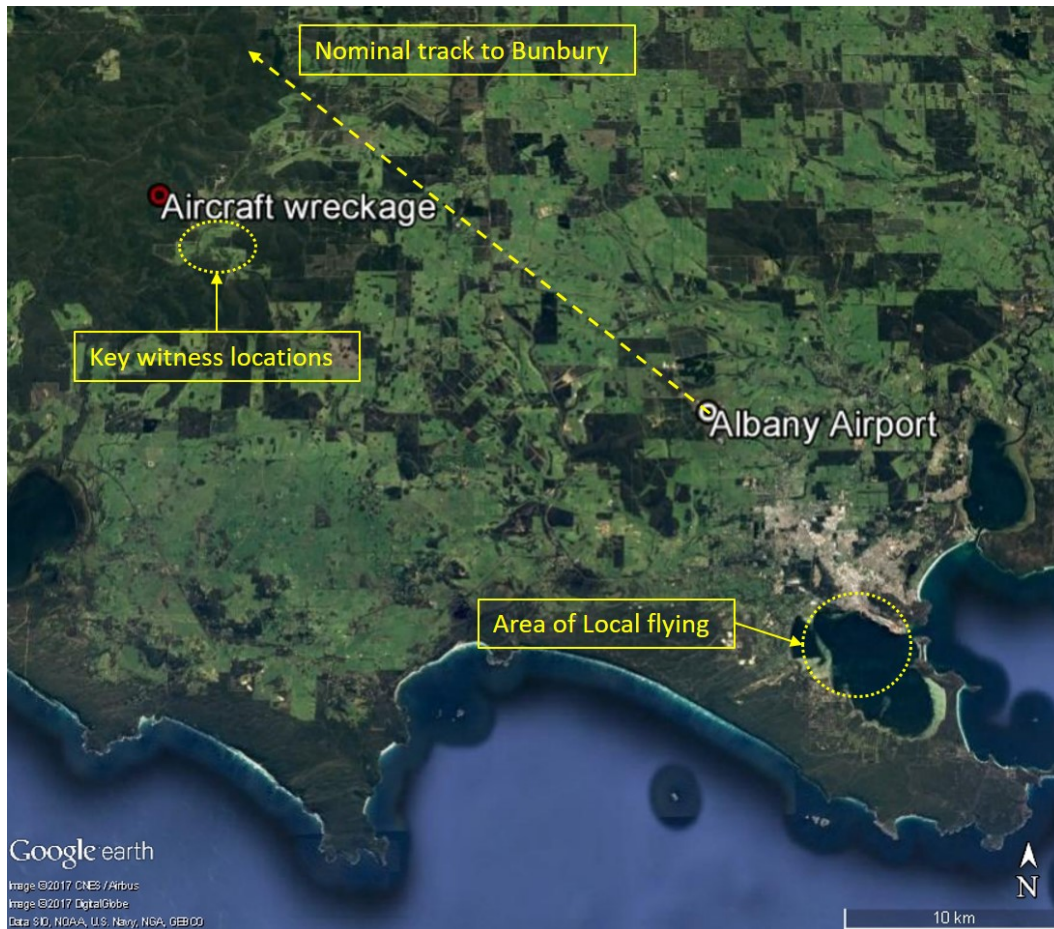
**Figure 2: Accident site and other locations of interest**

These events were reported to the authorities and the pilot of a nearby aircraft was diverted to conduct an aerial search. Aircraft wreckage was located in dense bushland within the Mount Lindesay National Park and the deceased pilot was found in the main wreckage.
