Runaway and collision between 'J' class and 'Nagasaki' class trams

Sydney Tramway Museum, Loftus, New South Wales | 15 May 2016

ATSB Transport Safety Report
Rail Occurrence Investigation
RO-2016-006
Final – 17 May 2019

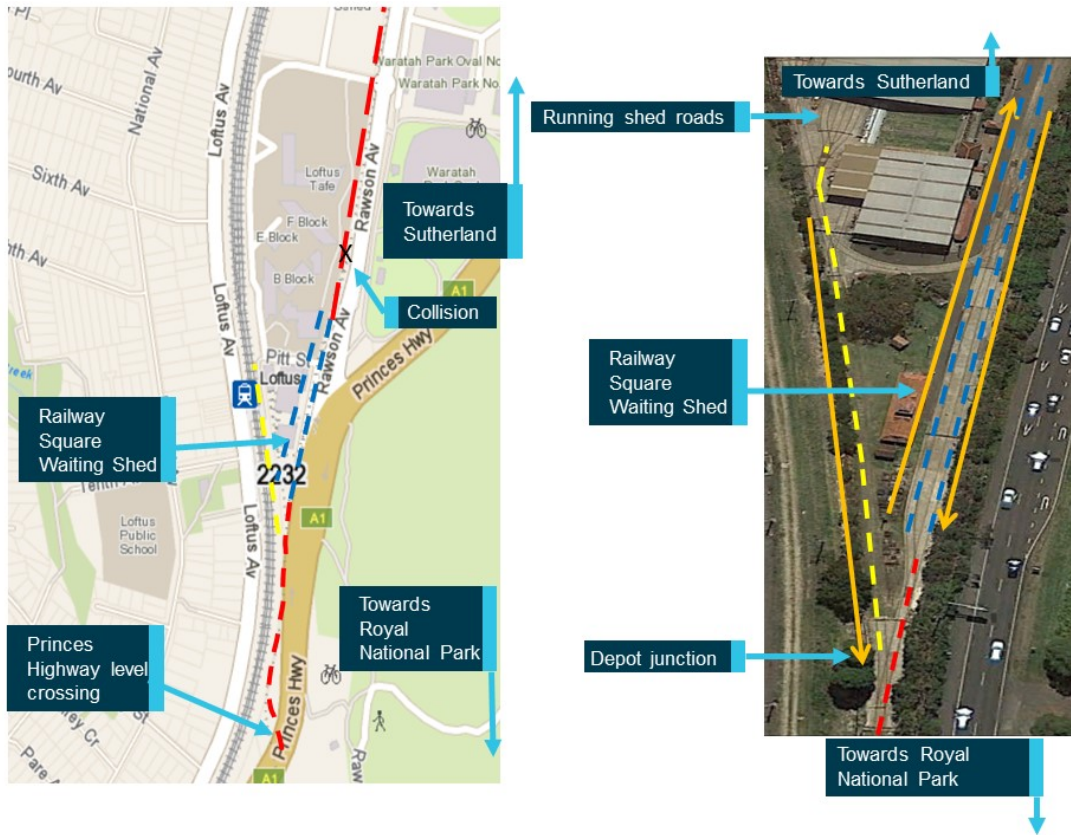
Figure 3: Yellow dotted line shows the depot mainline, red dotted line shows bidirectional lines, and blue dotted line shows the Up and Down mainlines at Loftus

At approximately 1055, a STM staff member noticed that the unmanned 'J' class had begun to roll down the falling gradient towards Sutherland. The 'J' class left the Up mainline and crossed onto the bidirectional line towards Sutherland (Figure 3). The 'J' class then headed towards the Nagasaki that was travelling in the opposite direction on the same line.

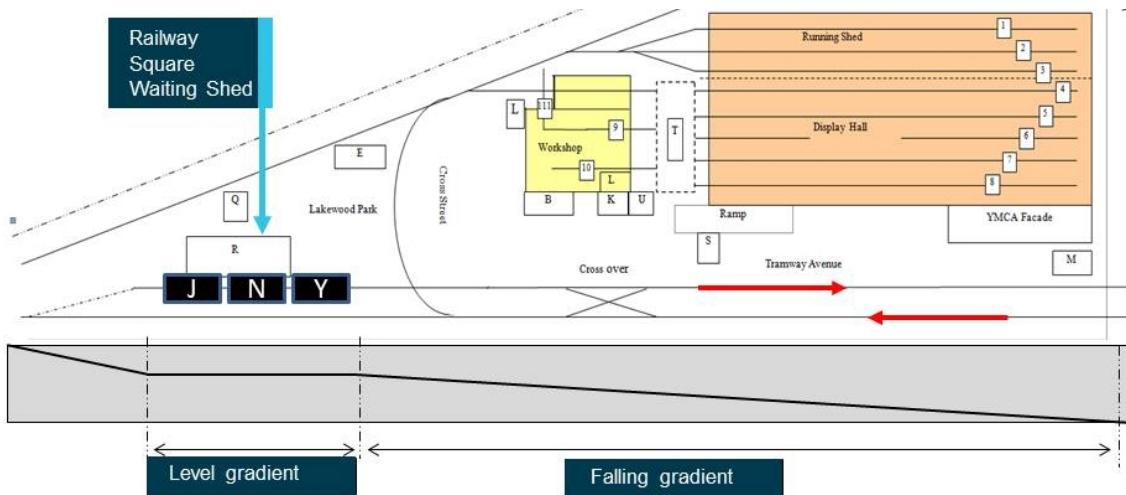
Figure 4: Sequence of trams parked before the 'Y' class departed to Sutherland

Another tram (‘J’ class) also departed the running shed to the RSWS and was parked behind the Nagasaki (Figure 4). The ‘J’ class driver applied the air brakes² but did not apply the handbrake when stabling it adjacent to the RSWS which was on a level gradient. A single hardwood wheel chock was placed under the ‘J’ class’s left-hand leading wheel.

The 'Y' class returned to Loftus from the RNP at approximately 1040. It was then parked behind the 'J' class, which was parked behind the Nagasaki. At approximately 1048, the Nagasaki departed for Sutherland with 16 passengers and two crew members on board.
