Derailment of acid train 9T90

near Kimburra, Queensland | 28 September 2017

ATSB Transport Safety Report
Rail Occurrence Investigation
RO-2017-013
Final – 13 June 2019

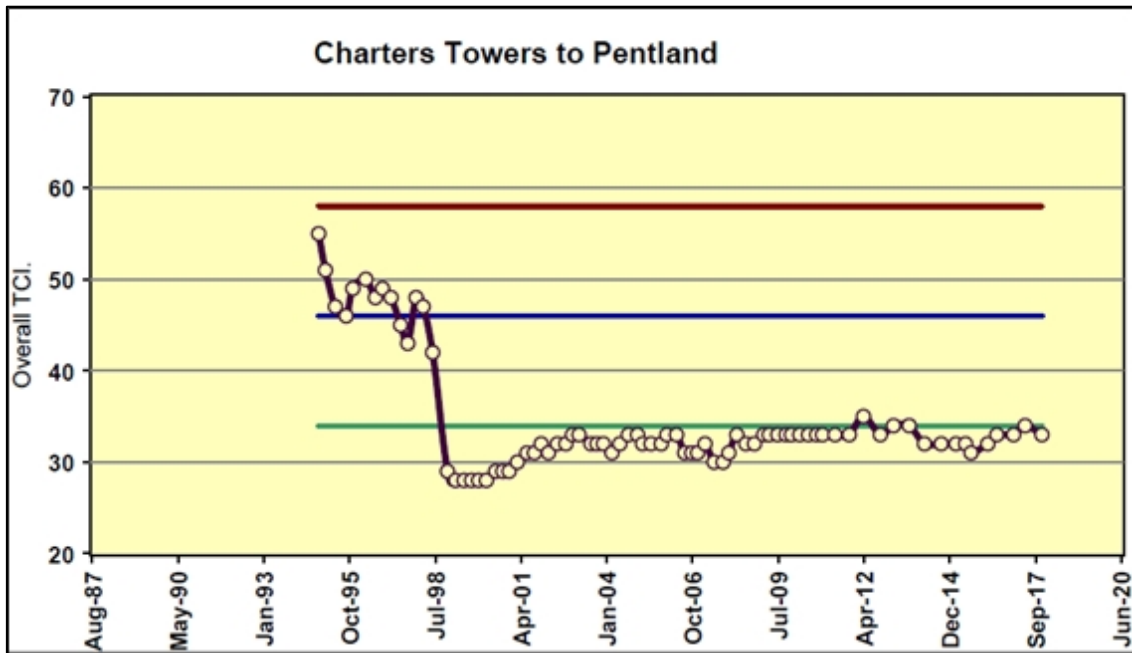
Figure 3: Charters Towers to Pentland section OTCI

QR applied a standard formula, known as track condition indices (TCI), to determine the overall condition of the track. The TCI was calculated by adding the condition index values of four track geometry parameters - top, twist, gauge and versine.² The resultant number represents the condition of one length of track. Weighted averages for all TCIs over a line section are known as overall track condition index (OTCI). Figure 3 shows the OTCI for the line between Charters Towers and Pentland. The lower the score, the better the general condition of the track. The figure shows a consistently low index, below the designated maintenance intervention level of 58 (red line).

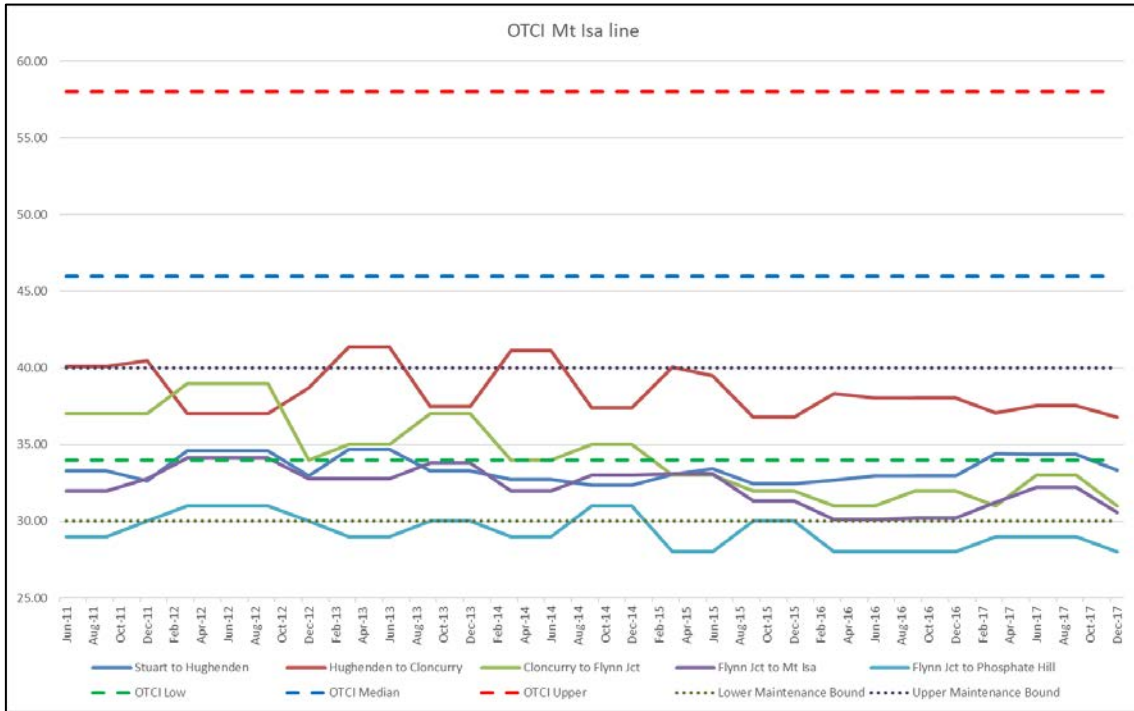
Figure 4: Mt Isa line OTCI

The OTCI of the Mount Isa line, (Figure 4) from June 2011 until December 2017 similarly identified that the general condition of the track was below the intervention level.

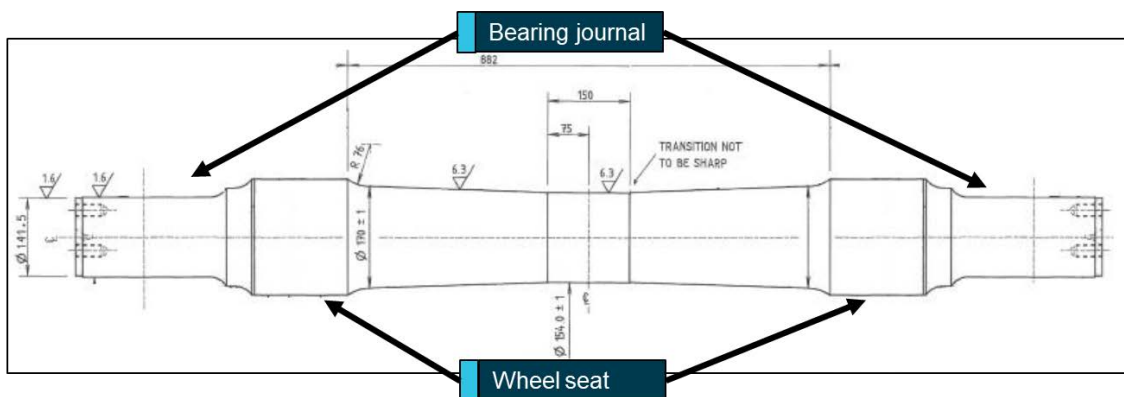
Figure 5: 840P1 axle

The solid steel axles of the GATX fleet, designated as 840P1, are 1,879 mm long with a central barrel tapered from 154 mm in the centre to 170 mm towards the wheel seats, (Figure 5). Other operators also used rolling stock configurations with 840P1 axles.

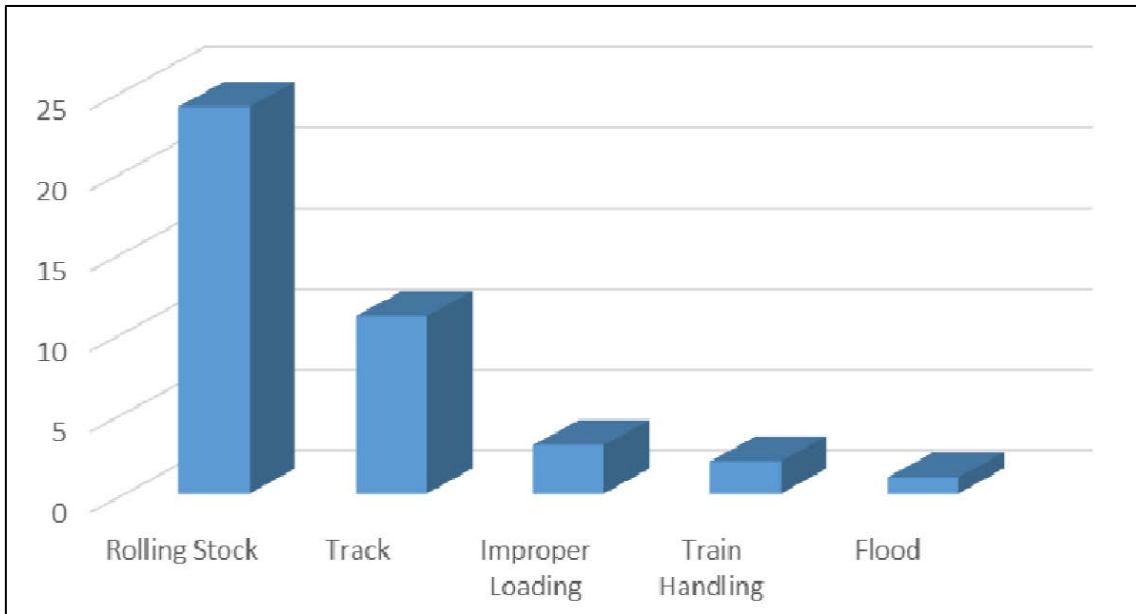
Figure 13: Principal causal factors

The rail regulation unit assessed each derailment to identify the principal causal factor, identifying rolling stock as the most frequent contributor, followed by track-related defects (Figure 13).

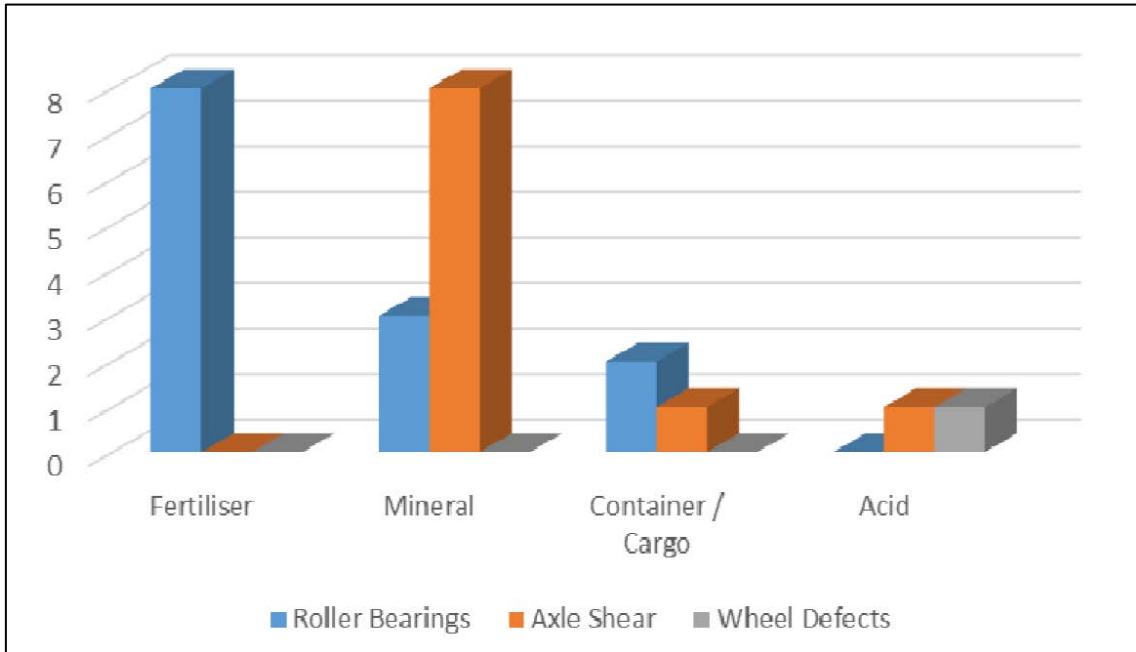
Figure 14: Defect by train type

The number of rolling stock-related causal factors was broken down into occurrence and train types (Figure 14).

The rail regulation unit cited legacy issues associated with rail infrastructure and rolling stock, together with loading irregularities, and identified a series of recommendations to the rolling stock and rail infrastructure managers for consideration.
