# Derailment of coal train 9869

8 km west of Oakey, Queensland | 21 July 2017

**ATSB Transport Safety Report**  
Rail Occurrence Investigation  
RO-2017-007  
Final – 26 June 2019

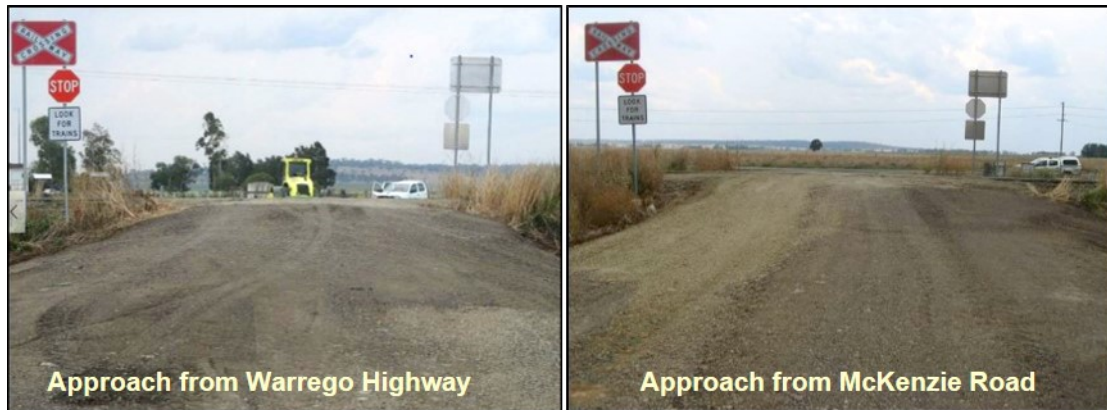
**Figure 4: Dunkeld Access Road / level crossing ID 2309 upgrade in October 2011**

QR records showed that in October 2011, repair work was undertaken to eliminate longstanding drainage issues at level crossing ID 2309. In addition, the approach roads to the level crossing were upgraded (Figure 4).

*The images show the condition of the approach road surface on the day of the upgrade (October 2011).  
Source: QR*
