From: s. 47F(1)
Sent: Monday, 27 July 2015 12:04 PM
To: ATSB - Comms
Cc: s. 47F(1)
Subject: FW: AO-2015-086 Collision with terrain involving a PA32 aircraft, VH-BDG at Lakeside Airpark, Queensland on 26 July, 2015 [DLM=For-Official-Use-Only] Aviation Investigation Web Notification.pdf

The ATSB is investigation a collision with terrain at Lakeside Airpark, Queensland on 26 July, 2015 involving a PA32 aircraft, registered VH-BKD. [sic]

During landing, the aircraft struck the runway, then veered off, striking an embankment before coming to a stop in a nearby dam.

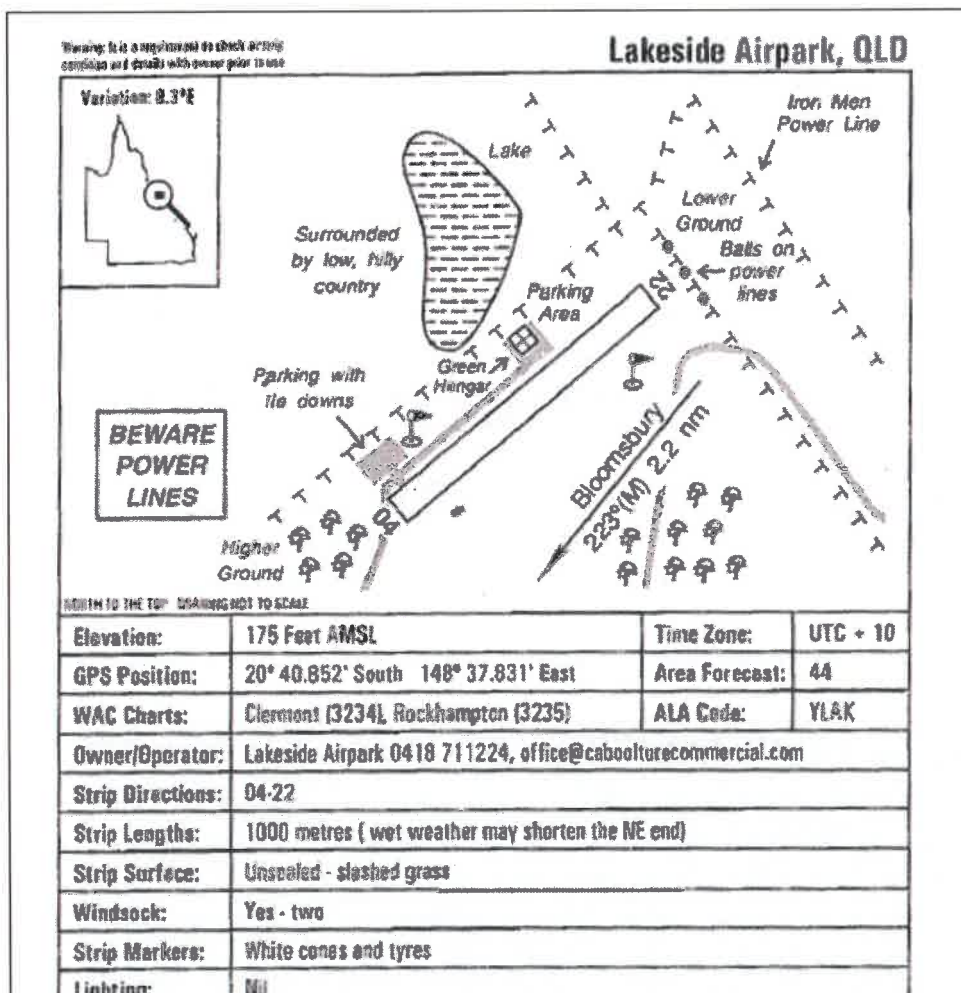
Figure 2: An extract from the Queensland Country Airstrip Guide. Diagrammatic representation of Lakeside Airpark and local hazards

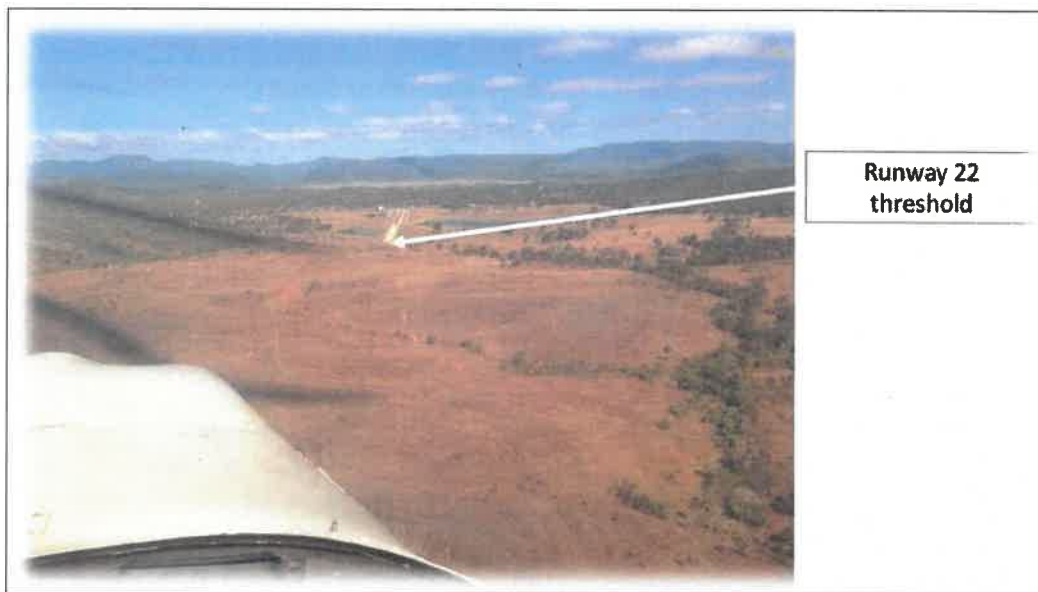
Figure 3: Approach to runway 22 at Lakeside Airpark. Note the unsealed and sealed portion of the runway. Also, note the difficulty in detecting the power lines on approach. Photo taken about a week prior to the accident

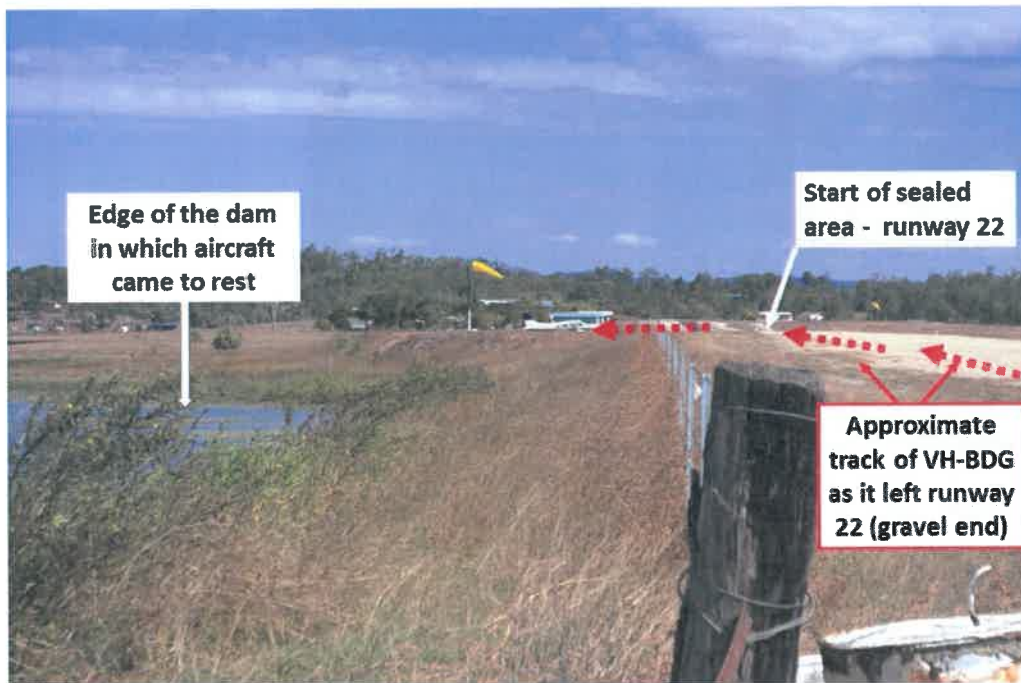
Once into the grassed area, and with the aircraft most probably airborne, it struck a wire fence (Figure 4) then the raised embankment of the dam, which ran perpendicular to the runway. The pilot reported that the left wing tip struck the water and the aircraft spun around and entered the water. At some point throughout this sequence, the main wheels detached from the aircraft. The pilot reported continuing to battle for control of the aircraft, up until it arrived in the water.

Figure 4: Looking along runway 22 taken a few days after the accident

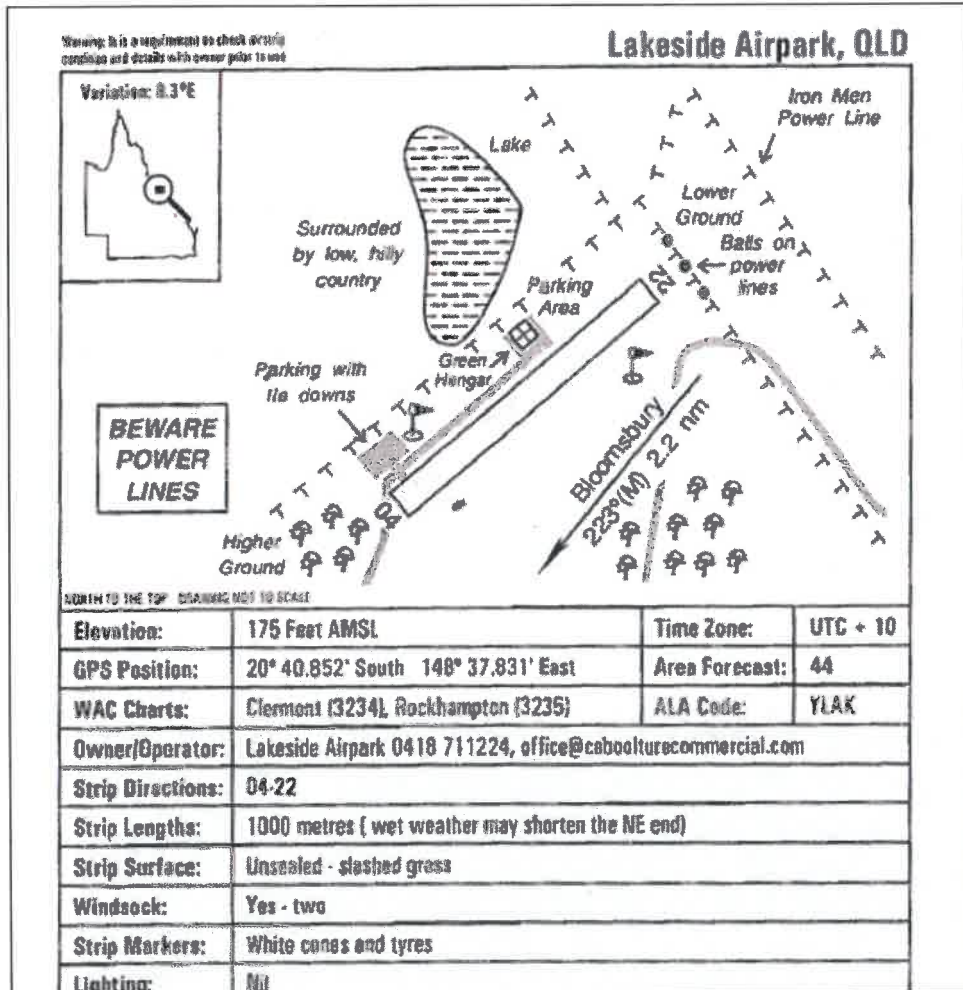
Figure 2: An extract from the Queensland Country Airstrip Guide. Diagrammatic representation of Lakeside Airpark and local hazards

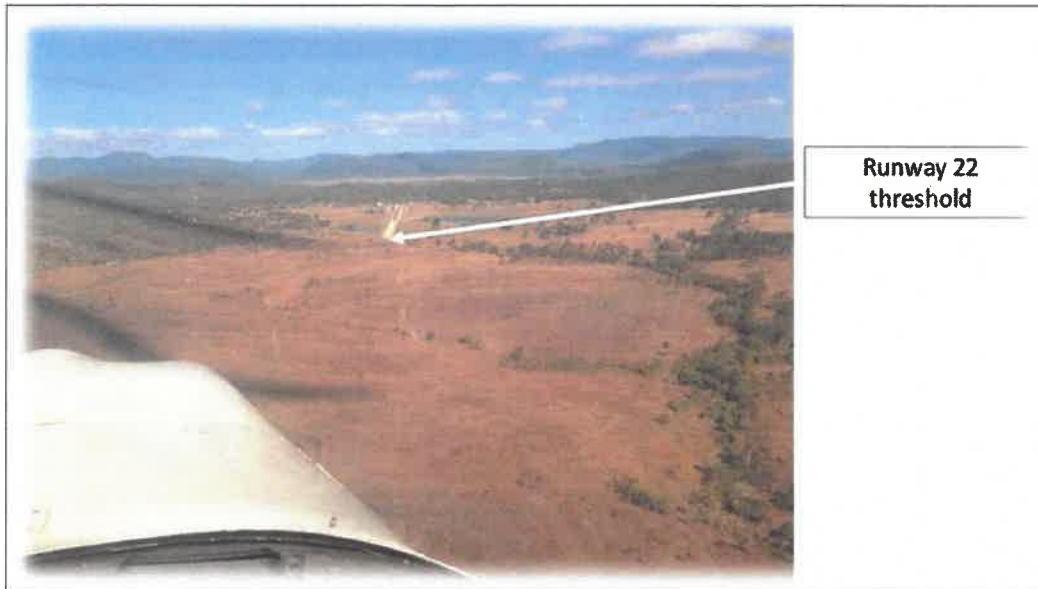
Figure 3: Approach to runway 22 at Lakeside Airpark. Note the unsealed and sealed portion of the runway. Also, note the difficulty in detecting the power lines on approach. Photo taken about a week prior to the accident

In order to maintain sufficient clearance over the two rows of power lines, and still land near the threshold, well before the sealed section of the runway, the pilot planned a steeper approach than normal. The flap was set to 40° (full flap) and the rate of descent increased to about 500-600 feet per minute.

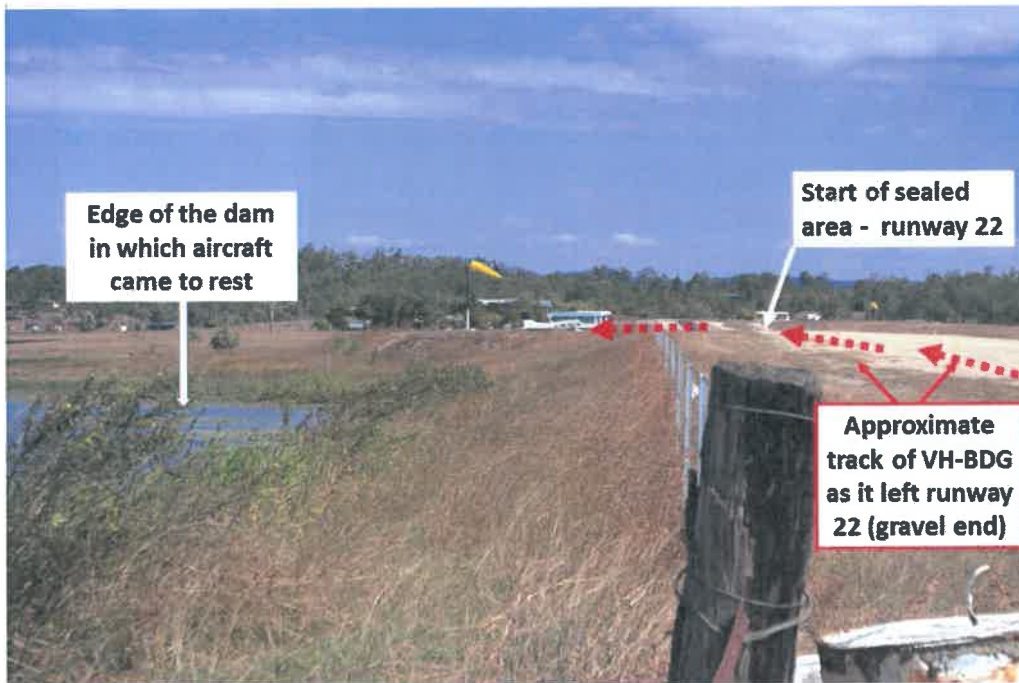
Once into the grassed area, and with the aircraft most probably airborne, it struck a wire fence (Figure 4) then the raised embankment of the dam, which ran perpendicular to the runway. The pilot reported that the left wing tip struck the water and the aircraft spun around and entered the water. At some point throughout this sequence, the main wheels detached from the aircraft. The pilot reported continuing to battle for control of the aircraft, up until it arrived in the water.

Figure 4: Looking along runway 22 taken a few days after the accident

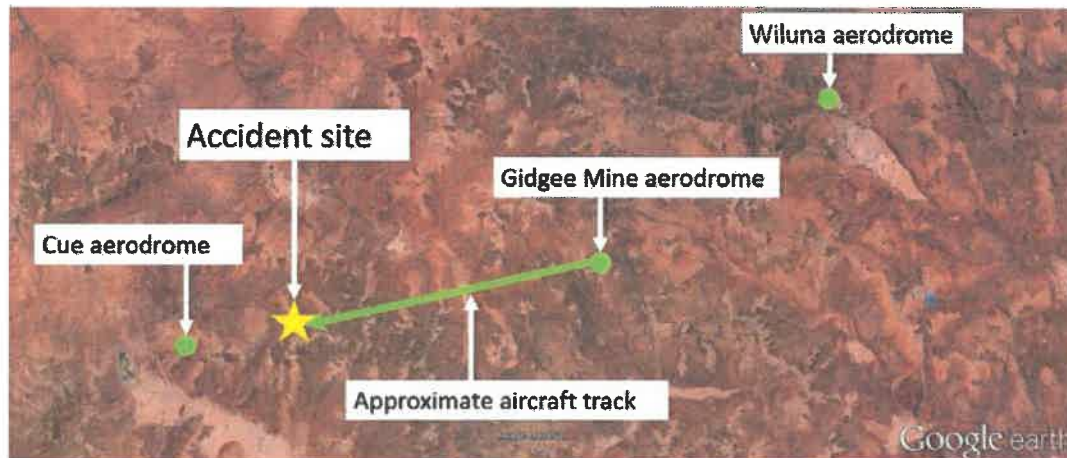
On 1 August 2015, at about 1110 Western Standard Time (WST), a Cessna 210 aircraft, registered VH-ERU, departed Gidgee Gold mine for a private flight to Cue, Western Australia (Figure 1). The pilot was the sole occupant of the aircraft. The pilot reported that all engine indications were normal from the start and into the cruise at 3,500 ft above mean sea level. The elevation of the terrain in the area was about 1,700 ft above mean sea level.

Figure 1: Aircraft track and accident location

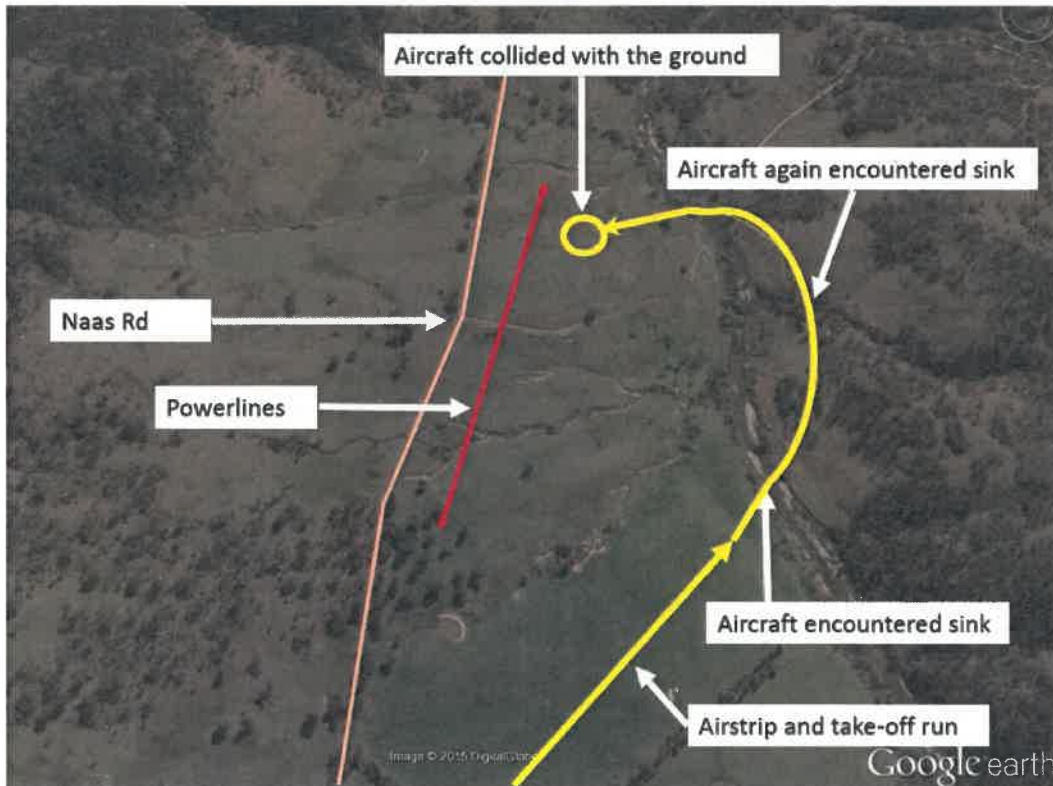
At about 1400, the pilot commenced the take-off run for the seventh load of the day. As the aircraft became airborne, the aircraft started to sink (Figure 1). To stop the aircraft sinking, the pilot applied the dump lever to start dumping the load of superphosphate. The aircraft then started to climb, so the pilot stopped dumping the load. The pilot also commenced a shallow left turn, away from rising terrain. As the aircraft turned, when at about 100 ft above ground level, it started to sink again. As it sank, the pilot felt a shake through the airframe, indicating that the aircraft was close to stalling. The pilot re-applied the dump lever to open the hopper door and try to reduce the aircraft load. Simultaneously, the pilot lowered the aircraft's nose and rolled the wings level, to try to recover from the incipient stall.

Figure 1: Departure airstrip, aircraft track and accident location

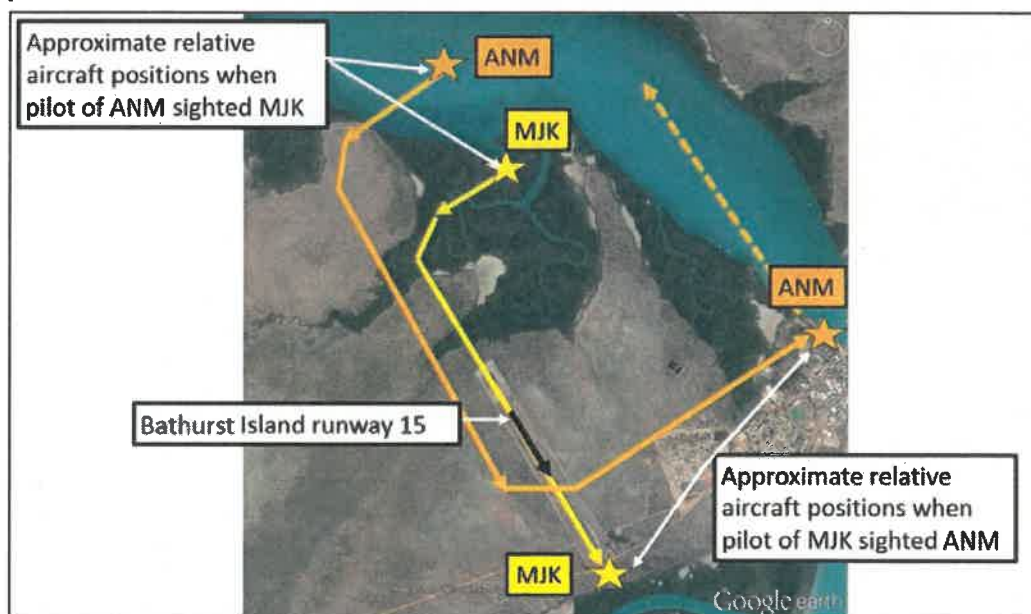
After the touch-and-go, when upwind of the runway at about 500 ft above ground level, the pilot of MJK sighted ANM. ANM was then to the left, above MJK at 1,000 ft, and turning onto the downwind leg. The pilot of MJK then saw that the radio was selected to frequency 126.6 MHz. The pilot checked their flight plan, noted that the correct frequency was 126.5, and immediately changed the radio to that frequency. The pilot of MJK then broadcast a departure call on the CTAF. The pilot of ANM then contacted the pilot of MJK, who advised that the radio had been on the wrong frequency.

Figure 2: Bathurst Island Airport showing approximate aircraft tracks and relative positions

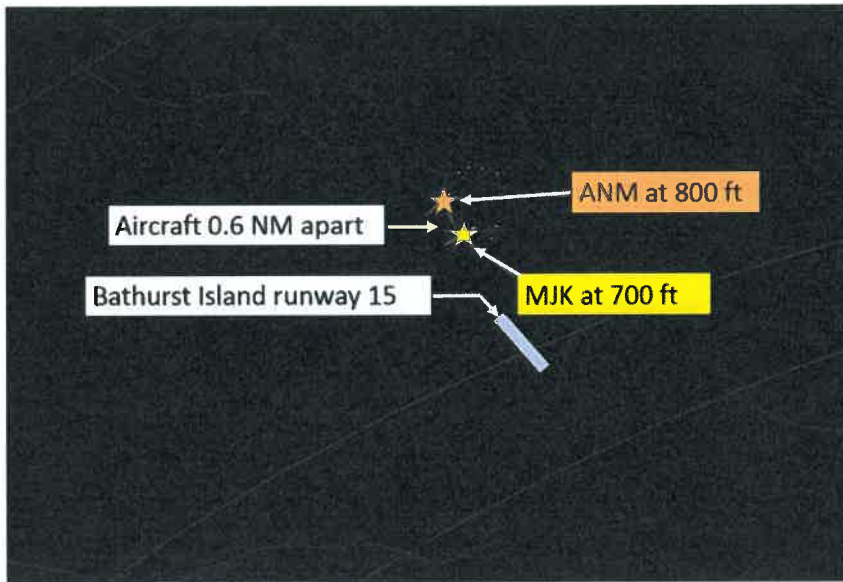
The radar data provided to the ATSB by Darwin air traffic control, indicated the aircraft came within about 100 ft vertically and 0.6 NM at the closest proximity (Figure 3).

Figure 3: Radar display showing relative aircraft positions

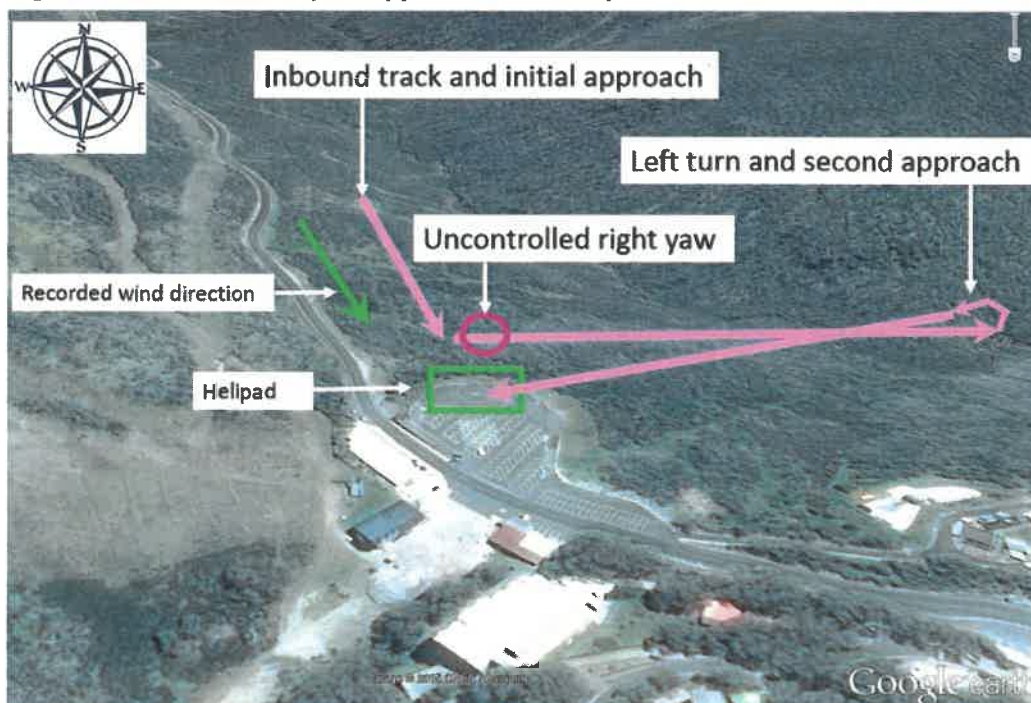
At about 1030, while 700 ft above ground level and tracking from the north-west, the pilot conducted a shallow approach towards the helipad at Falls Creek (Figure 1). As the helicopter descended to about 50 ft above ground level, the pilot found that significantly more power was required to conduct the approach than anticipated. The pilot assessed that there was insufficient power available to continue to land, and elected to abort the approach. The pilot pushed forwards on the cyclic¹ to increase the helicopter's airspeed and conducted a left turn towards the valley.

Figure 1: Falls Creek helipad, approximate helicopter track and wind direction
