Derailment of freight train WG713

Denman, New South Wales | 19 January 2016

ATSB Transport Safety Report
Rail Occurrence Investigation
RO-2016-001
Final – 22 March 2019

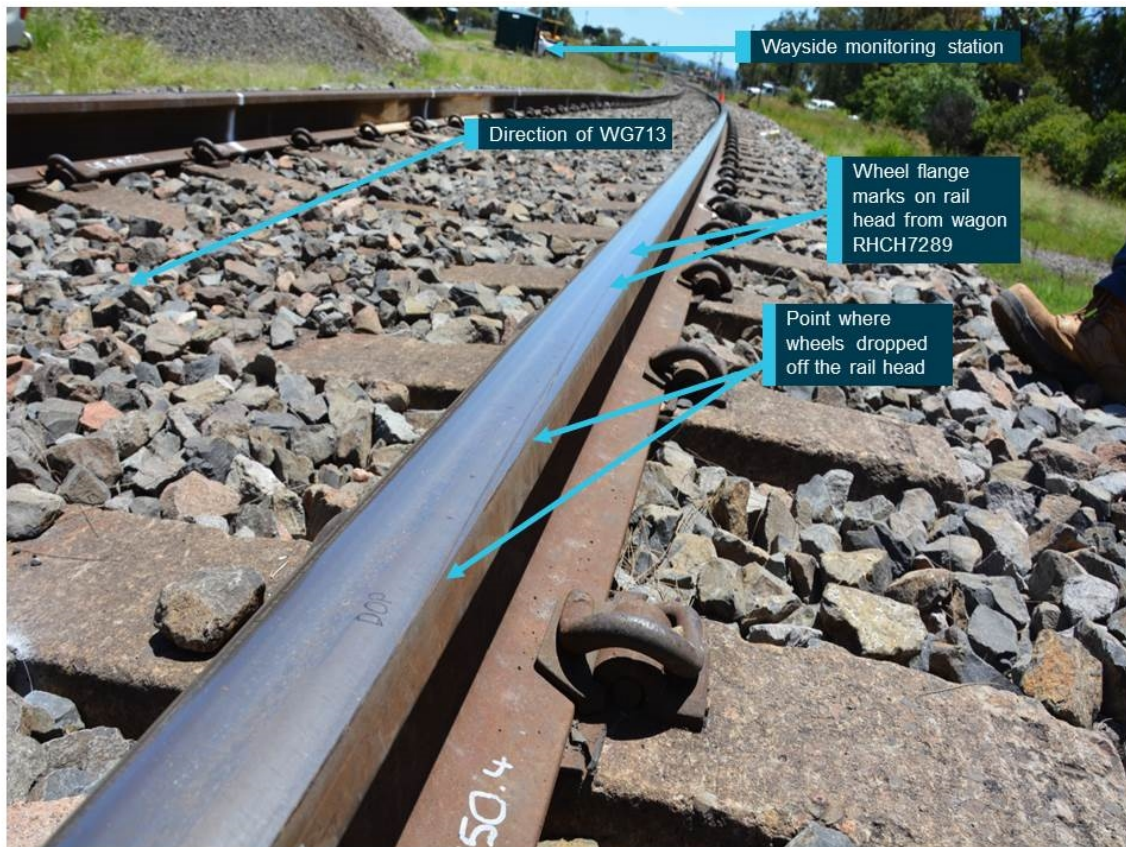
Figure 1: Incident location, Denman, NSW

At 314.540 km, the left-hand wheels (in the direction of travel) of the lead bogie of the 64th wagon behind the locomotives mounted the rail. The right-hand wheels likely followed the profile of a long twist¹ defect approximately 30 m before the Point of Mount (POM) which resulted in the left-hand wheels losing vertical load (unloading). This wheel unloading allowed the left-hand wheel flanges to rise onto the Down rail² (outside rail) head. The left-hand wheels then tracked across the railhead of the Down rail for 10 m before dropping off the rail at 314.550 km (see Figure 1).
