Grounding of *ABFC Roebuck Bay*

Henry Reef, Queensland | 30 September 2017

ATSB Transport Safety Report
Marine Occurrence Investigation
MO-2017-009
Final – 27 June 2019

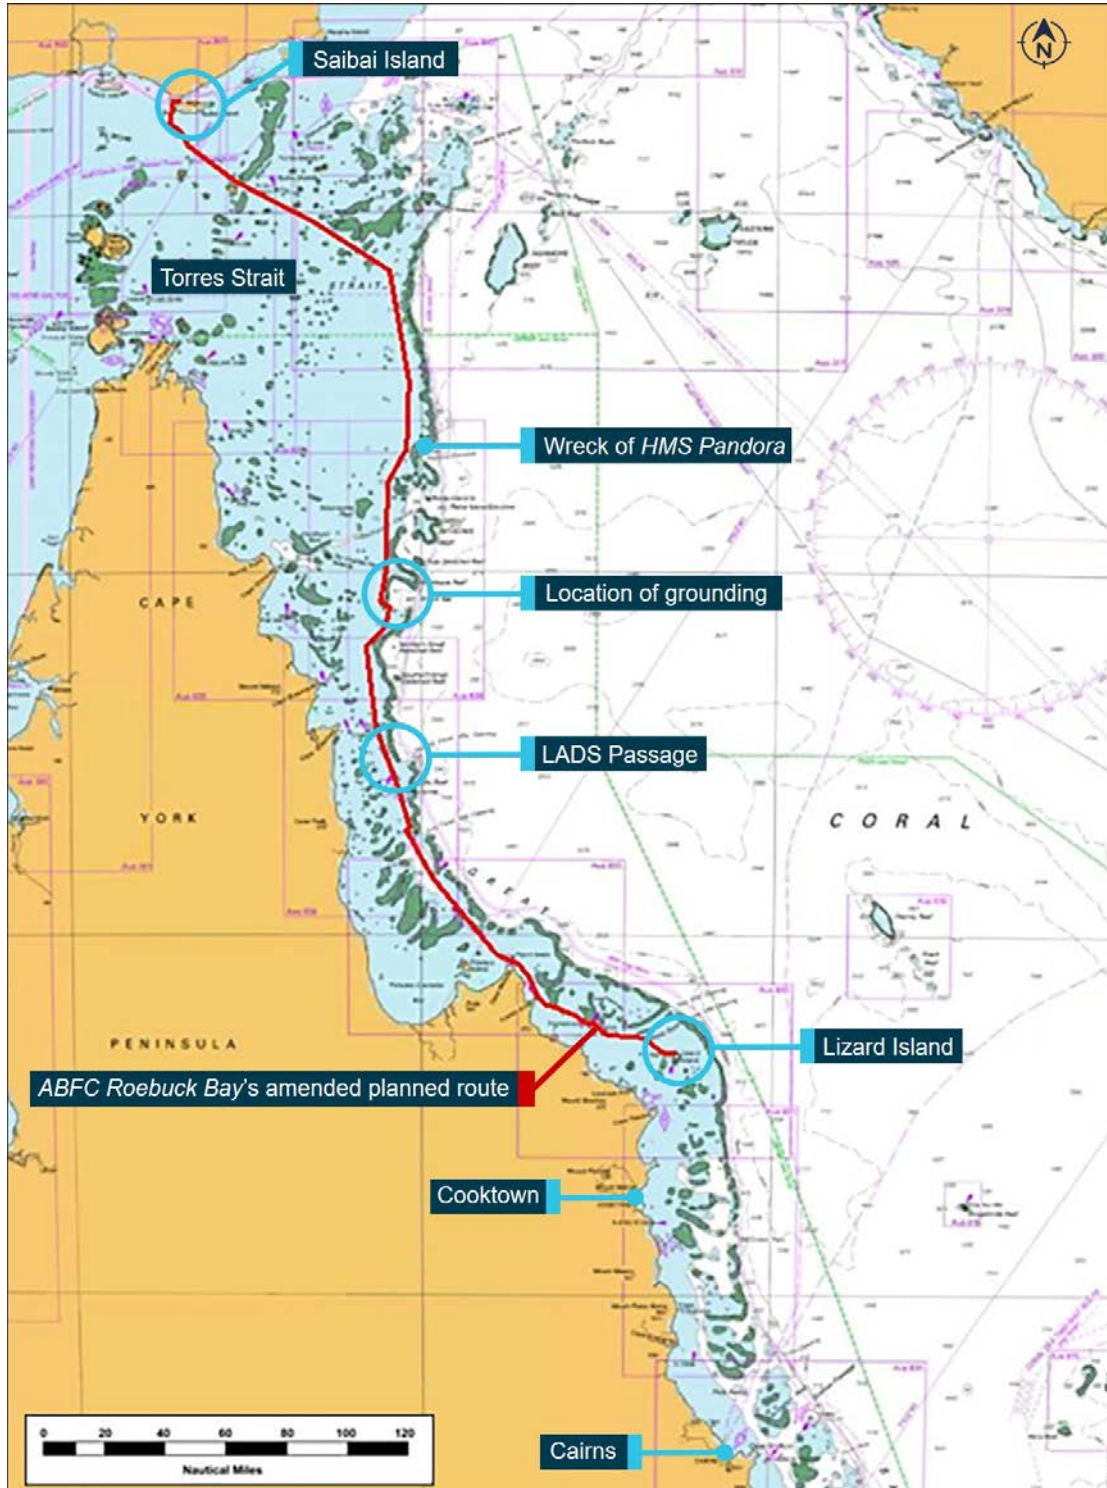
Figure 3: Section of navigational chart Aus 4620 showing ABFC Roebuck Bay's planned route and key locations

The passage plan was subsequently split into two routes with a brief stop at Lizard Island, Queensland before continuing on to Cairns for the end of the patrol. The two routes were then saved on the cutter's ECDIS and named 'Saibai to Lizard via Outer Reef' (Figure 3) and 'Lizard to Cairns'. No further changes were made to the route plan.

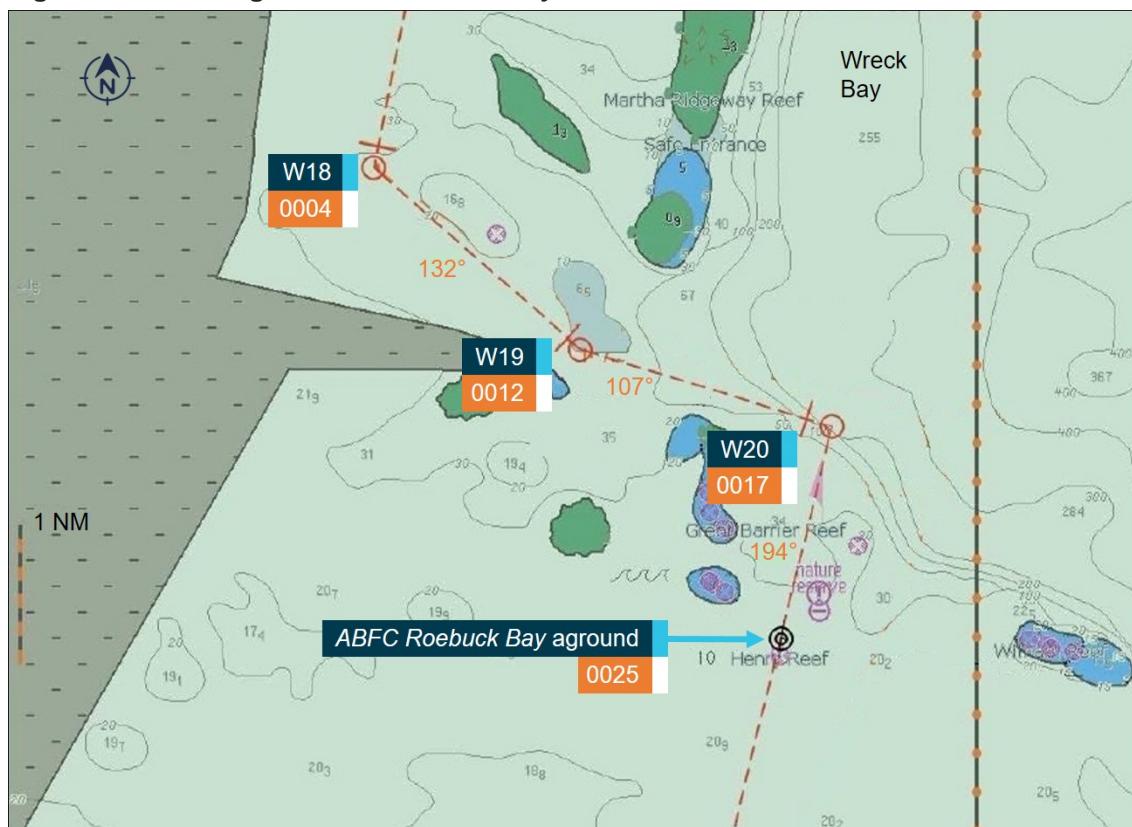
Figure 5: Grounding of *ABFC Roebuck Bay*

At about 0025, with the cutter about 15 m to east of the planned route, the bridge team felt a bump and a shuddering sensation through the cutter's hull. Almost immediately after, *ABFC Roebuck Bay* abruptly grounded on Henry Reef and came to a complete stop (Figure 5). The OOW and lookout were thrown out of their seats onto the display screens in front of them.

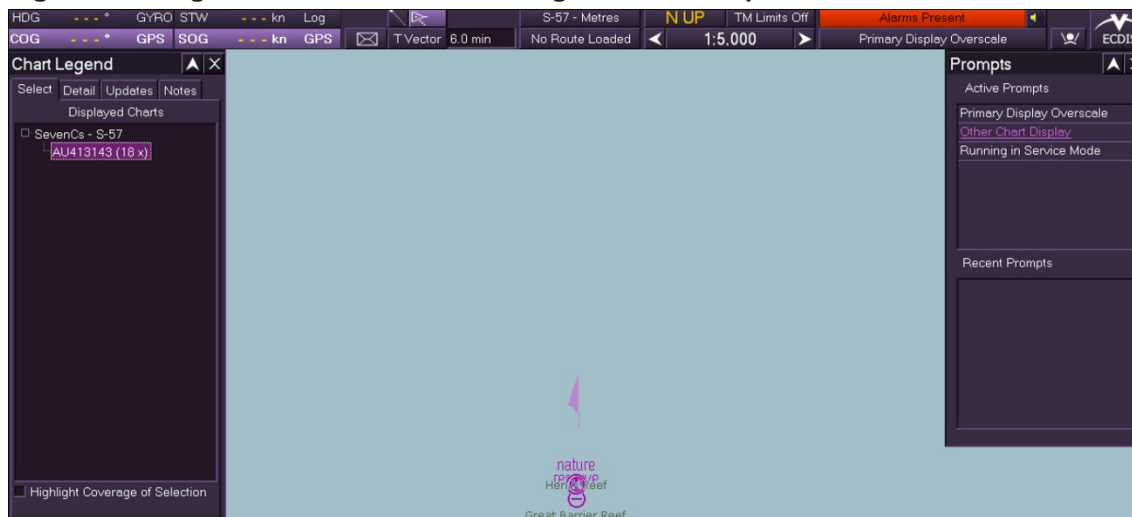
Figure 14: Image of ENC AU413143 showing no overscale pattern

During tests on chart AU413143, conducted by the ATSB and the manufacturer, it became apparent that, while the overscale text prompt appeared when the chart was viewed at scales larger than the compilation scale, the overscale pattern was not generated regardless of the scale at which the chart was viewed (Figure 14). However, the pattern did appear on other charts of the same compilation scale and navigational purpose as ENC AU413143 (see Figure 13).

Image of a VisionMaster FT ECDIS display showing ENC AU413143 at a scale of 1:5,000 and displaying no overscale pattern. Source: Northrop Grumman Sperry Marine, modified by the ATSB

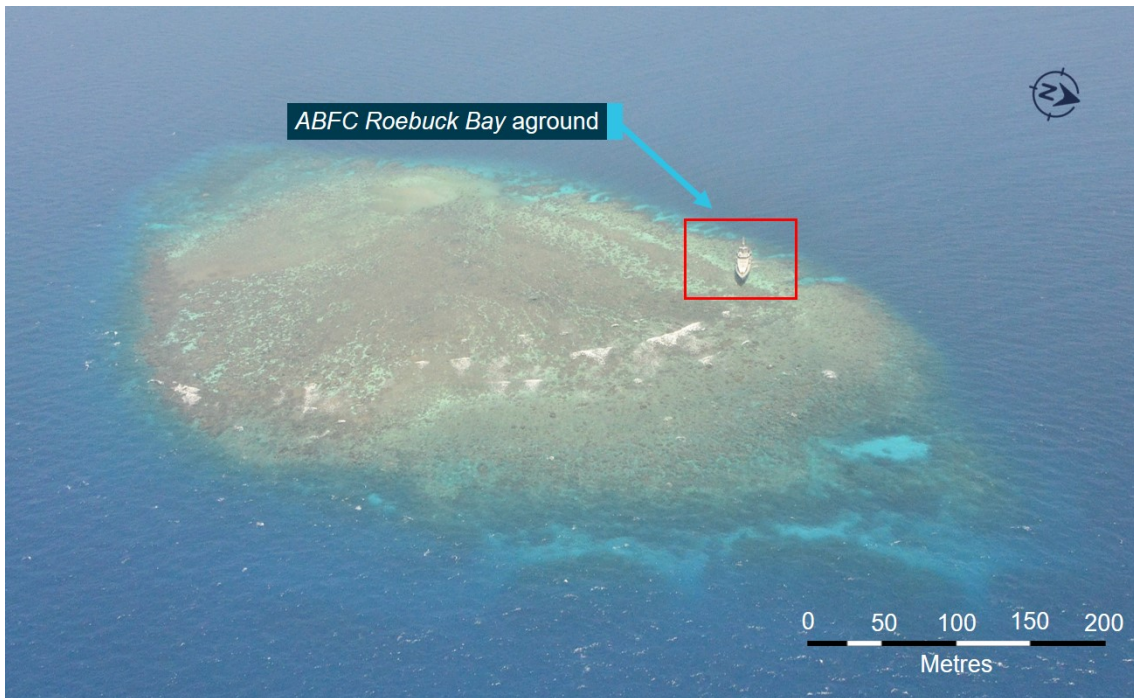
Figure 17: Henry Reef

Henry Reef (Figure 17) is located about 45 NM north-east of Lockhart River, Queensland on the south-western side of Wreck Bay in the outer Great Barrier Reef. The reef's diameter ranges between 400 to 600 m and rises sharply out of the surrounding waters of a depth between 20 to 30 m. In places, the reef has a shallow shelf at a depth of about 5 to 8 m with the reef gently sloping up to the reef crest on the eastern flank at or about the lowest astronomical tide.⁵⁰

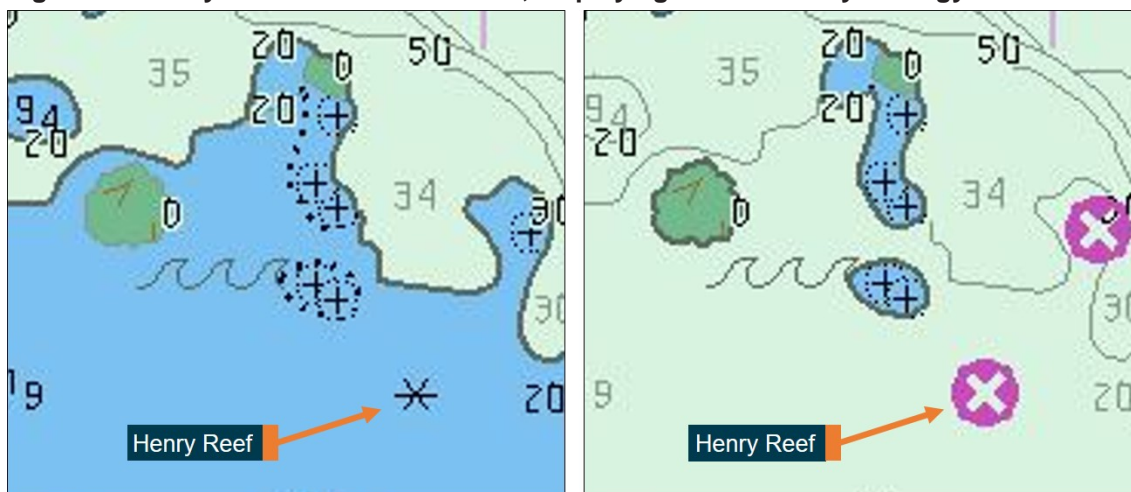
Figure 19: Henry Reef on ENC AU413143, displaying conditional symbology

As an ‘underwater/awash rock’, conditional symbology rules applied to the feature. Thus, when situated within the user-defined safety contour value, Henry Reef displayed as an asterisk-like symbol for an ‘underwater/awash rock’ (Figure 19 left). However, when situated in waters deeper than the safety contour, such as in otherwise ‘safe’ waters where one would expect to be navigating, Henry Reef’s symbol changed to an isolated danger symbol (Figure 19 right).

Image on left shows Henry Reef displayed as a 'rock awash' symbol when lying within the user-defined safety contour. The image on the right shows Henry Reef displaying as an 'isolated danger symbol' when lying outside the user-defined safety contour.
 Source: Australian Hydrographic Office, annotated by the ATSB

The IHO presentation library applicable at the time of the grounding, PresLib 4.0, mandated that the user be given the option of displaying the isolated danger symbol even for features in waters shallower than the safety contour value. However, some ECDIS operating on previous versions of the presentation library, including the ECDIS on board *ABFC Roebuck Bay*, always displayed the isolated danger symbol for applicable features regardless of their location in relation to the safety contour. Therefore, on *ABFC Roebuck Bay's* ECDIS, Henry Reef always displayed as an isolated danger symbol.

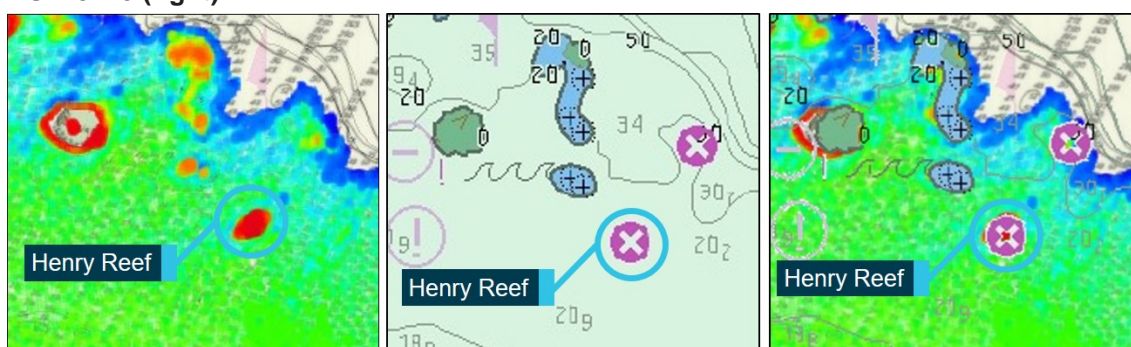
Figure 20: AHO survey data (left), AU413143 (centre) and survey data overlaid on AU413143 (right)

A cursory analysis of AHO survey data⁵³ obtained shortly after the grounding showed that, when superimposed on ENC AU413143 at compilation scale and, taking into account the position accuracy limits defined by the appropriate CATZOC, the isolated danger symbol appears adequately representative of the observed extent of Henry Reef (Figure 20). However, when viewed at scales progressively larger than the compilation scale, the symbol would progressively represent a smaller proportion of the reef on the ECDIS display.

Images show AHO survey data (left), section of ENC AU413143 (centre) and ENC AU413143 superimposed on survey data at compilation scale (right).
 Source: Australian Hydrographic Office, modified, annotated and superimposed by the ATSB

At compilation scale, the isolated danger symbol was reasonably comparable to the physical extent of Henry Reef (see Figure 20). A visual assessment of ABFC Roebuck Bay's planned route at compilation scale showed the route passing over Henry Reef (Figure 27, left). However, when viewed at progressively larger scales, the reef's isolated danger symbol appeared further away from the route. This could potentially give a false sense of sea room and safety.

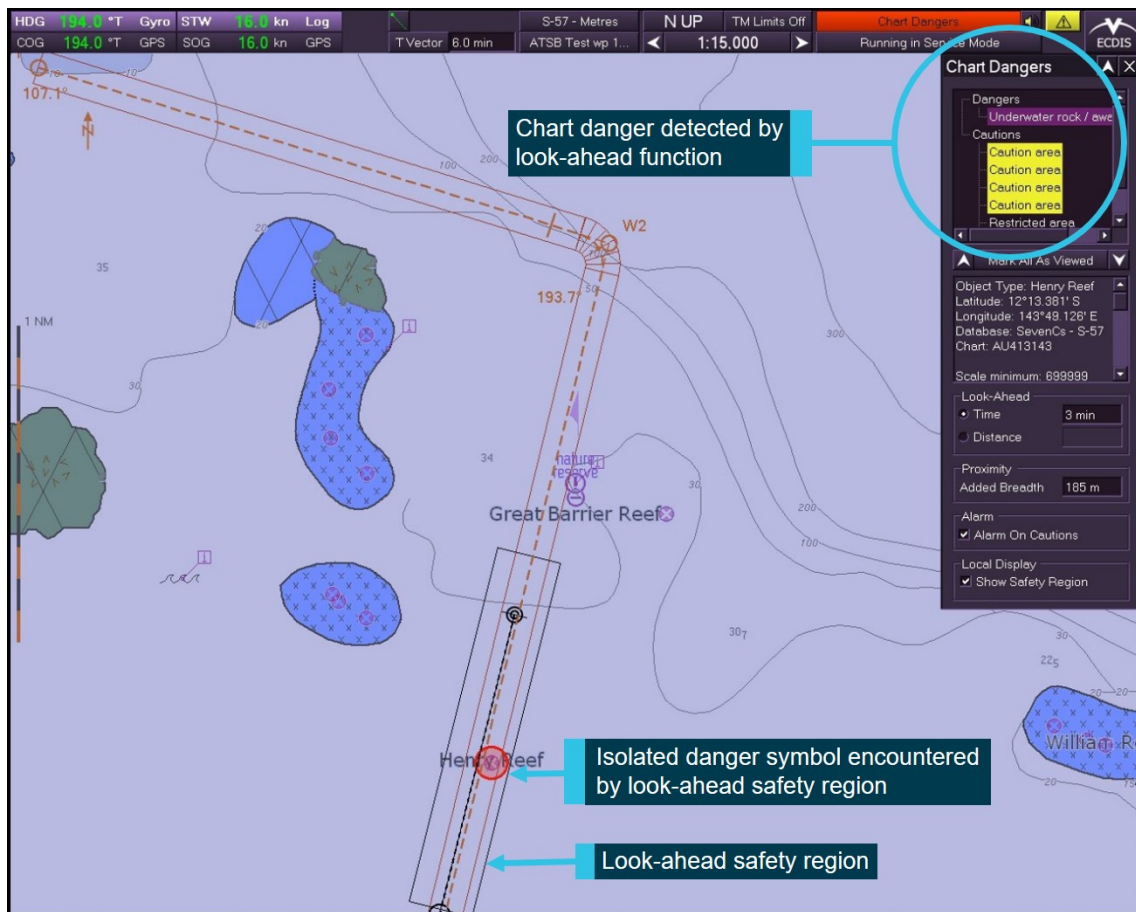
Figure 31: Image showing Henry Reef, detected by the look-ahead function during testing, based on the ‘restricted waters’ setting

ATSB tests using settings recommended in the 'restricted waters' category of the Annex C checklist in the ECDIS work instructions, namely the use of an added breadth of 0.1 NM (185 m), significantly increased the chances of the look-ahead function detecting the reef (Figure 31).

Image from ATSB testing showing Henry Reef being detected by the ECDIS's look-ahead function when set up with a 0.1 NM (185 m) added breadth based on settings in the Annex C – Restricted waters category checklist of the ABF work instructions. Selecting the danger highlights the reef graphically on the ECDIS display and provides available information on Henry Reef.

ATSB analysis also found the use of a 3-minute setting for the ECDIS's look-ahead function would have left limited time to take action in the event it did alert the OOW to the approaching reef. Calculations show that, given the 30-second interval of the look-ahead function, the cutter's speed of 16 knots and the actual extent of the reef in relation to its charted position (see *Charting of Henry Reef*); the OOW would potentially have had about 2 ½ minutes to take action before grounding.

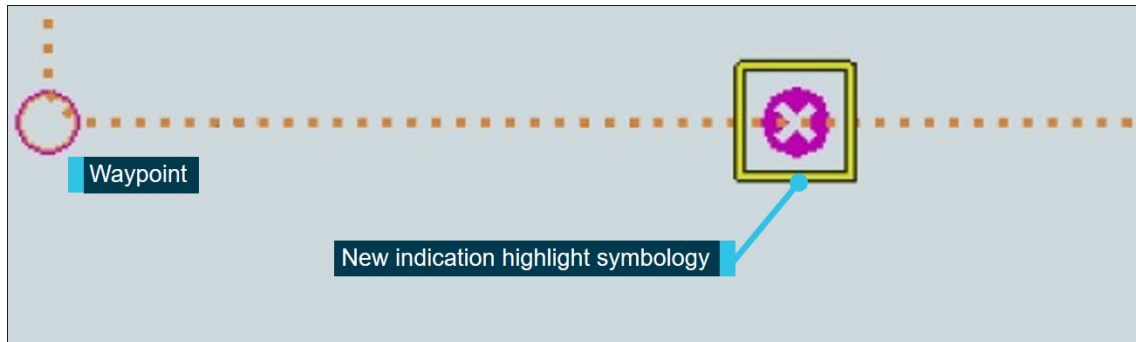
Figure 32: Route danger emphasised by new 'indication highlight' symbol in ECDIS updated to Presentation Library 4.0

PresLib 4.0 introduced new 'indication highlight' symbology for objects that posed a potential threat to the vessel. On ECDIS upgraded to PresLib 4.0, all navigational hazards identified on the route by the ECDIS route safety checking function could be automatically highlighted on the chart with the appropriate 'indication highlight' symbology (Figure 32). Identified hazards on the planned route could be highlighted during route planning and monitoring without the need for the user to manually select them in the danger tabs folder.

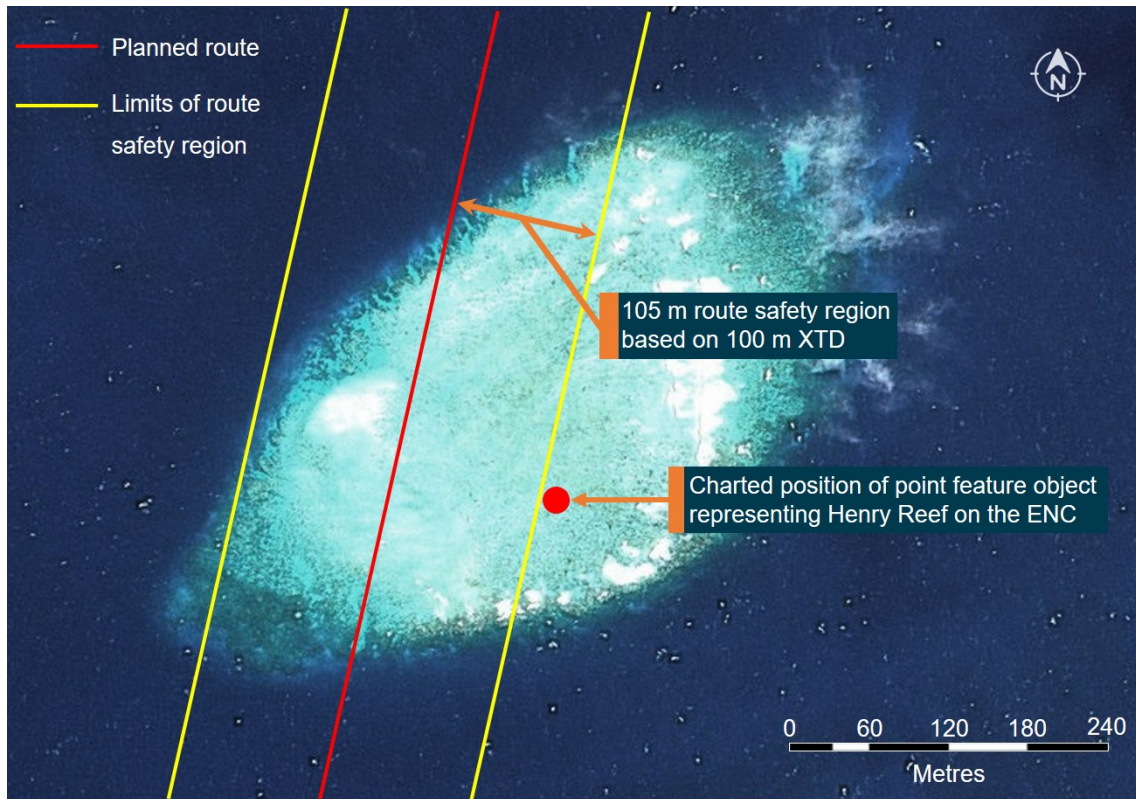
Figure 35: A hypothetical route and route safety region

However, when a point feature represents a physical feature of relatively significant size, it is possible for a part of the ECDIS route safety region to be obstructed by the feature despite its charted position falling outside the route safety region. If a hypothetical route were plotted about 55 m further to the west, the charted position of the point feature would now fall outside the ECDIS route safety region. In this case, the ECDIS would not have detected the reef as a danger to the planned route and it would not have been identified in the dangers tab folder. Nevertheless, the planned route and a significant proportion of the route safety region would remain across the reef (Figure 35). In this situation, ABFC Roebuck Bay would have potentially run aground with the ECDIS showing no identified dangers on the planned route. A similar scenario, and associated safety implications, would equally apply to the ECDIS look-ahead function and safety region.

Figure showing a hypothetical route laid about 55 m to the west of ABFC Roebuck Bay's planned route and the ECDIS route safety region based on a 100 m XTD. Note that the charted position of Henry Reef now falls just outside the route safety region. In this case, the route is still laid across Henry Reef but the ECDIS will not identify the reef as a danger on the route leg.
Source: DigitalGlobe, Esri, modified and annotated by the ATSB

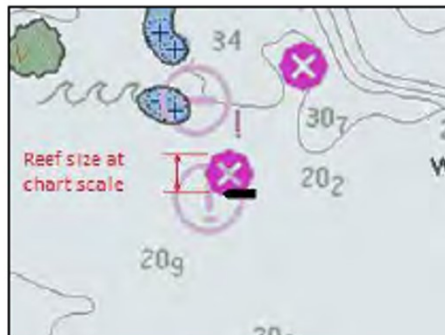
4. When the ENC is displayed correctly, the danger to a ship close to an isolated danger is clear.

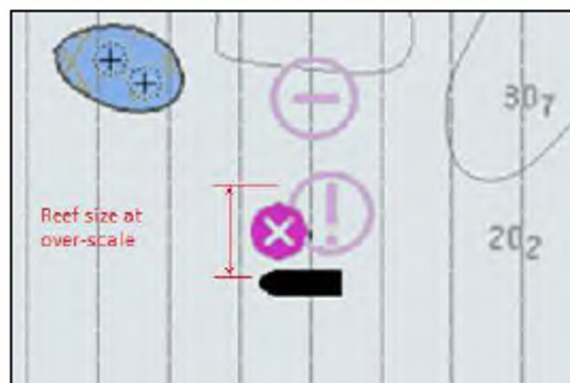
5. However, when displayed at over-scale, a ship the same unsafe distance from the isolated danger incorrectly appears to be safe because the isolated danger symbol is still the same size.

6. This is not more accurate, and is definitely not safe.
7. Remember, the positioning accuracy of the isolated danger may be worse than 500 metres. Routes should be planned to clear these dangers by at least as far as the ZOC category immediately around the danger dictates.
