# Non-operation of level crossing protection

Colac, Victoria on 22 September 2018

**ATSB Transport Safety Report**  
Rail Occurrence Investigation  
RO-2018-015  
FINAL – 8 October 2019

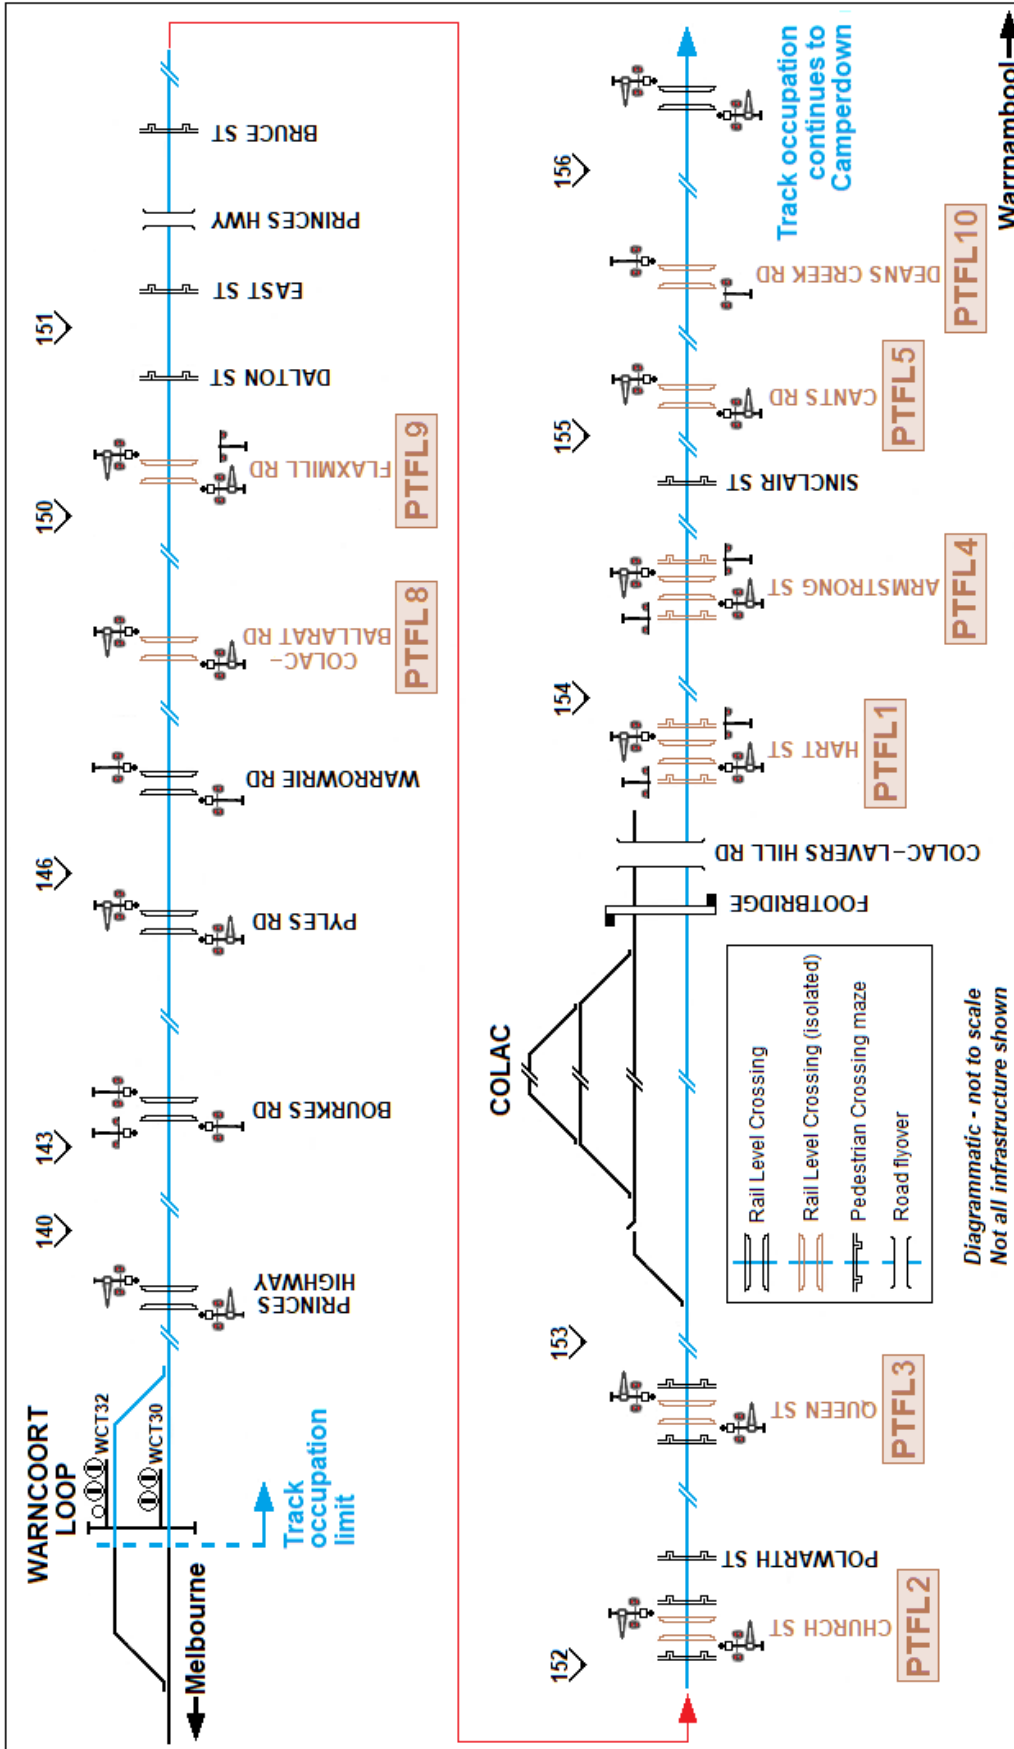
Figure 2: Diagram showing the area of works on 21 September, including RLXs

For the five crossings closest to Colac Railway Station, the SMT initially requested the issue of five Permits To Foul the Line (PTFL)<sup>3</sup> together (No’s 1-5) issued between 2216 and 2226 (Figure 2). This was so he could quickly isolate the protection equipment at these proximal crossings and remove their track connections to allow the track works to proceed.
