Runway excursion involving a Fairchild Metro 23, VH-UUB

Portland, Victoria | 20 February 2014

ATSB Transport Safety Report
Aviation Occurrence Investigation
AO-2014-028
Final – 22 March 2016

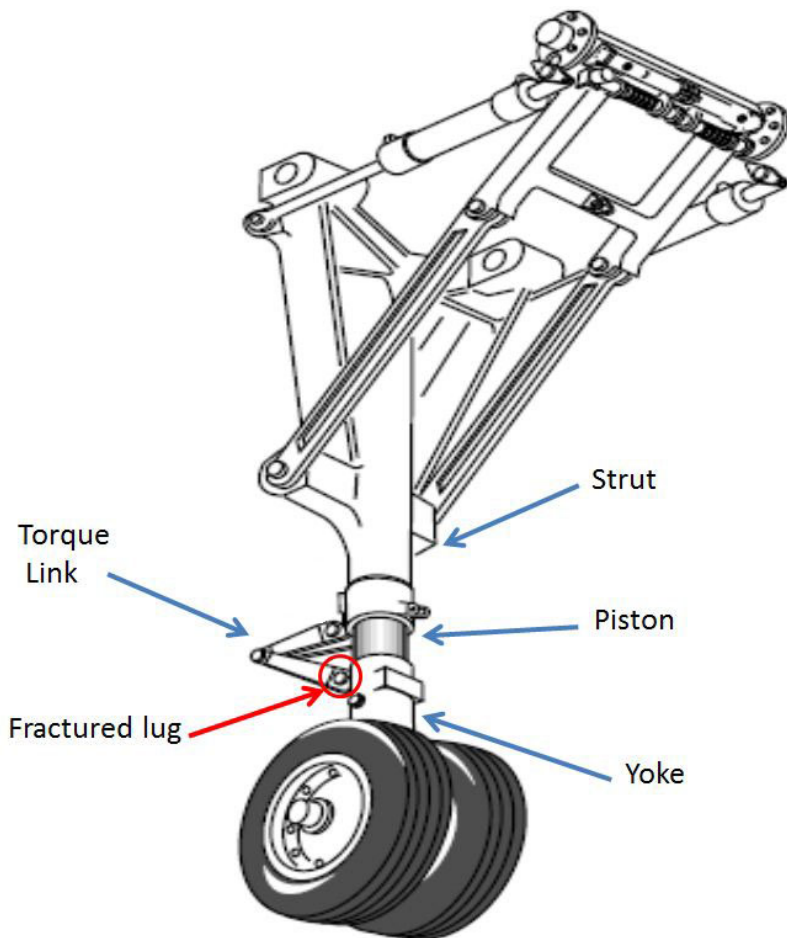
Figure 3: MLG assembly highlighting key components

The main landing gear assembly is composed of a telescoping upper cylinder (strut), a piston assembly and, at the lower end, the yoke (Figure 3). A torque link assembly connects at lugs on the strut and the yoke, allowing compression of the assembly while preventing rotation of the yoke. In this occurrence, the lug on the yoke had fractured.

Yokes in the MLGs of earlier SA227 models were manufactured by Ozone Industries as part number (P/N) OAS5453005-5³. In later models, manufacture was by another landing gear vendor, Klune Industries, and started with the fabrication of the 27-series part numbers. The fractured yoke from VH-UUB was identified as P/N 27-51505-005, manufactured by Klune Industries.
