# Collision of passenger train A42 with buffer stop

Richmond, New South Wales | 22 January 2018

**ATSB Transport Safety Report**  
Rail Occurrence Investigation  
RO-2018-004  
Final – 20 December 2019

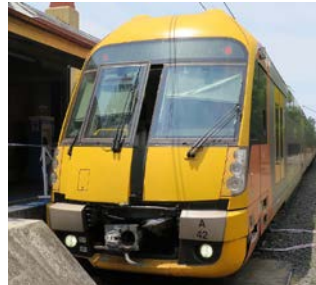
**A42 at Richmond Station**

On 22 January 2018, a Sydney Trains passenger train (A42) failed to stop as intended at the Richmond Station platform, and collided with the buffer stop at the end of the platform at a speed of about 26 km/h. There were 26 people on board the train (including the driver and a guard). Sixteen people were injured and treated at the scene, some with serious injuries.

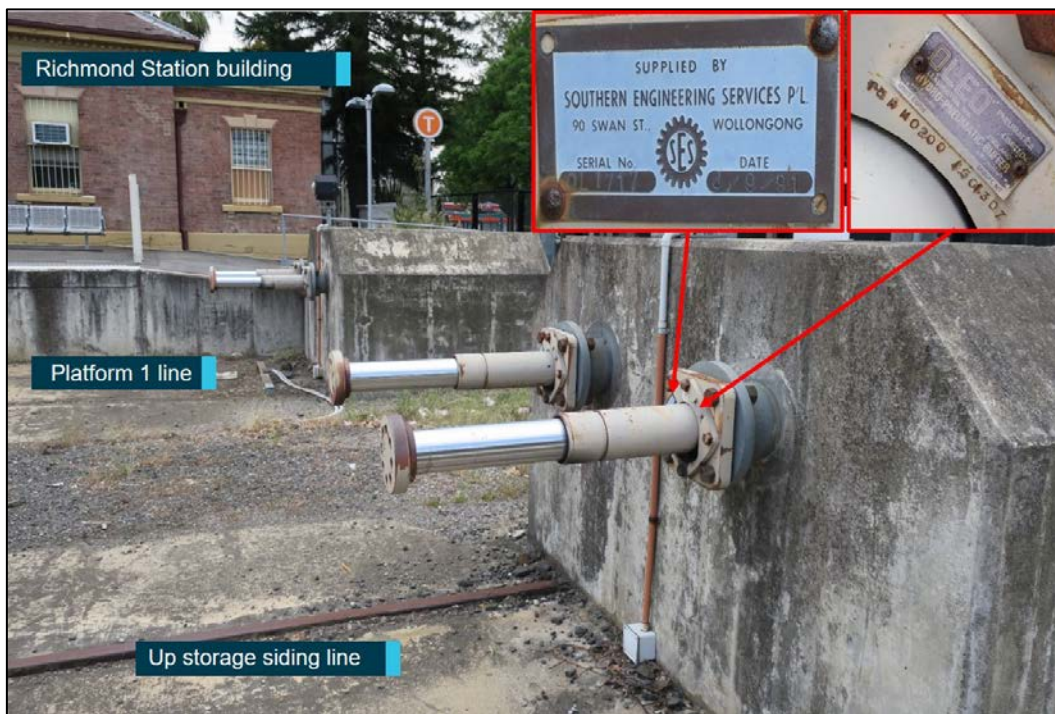
**Figure 9: Buffer stops, Platform 1 and Up storage siding, Richmond Station**

The hydro-pneumatic rams had a metal tag affixed to the end plate dated 3 September 1991 (Figure 9). These rams extend approximately 1.1 m from the face, with a hollow tubular area cast into the concrete behind the rams so that under impact they can collapse into this tube.

*This diagram shows the buffer stops at Richmond Station on the Up storage siding line (right) and Platform 1 line (left), the insert shows the identification tags on one buffer stop.*

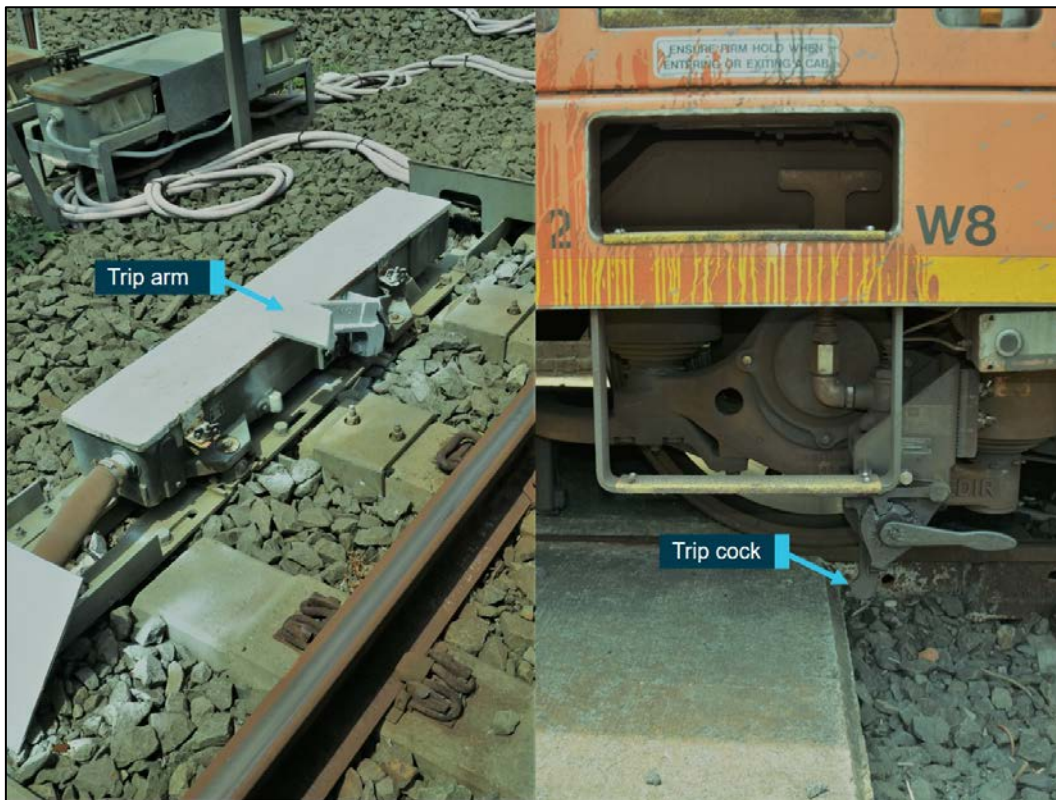
**Figure 13: Signal train stop system**

A train stop system involves a trip cock on the vehicle and a trip arm located trackside which, when engaged, directly initiates an emergency brake application (Figure 13).<sup>42</sup> In NSW, train stop systems are fitted to multiple-unit passenger trains operating on the electrified lines.

This figure shows the trip arm next to signal RD5 at Richmond (left) and the trip cock on A42 (right).  
Source: ATSB

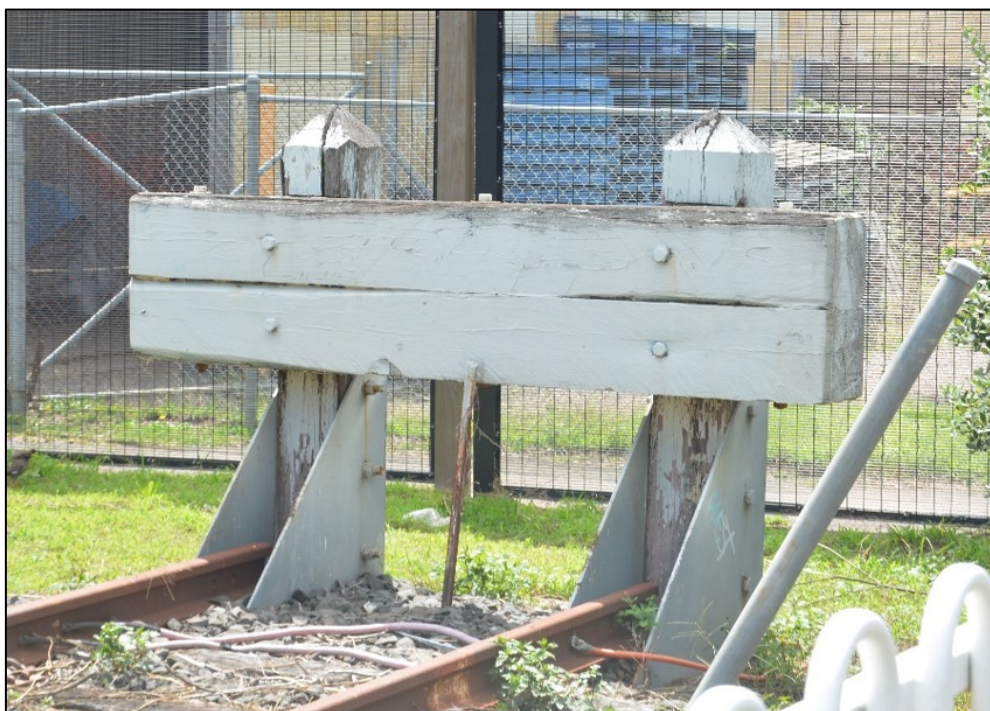
**Figure 21: Fixed buffer stop at Carlingford station**

The Carlingford buffer stop, when inspected in March 2019 (14 months after the Richmond collision), still had the standard Department of Railways NSW, Way and Works Branch, 1963-designed timber fixed buffer stop bolted to the track (Figure 21). Reviewing the effectiveness of this buffer stop, the 2008 report calculated that timber buffer stops are unable to resist a force of 1000 kN and would break away. The report stated that ‘the current fixed timber buffer stop would not be able to arrest any train effectively at any speed.’<sup>61</sup>

*This figure shows the buffer stop at the end of the line at Carlingford station on the Sydney rail network.*  
Source: ATSB

Following the collision, Sydney Trains conducted an end-of-line risk prioritisation of the safety-critical buffer stops on its network. The review rated 23 buffer stops with a category 1 level hazard rating and a further 15 with a ranking range from 2 to 5. The following four locations achieved a top prioritisation for mitigation measures to be put in place: Central Platform 9, Richmond Platform 2, Macarthur turn-back road, and Carlingford.

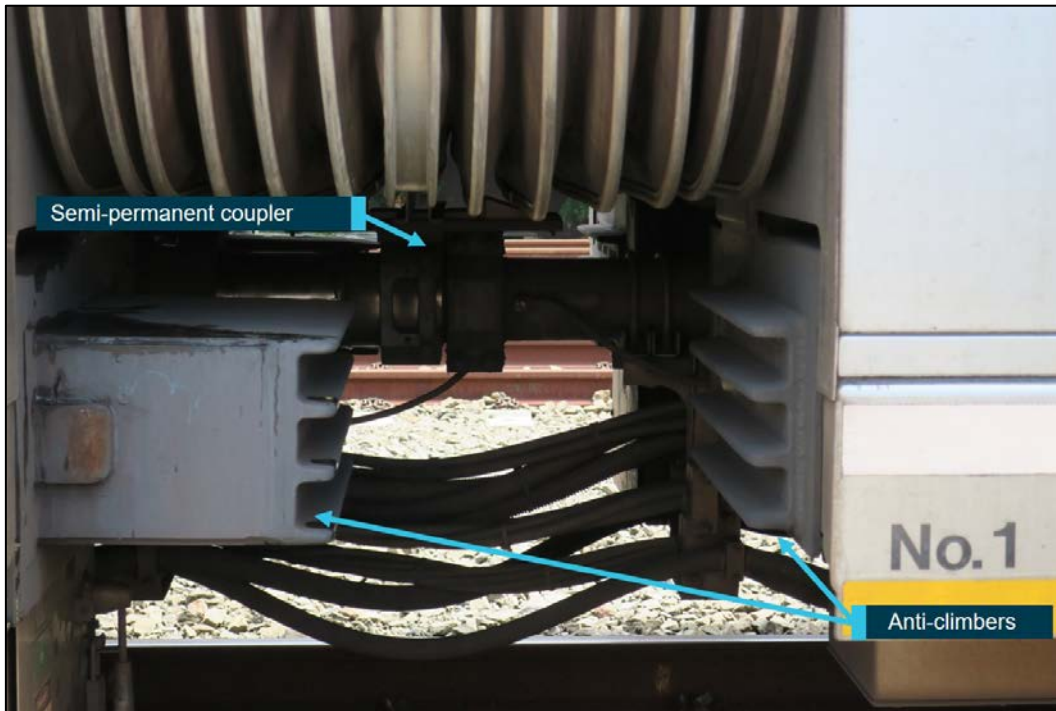
**Figure 31: Normal configuration of anti-climbers**

The bending of the couplers between the first two car interfaces, and the derailment of all wheels of a bogie (Figure 30), is indicative of vertical pitching that occurred because of the forces being transferred along the train not in a line of action close to the centreline through the couplers. This affected the alignment of the anti-climbers, which reduced their effectiveness in containing vertical movement (Figure 31).

*This figure shows the anti-climbers in their normal configuration between the seventh car (N5442) and the eighth car (D6442).  
Source: ATSB*
