# Running line collision with worker involving passenger train T570

Petrie, Queensland, on 29 May 2017

**ATSB Transport Safety Report**

RO-2017-003

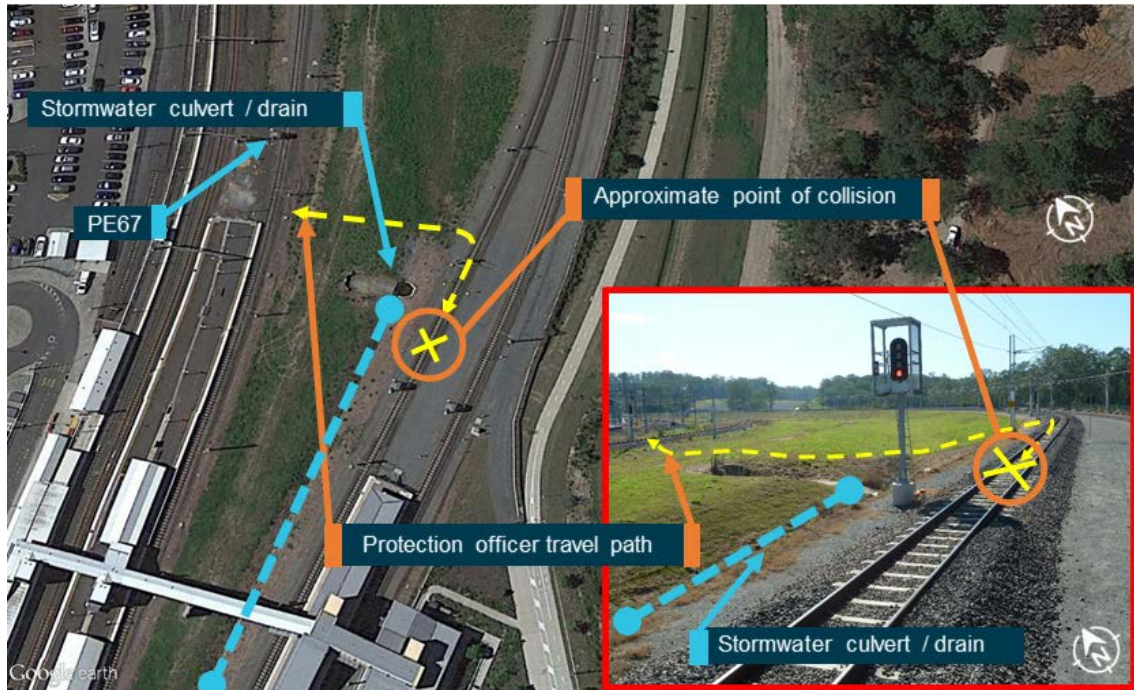
**Figure 3: Petrie stormwater culvert/drain layout**

The images show the stormwater drain/culvert (blue dashed line) and the direction of the protection officer's travel to and on return from PE67 near platform 3 (yellow dashed line). Source: Google Earth, Annotated by the ATSB.

PO1 again walked in the middle of the Up Caboolture line, the reverse path he had previously used to avoid the culvert and drain (yellow line in Figure 3). Video footage showed that PO1 was looking in his direction of travel, and was not looking behind him. At about this time, a passenger train, designation T570, approached Petrie Station on the Up Caboolture main line from the north. The distance separating train T570 and the protection officer when PO1 reached the Up Caboolture line was about 400 m.

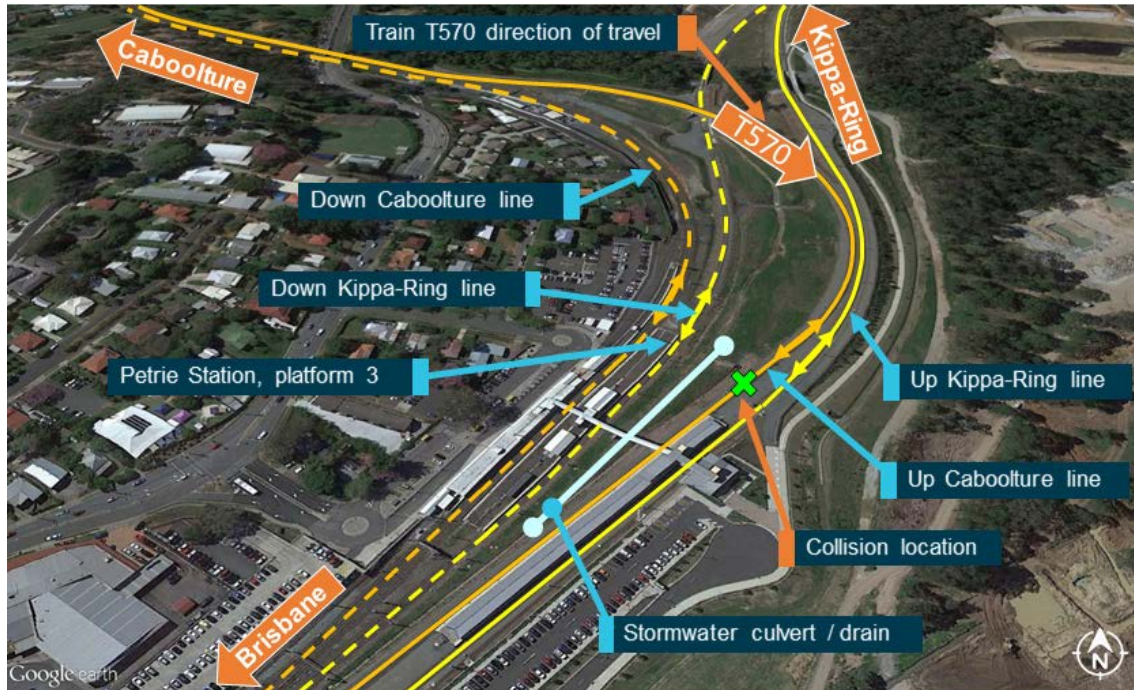
**Figure 4: Layout of the Petrie Station**

The train's headlights and ditch lights were on and functioning correctly as the train travelled a 50 km/h sweeping right hand curve (Figure 4). However, the lights only illuminated a short length of track ahead due to the curvature of the track. With his back to the train, PO1 was not aware of the approaching train and the driver of the train was unaware PO1 was positioned in the middle of the rail lines.

At about 2225, video footage showed PO1 had stopped walking in the middle of the rail lines at the same time as his mobile phone clipped to the front of his shirt illuminated. He remained in a stationary position, for about 6 seconds, with the phone illuminated and his back to the approaching train. As the train exited the sweeping curve, the headlights shone directly on PO1. Upon sighting PO1, the train driver applied the emergency brake and sounded the train horn. The protection officer attempted to vacate the track, however, there was insufficient time and the train collided with the PO1 (Figure 4). As a result of the collision, PO1 sustained fatal injuries.

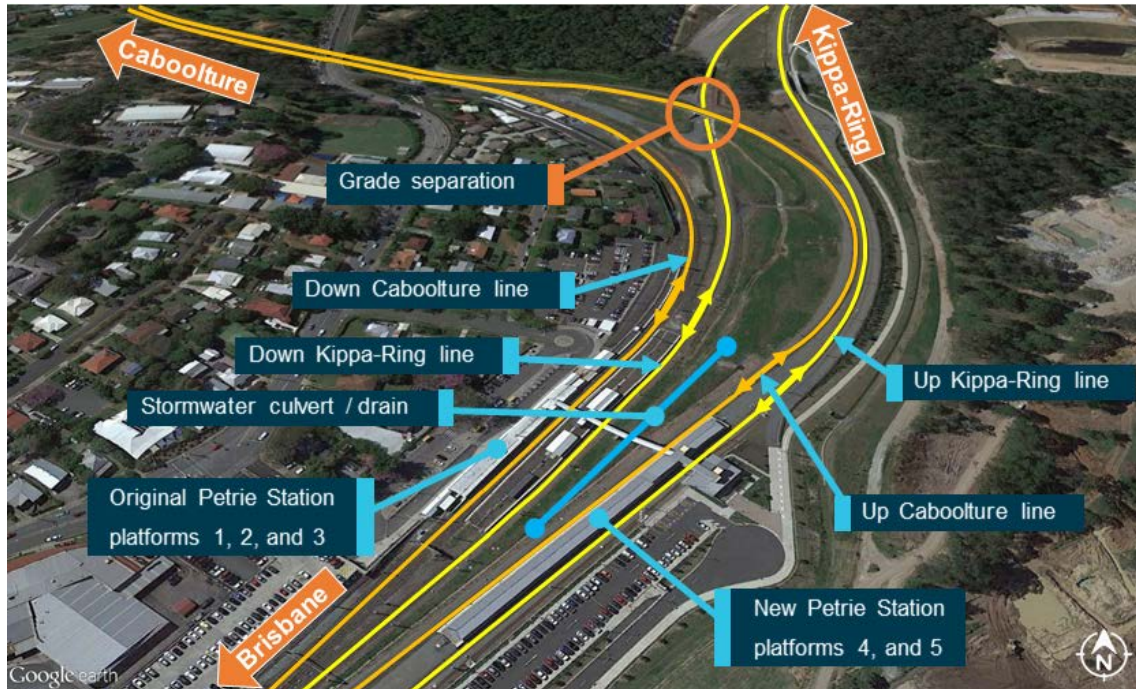
Figure 7: Petrie Station layout

Platforms 1, 2, and 3, were separated by about 40 m from Platforms 4 and 5 due to a stormwater culvert/drain (Figure 7). Platforms 4 and 5 were configured in an island platform arrangement in a separate structure, and were connected to the other Petrie platforms by an overhead pedestrian walkway (Figure 7).

The Up Caboolture line and the Down Kippa-Ring line were grade separated about 400 m north-west of the Petrie Station (Figure 7). The grade separation created a relatively uncommon configuration in the QR Network, whereby two adjacent platforms (4 and 5) both serviced tracks that carried mainly Up direction traffic.

In October 2016, Petrie Station was opened with its new layout. The new layout included a grade separation of the Up Caboolture Main and the Down Kippa-Ring lines which is an uncommon infrastructure configuration within the QR network. This grade separation creates the situation where the Up Caboolture Main and the Up Kippa-Ring lines are adjacent to each other as they feed into the island configuration platform (Figure 7 above).

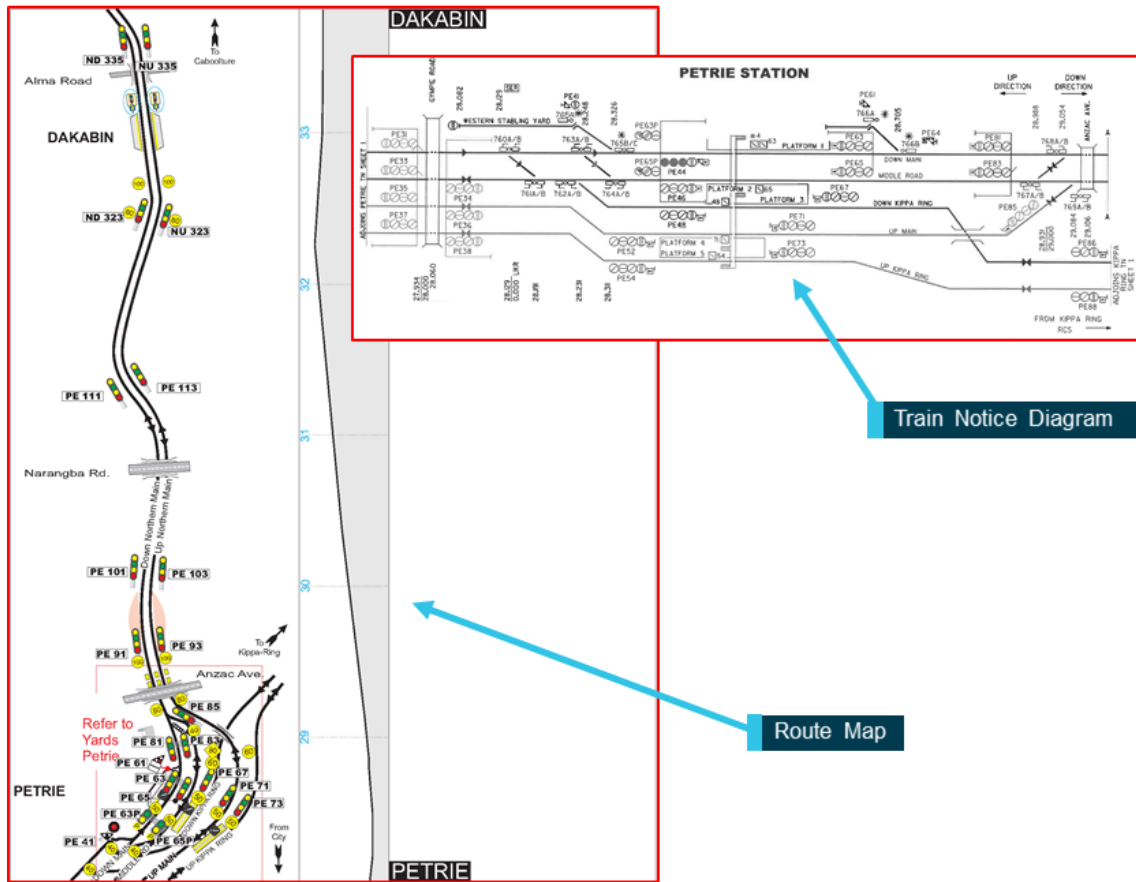
Figure 8: Queensland Rail Train Notice Diagram and Route Map sample

At the time of the accident, QR relied on protection officers becoming familiar with a new location by reviewing Train Notice Diagrams or route maps. These Train Notice Diagrams and route maps provided information about the configuration of rail infrastructure as well as some operational information (Figure 8). The diagrams and maps were limited in the topological information they contained, such as physical barriers that might create additional safety hazards to the work at the intended location.

Image shows samples of the information available from a Queensland Rail train notice diagram and route map for Petrie. Noting that there is limited information about physical site topology. Source: Queensland Rail, annotated by ATSB

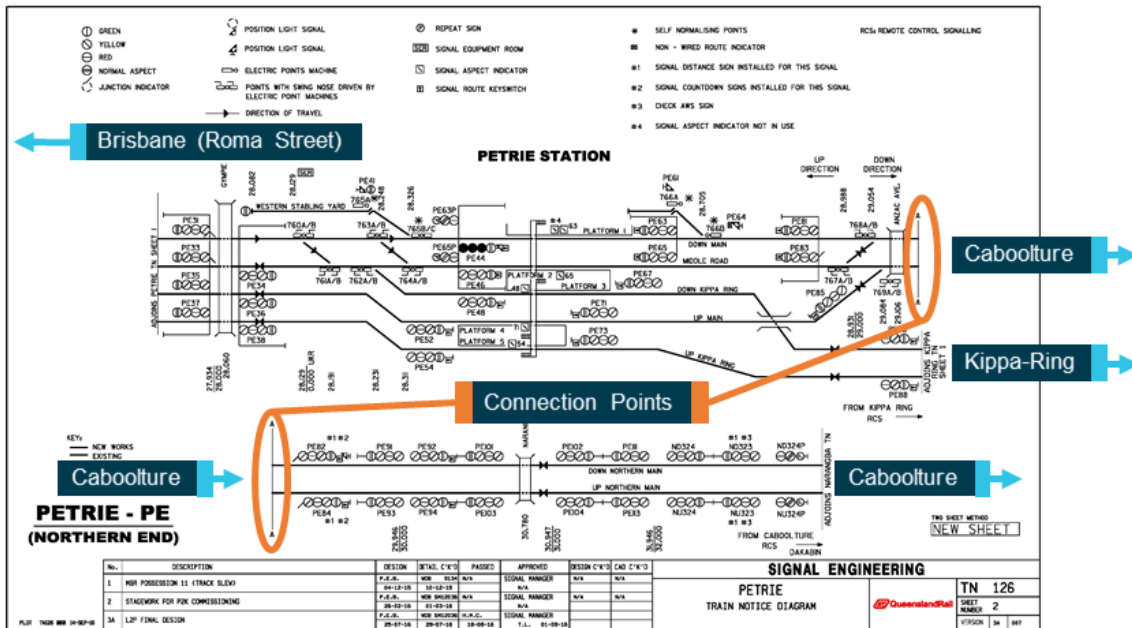
**Figure 13: Train Notice Diagram 126, for Petrie Station**

In regards to the Kippa-Ring closure, a Train Notice Diagram for the Petrie Station area was used to sketch or mark-up the closure information. The base (unmarked) Train Notice Diagram displayed the rail infrastructure layout of the Petrie Station, and about 3 km of the Up and Down Northern Lines towards Caboolture. The layout of the Train Notice Diagram was arranged with the Petrie Station layout at the top of the page, with the Caboolture line extension displayed at the bottom of the page (Figure 13).

Image showing Train Notice Diagram TN 126. Train Notice Diagram TN 126 describes the rail infrastructure layout and some operational information for Petrie Station. Noting the connection points on the map between the two portions of the Caboolture line. This Train Notice Diagram was used as the base or starting point for recording the worksite sketch information required by the safety assessment and Queensland Rail SW01 Form. Source: Queensland Rail, annotated by ATSB
