# Loss of control in flight involving Leonardo Helicopters AW139 helicopter, VH-YHF

Near Adelaide River mouth, 38 km ENE of Darwin, NT, on 13 May 2018

**ATSB Transport Safety Report**  
Aviation Occurrence Investigation  
AO-2018-039  
Final – 16 April 2020

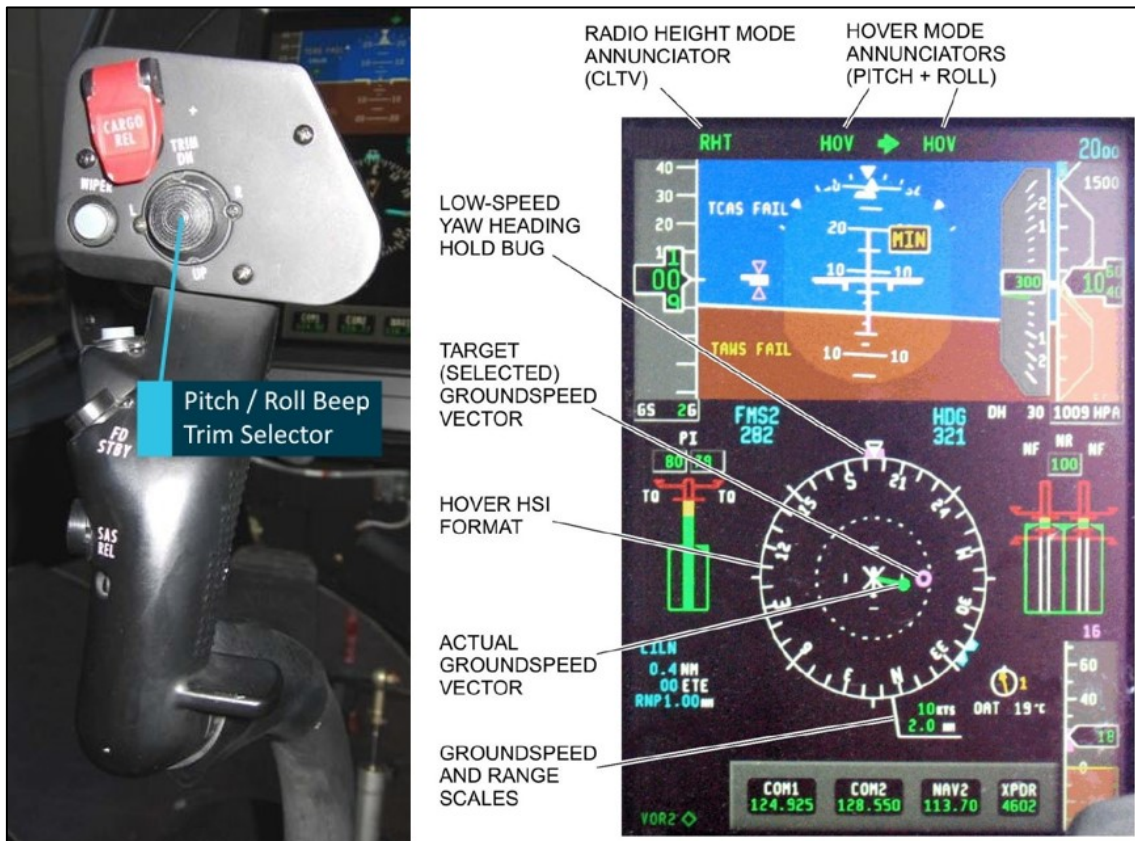
**Figure 4: Exemplar AW139 Cyclic and PFD showing HOV Mode engaged**

If engaged with a high vertical speed, the system would show as engaged and the autopilot would make adjustments necessary to attain the height designated by the pilot. This would induce a magnitude of overshoot relative to the vertical speed at time of engagement. A difference between the reference height and actual height would trigger a warning once large enough. For example, at a reference height of 500 ft, a message ‘HTLM’ appears on the PFD and ‘ALTITUDE, ALTITUDE’ sounds when the actual height passes below 430 ft.

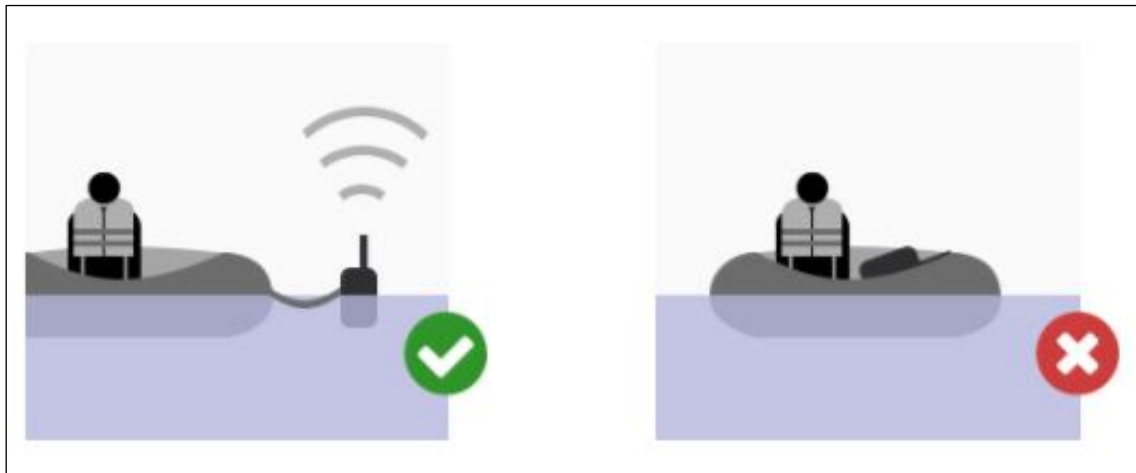
**Figure 7: Correct EPIRB placement following activation**

The lack of accurate registration details and sporadic output of the DF caused distraction to the crew and increased their time to find the target. The result for the crew was that they were required to identify a number of targets and make approaches to them for visual identification. This increased the complexity and time taken to complete the operation.
