Track worker fatally injured when struck by train W510

Clyde, New South Wales, on 18 June 2016

ATSB Transport Safety Report

RO-2016-008 – 20 April 2020

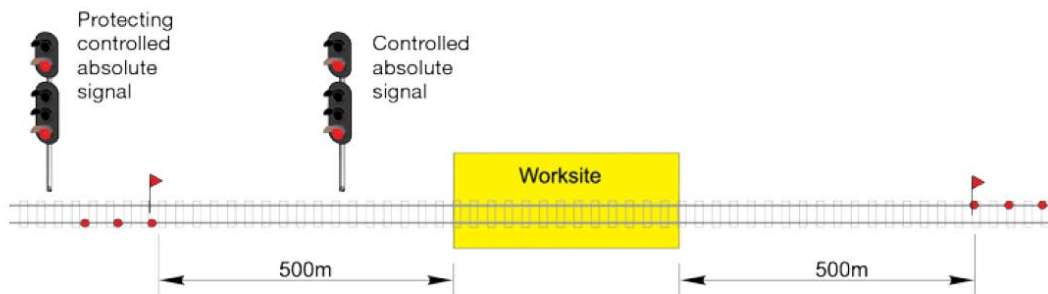
Figure 7: Worksite protection

Figure 7 illustrates the typical protection arrangements for a worksite on straight track. A signal at least 500 m from the worksite is required for the ‘Protecting Controlled Absolute Signal’. Blocking facilities applied to the protecting controlled absolute signal provides the primary method for excluding rail traffic from the worksite.

If a train driver inadvertently passes the protecting controlled absolute signal, the train would subsequently pass over the worksite protection (track signals, flags/lights) 500 m before reaching the worksite. This, in effect, provides a second layer of defence whereby the train driver receives a warning that they are approaching a worksite and must take action to prevent entry into the worksite.

When implementing the TOA on the night of 17 June 2016, the PO thought protection had to be implemented as per the scenario illustrated in Figure 7. That is, the facilities providing worksite protection were to be located on the main line, at least 500 m from the worksite.

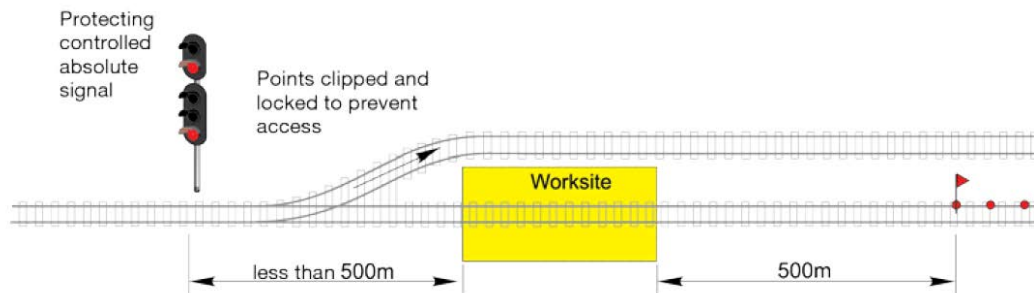
Figure 8: Worksite protection

Figure 8 illustrates the protection arrangements for a worksite where the protecting controlled absolute signal is within 500 m of the worksite, but a set of points is available to route trains on a track other than the one containing the worksite. In this scenario, the points must be set, clipped and locked for the alternative route to prevent trains accessing the TOA limits and the worksite contained within. The signaller could also apply blocking to the point controls as part of the protection arrangements.

However, after several discussions with train controllers, signallers and ICON, the PO was made aware the application of protections could be done as illustrated by the scenario in Figure 8. That is, since the IBA on 63B points meant they were set, clipped and locked for the main line, rail traffic was excluded from the track containing the worksite. The scenario also negated the requirement to place worksite protections (track signals, flags/lights) 500 m from the worksite. The solution proposed by Sydney Trains' operations staff provided the operational advantage of not occupying the main line, leaving it active for the passage of rail traffic.

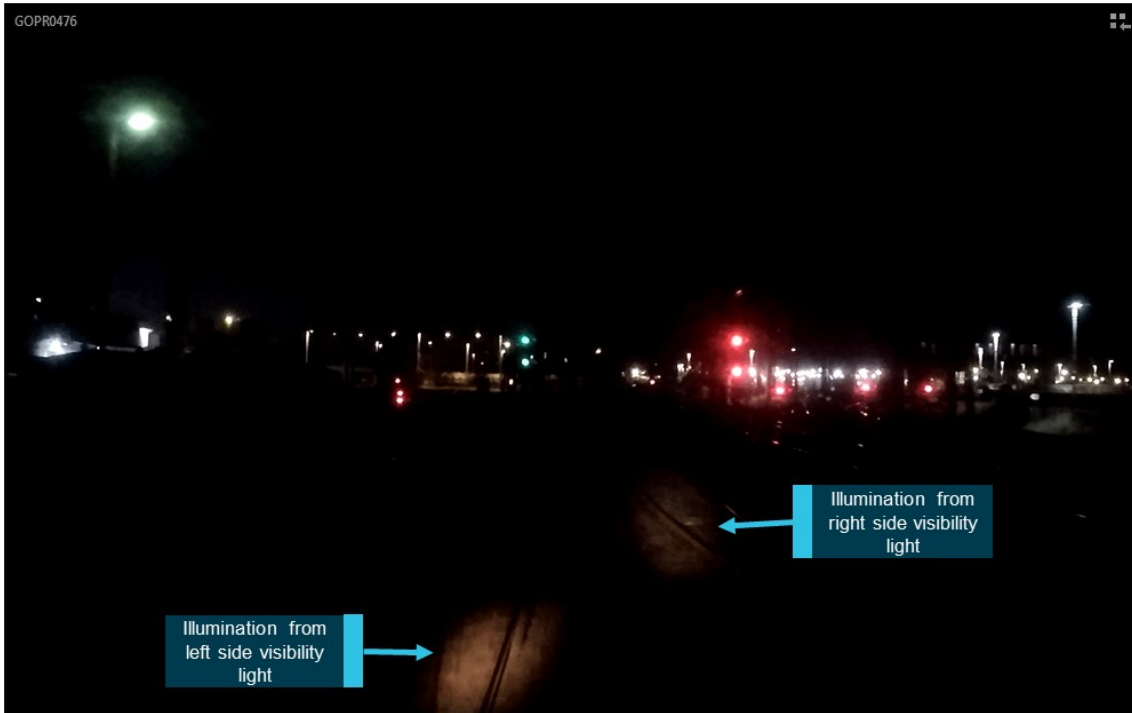
Figure 12: Similar train type showing visibility (ditch) lights illuminating track ahead

Figure 12, taken from a similar Sydney Trains K-Set type car showing the typical illumination pattern and forward illumination of the track provided by the visibility lights.

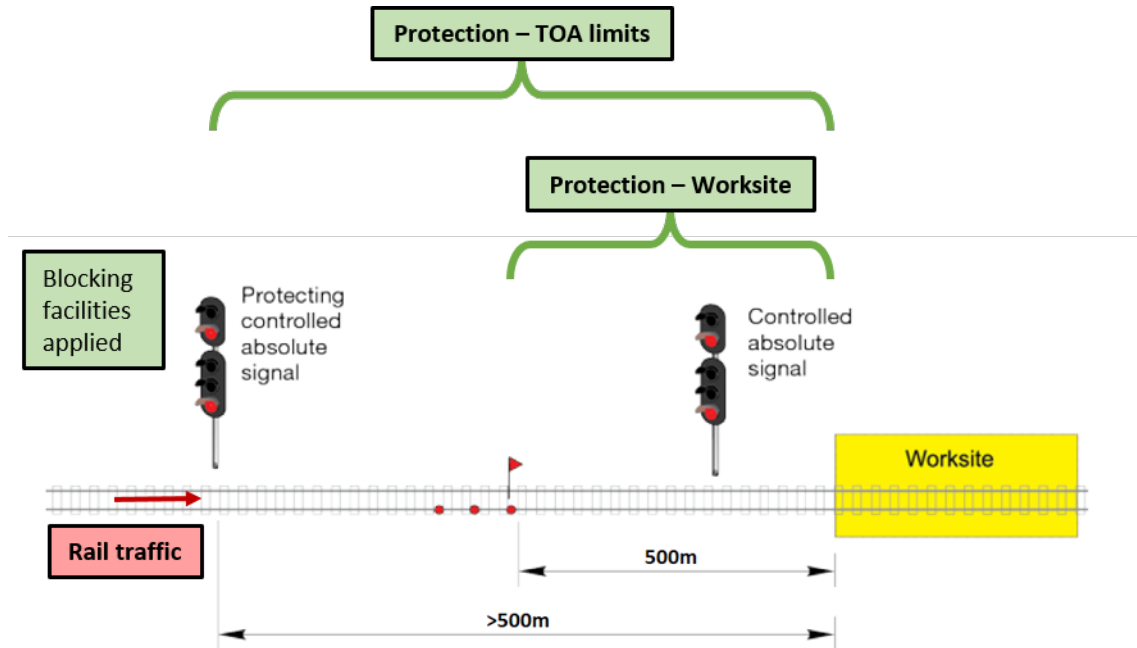
Figure 15: Worksite protection

provided a buffer zone of at least 500 m outside a worksite, plus a further train exclusion zone in excess of 500 m from the worksite. That is, trains must stop at the protecting controlled absolute signal. If a train inadvertently passes the protecting signal, then the train will trigger the audible track signal warning devices at least 500 m before reaching the worksite (Figure 15). This delivered an additional level of control to track workers by providing advice of an approaching train.

The TOA rule (NWT 304) and procedure (NPR 701) also provide for a scenario where the protecting controlled absolute signal may be less than 500 m from the worksite, so long as points can be clipped and locked for a different route. It was this scenario that was considered for the night of 17 June 2016.
