**Australian Transport Safety Bureau**

# Drum stock fuel contamination

Cloncurry Airport, Queensland on 7 September 2016

**ATSB Transport Safety Report**  
Aviation Occurrence Investigation  
AO-2016-144  
Final – 22 April 2020

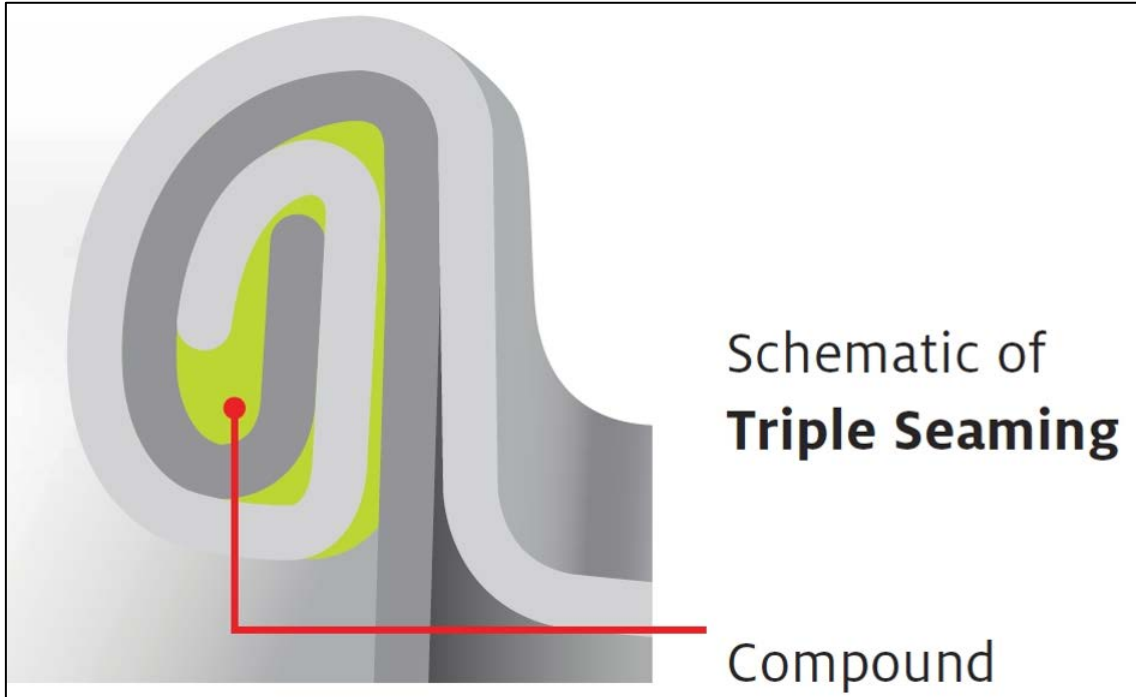
**Figure 6: Cross section of a drum's triple seam**

The assembly process involved rolling the lid/base and the barrel of the drum together to create a sealed vessel with a cylindrical lip on the top and bottom to add rigidity (Figure 6).
