Derailment of freight train 7MB9

Goulburn, New South Wales, on 31 March 2019

ATSB Transport Safety Report

RO-2019-010

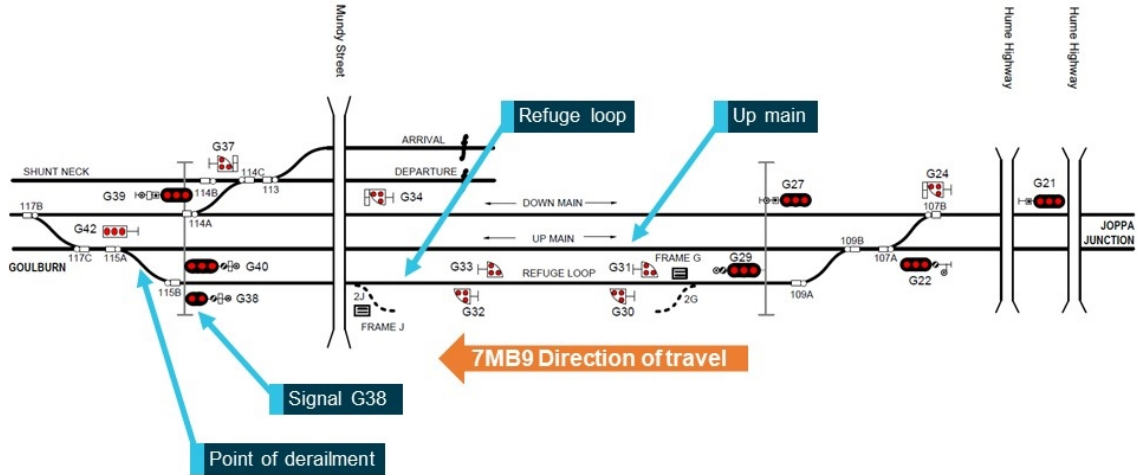
Figure 2: Goulburn track diagram

Train 7MB9 was travelling at 17 km/h as it traversed over points 115B and 115A when, at 0416, the driver noticed a loss of brake pipe (BP) pressure and brought the train to a stand. The NC received a track circuit fault indicator and contacted the driver of 7MB9. The driver advised the NC that 7MB9 may have parted and that he would check the status of the train. Shortly afterwards, the driver confirmed 7MB9 had derailed while passing through the turnout and the NC implemented safeworking protection (Figure 2).

A total of five wagons derailed due to a broken Up rail at 225.413 km³ with the wagons coming to a rest across the Up and Down main lines (Figure 3 to Figure 5).

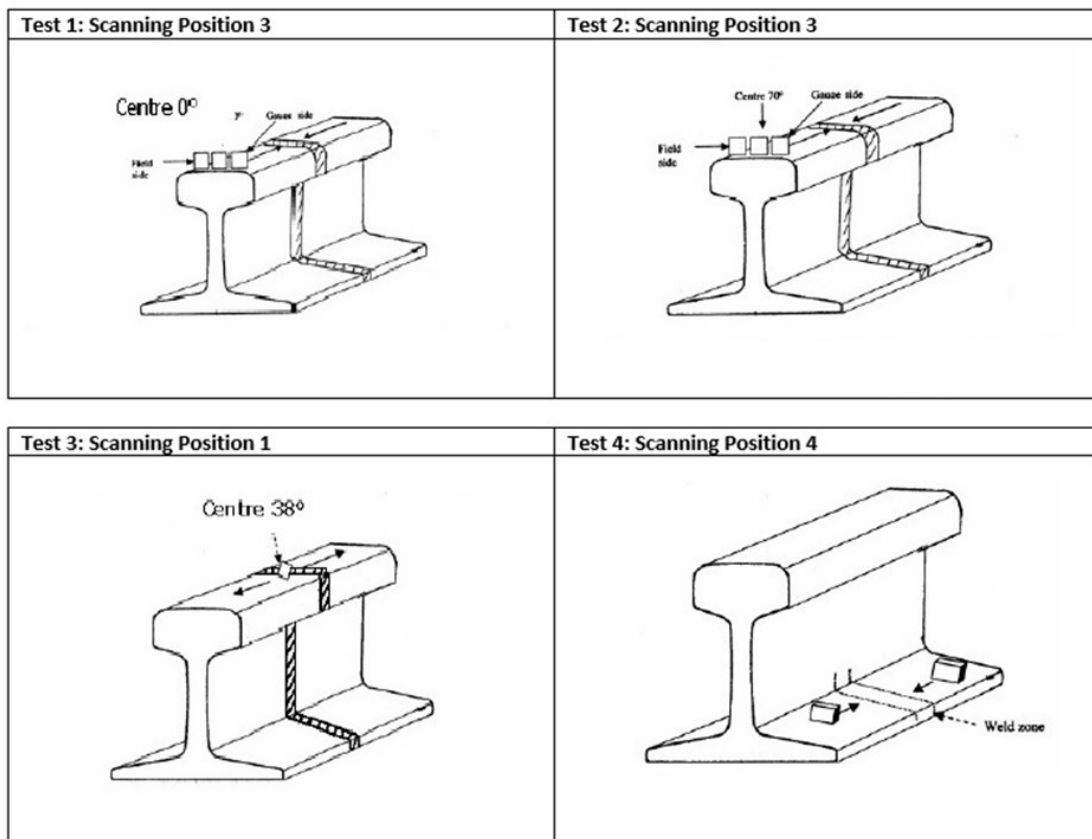
Figure 6: Typical manual ultrasonic weld-testing positions

Manual ultrasonic weld testing is completed using hand-held equipment with a number of testing probes to allow for the rail head, web and foot of the rail to be inspected (Figure 6). Hand-held ultrasonic testing is only carried out directly after welding or in response to defects detected through other methods such as continuous ultrasonic testing.¹⁰ The foot of the rail is not typically ultrasonically tested after the weld has been certified.

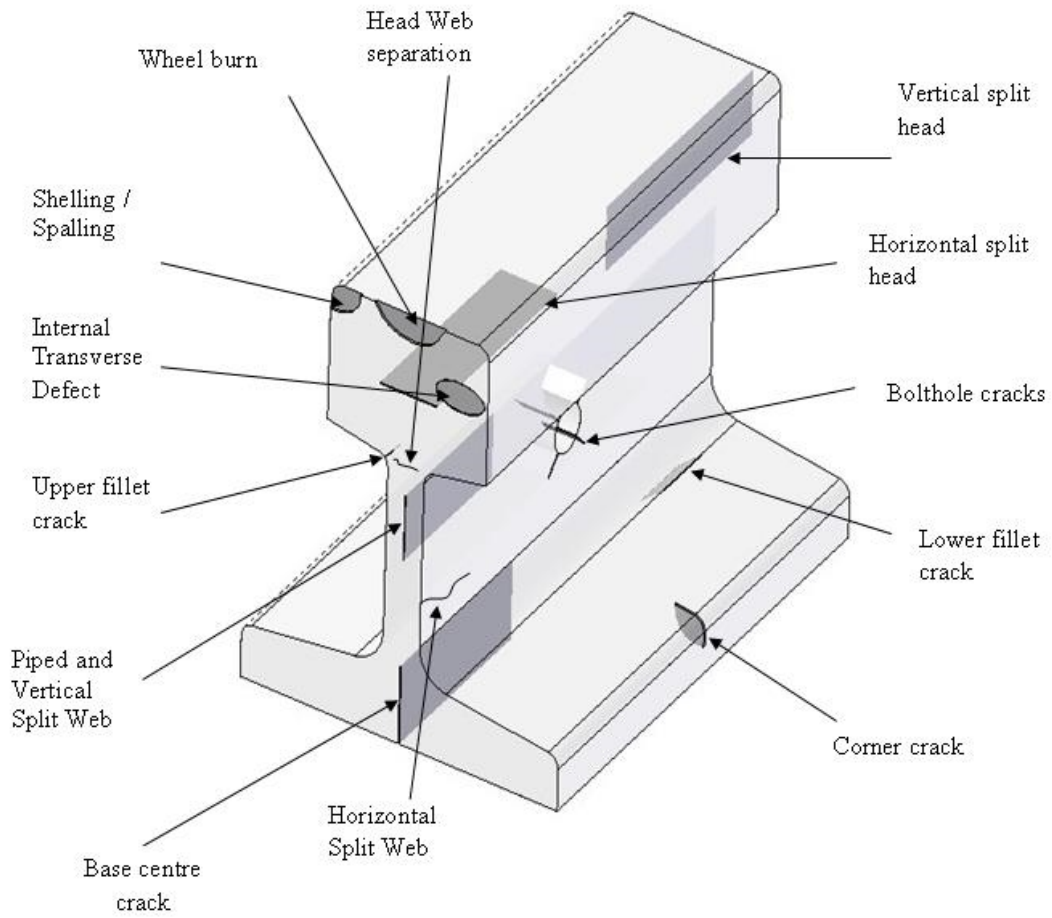
Figure 7: Rail defect types

Ultrasonic testing provides a level of assurance but does not and cannot detect all defects. The ability of this method to detect rail defects (Figure 7) will vary depending on the method of ultrasonic testing utilised, but also on the calibration of the equipment. Calibration of testing equipment is performed on a rolled steel test piece to represent a section of rail, however, may not be representative of a rail weld to the same degree. Continuous ultrasonic rail testing is capable of detecting defects in the rail head and through the web of the rail to the foot. Defects in the rail foot either side of the web are outside the detectable area unless hand-held testing equipment is used (Figure 8).

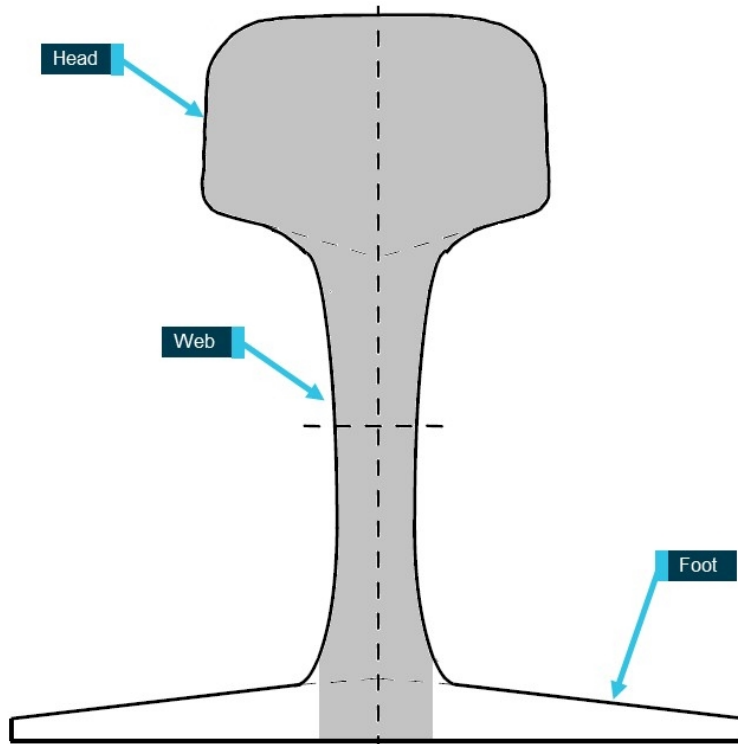
Figure 8: Continuous ultrasonic rail flaw detectable area

Regions detectable through continuous ultrasonic rail flaw inspection is shown in grey.
Source: Transport for NSW, modified and annotated by OTSI
