Derailment of grain train 8838N

Narwonah, New South Wales, on 1 October 2017

ATSB Transport Safety Report

RO-2017-014

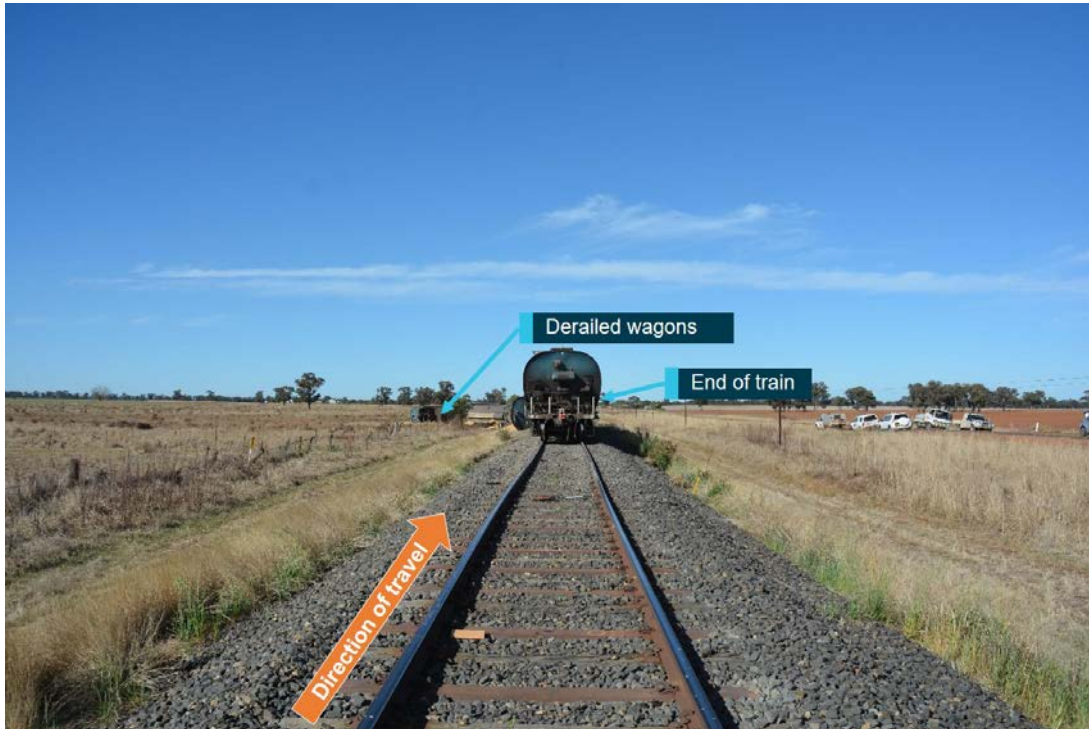
Figure 3: View to derailment site

Narwonah is a rural location in north-western New South Wales, approximately 537 km by rail from Sydney. The incident occurred in a rural area bounded by farm paddocks on each side of the rail corridor (Figure 3).

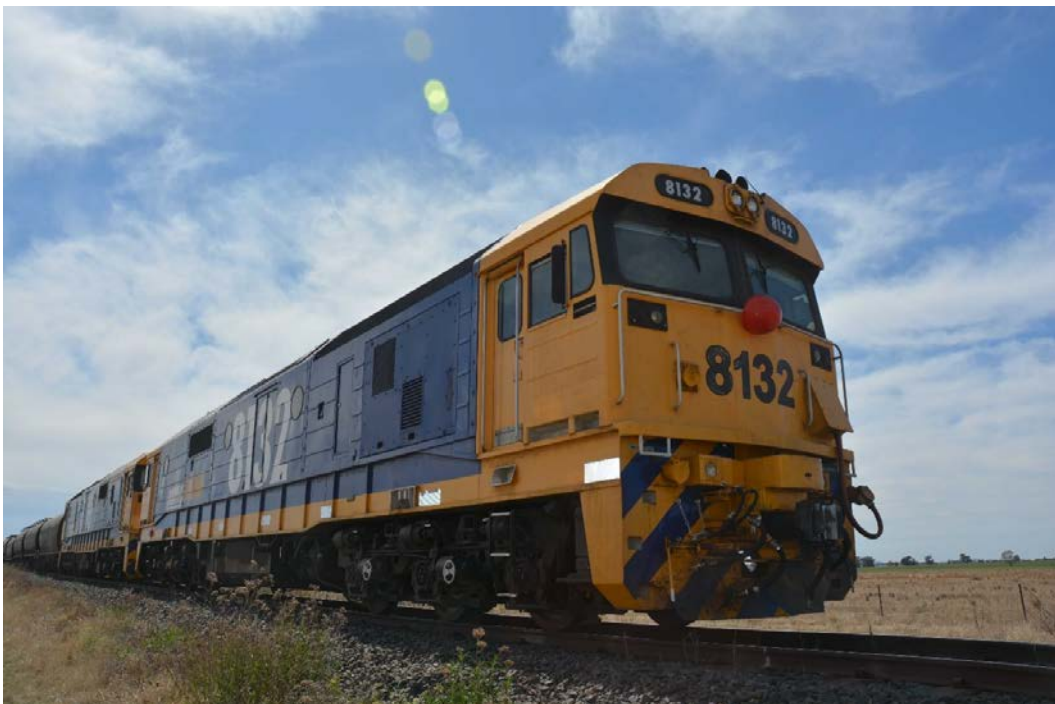
Figure 7: 81-class locomotive at front of train 8838N

The train involved in the incident was Pacific National freight service 8838N. The train consisted of 2 locomotives and 23 wagons, with a total mass of 1852 t. The total length of the train was 371 m. The two 81-class locomotives were positioned at the front of the train (locomotive 8132 and 8110) (Figure 7). Each locomotive had a total mass of approximately 129 t. Of the 23 grain hopper wagons, seven were NGKF-type with 16 wagons NGPF wagons (Figure 8).
