Derailment of train 7MP7

Coonana, Western Australia on 19 August 2018

ATSB Transport Safety Report

RO-2018-012

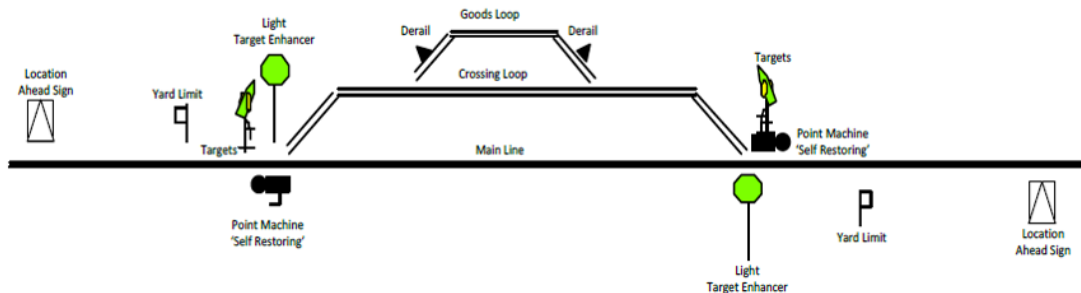
Figure 5: Typical Train Order Location with Light Indicators and self-restoring points.

Each location was similar in track configuration, equipped with trackside signage, targets and light indicators adjacent to the track. The features provided additional information to train crew approaching the self-restoring point machines¹⁰ located at either end (Figure 5).

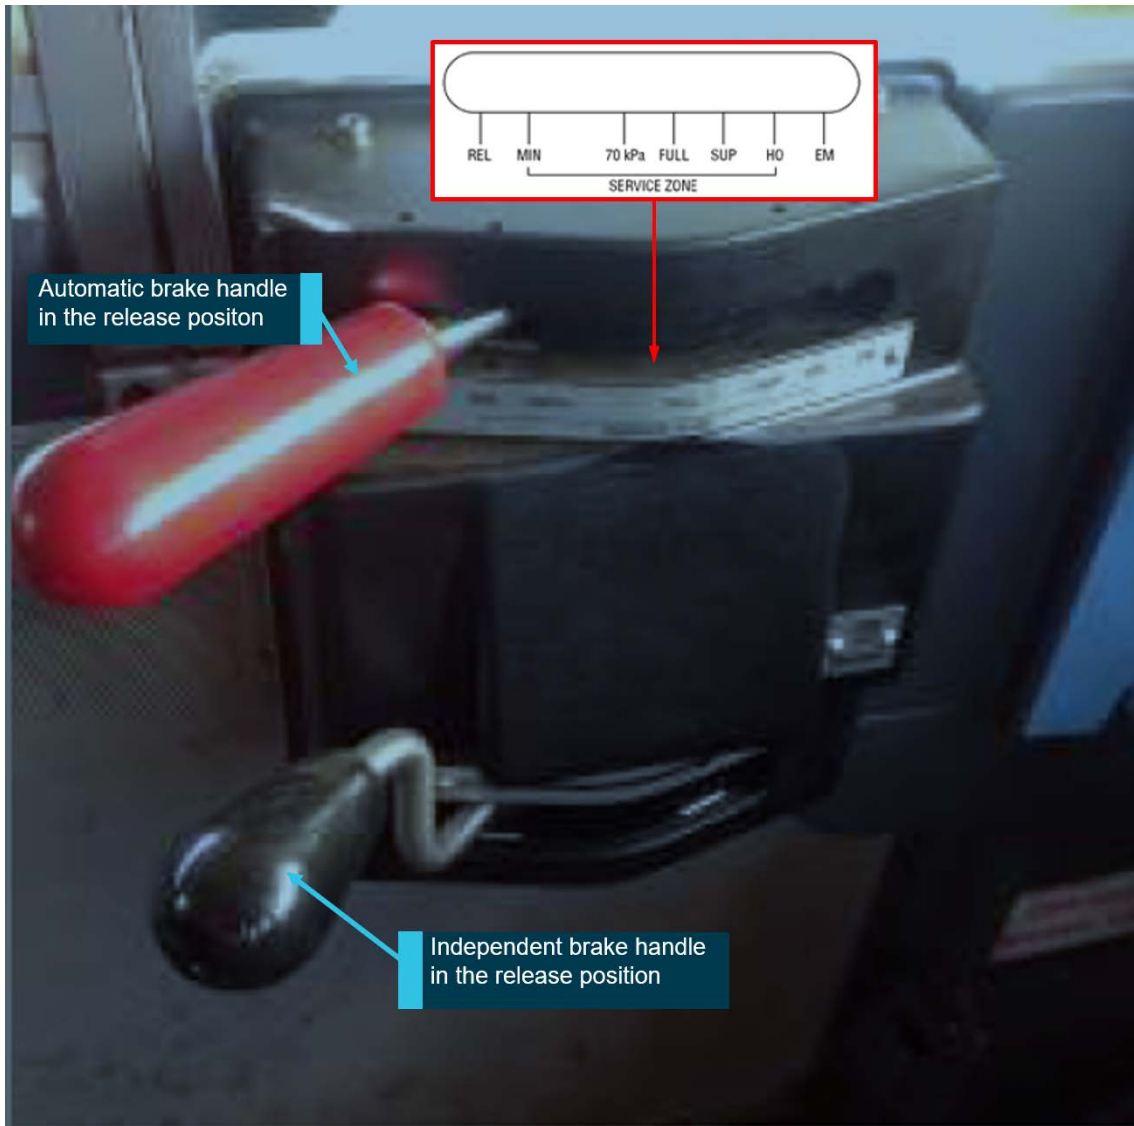
Figure 8: Handle control unit located in the locomotive cab to the left of the drivers position.

Locomotive NR 54 was equipped with the Wabtec Fast Brake electronic air brake system. The Wabtec system consisted of two major components, the Handle Controller Unit (HCU) and the Pneumatic Operating Unit. The HCU provided the driver with the ability to control separately the application of train or locomotive braking through the operation of the automatic or independent brake handles respectively (Figure 8). The locomotive event logger recorded the brake pipe and brake cylinder pressures resulting from the manipulation of the HCU handles.
