Aircraft loading-related occurrence involving Airbus A330-303, VH-QPD

Sydney Airport, New South Wales, on 17 December 2017

ATSB Transport Safety Report

AO-2018-003

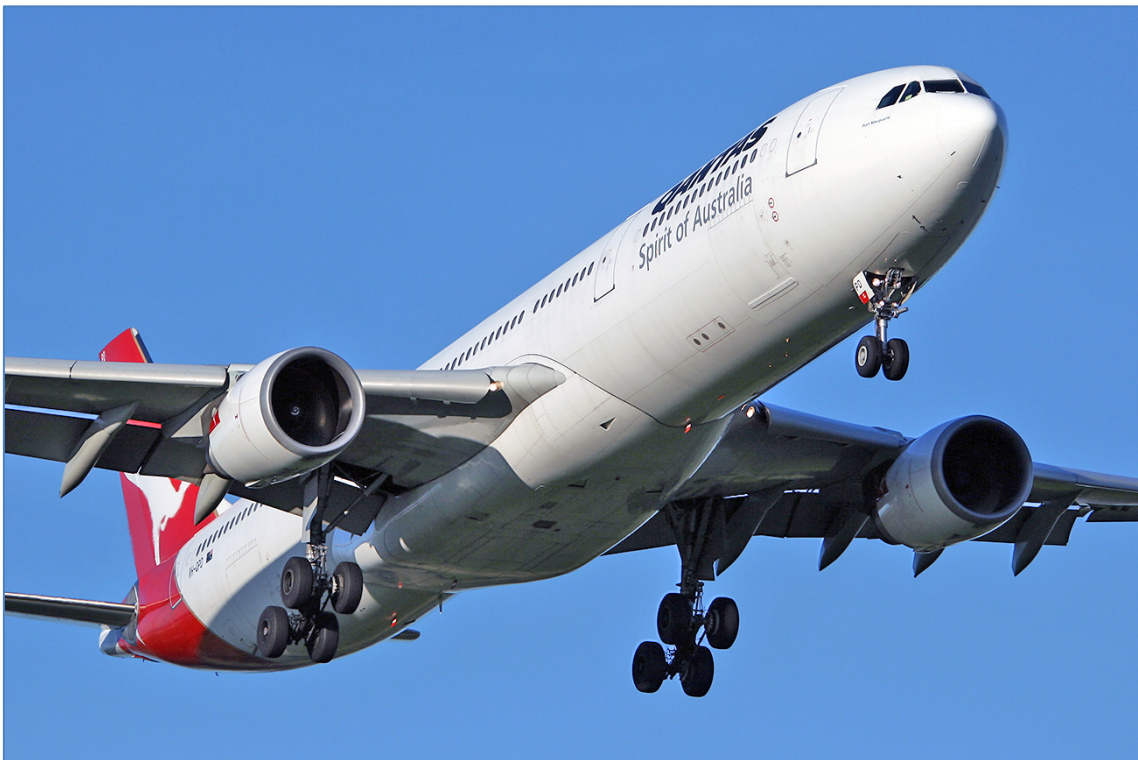
On 17 December 2017, an Airbus A330-303 aircraft, registered VH-QPD and operated by Qantas Airways, was being prepared for passenger flight QF107 from Sydney, New South Wales, to Beijing, China (Figure 1). The loading of baggage and freight into the lower hold of the aircraft was conducted as part of pre-departure operations. The aircraft departed from the international terminal at Sydney Airport at 1346 Eastern Daylight-saving Time.¹ After landing in Beijing, the operator's freight agents identified that the aircraft had been loaded incorrectly. An incorrect freight pallet resulted in the aircraft exceeding its maximum take-off weight on departure from Sydney.

Figure 1: A330 aircraft VH-QPD

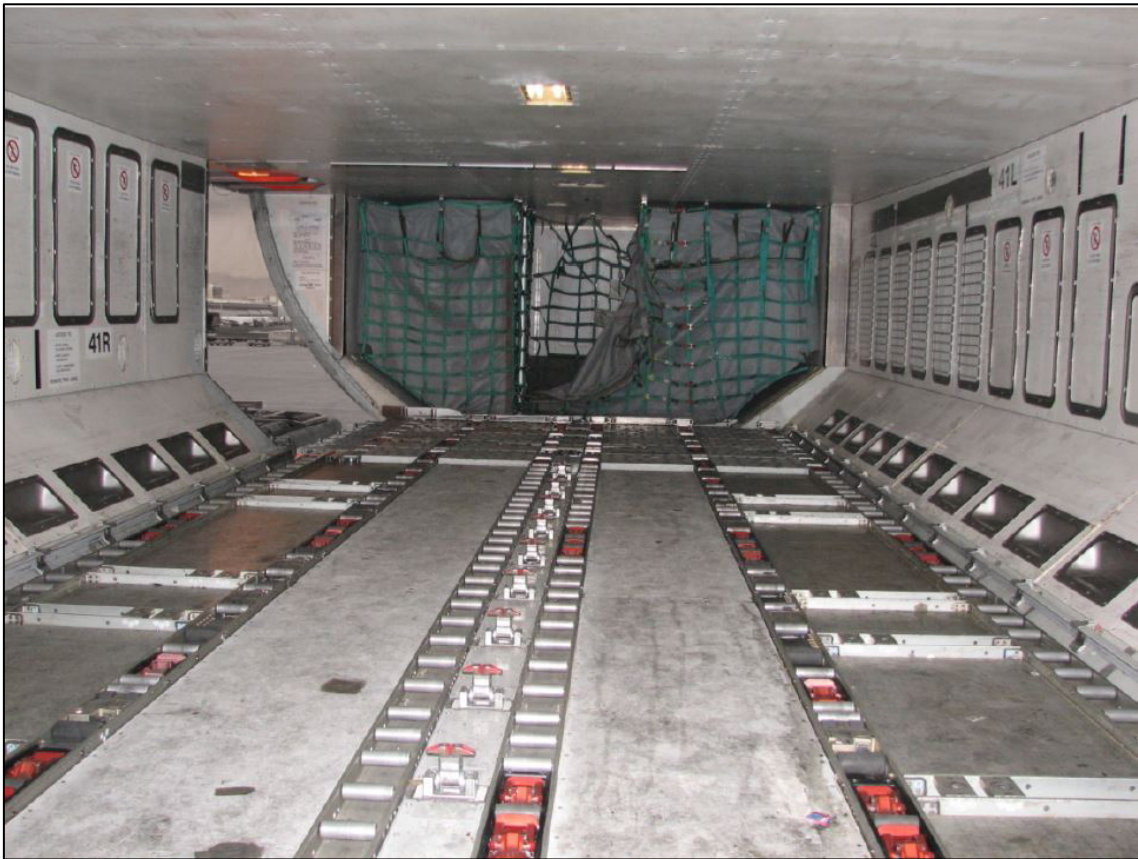
Figure 3: Typical A330-300 cargo hold

For reference only – internal detail of the A330-300 rear cargo hold.
Image source: ATSB

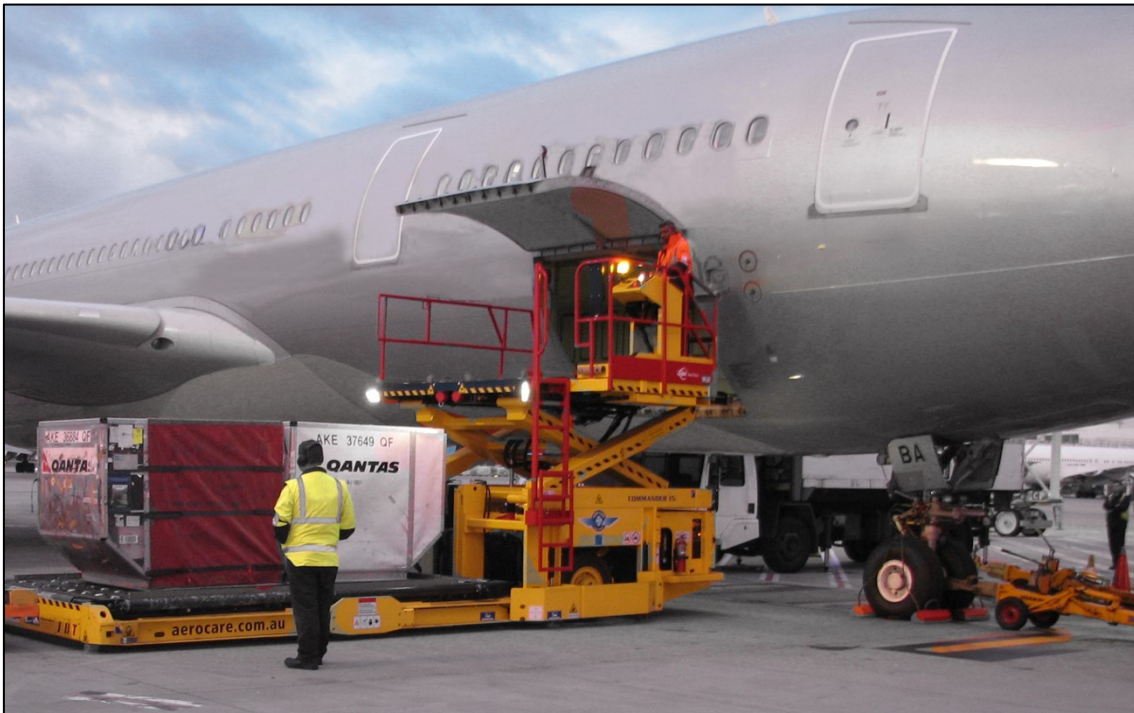
Figure 4: Sample unit load devices being loaded into an A330 forward hold

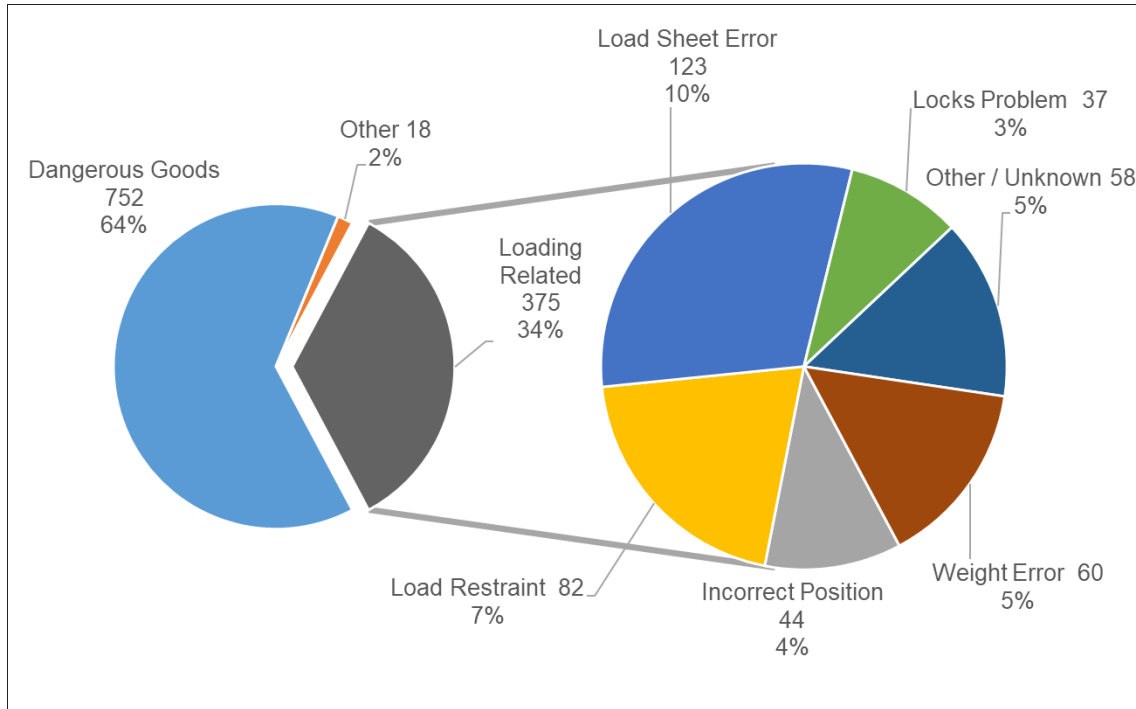
Figure 6: Aircraft Loading occurrence types over the period 2010 to 2019 (left chart), and (right chart), a subset of the Loading Related occurrence types with a descriptor breakdown

Further derivation of the *Loading Related* data revealed 123 occurrences attributable to 'Load Sheet Errors' that included unaccounted freight, receipt of a new load sheet after take-off, incorrectly recorded weights of baggage and freight items, and calculation of the weight of children as adult passengers.
