Flight below minimum altitude involving Boeing 787, registered 9V-OJC

Near Perth Airport, Western Australia on 4 December 2015

ATSB Transport Safety Report
Aviation Occurrence Investigation
AO-2015-144
Final – 26 June 2020

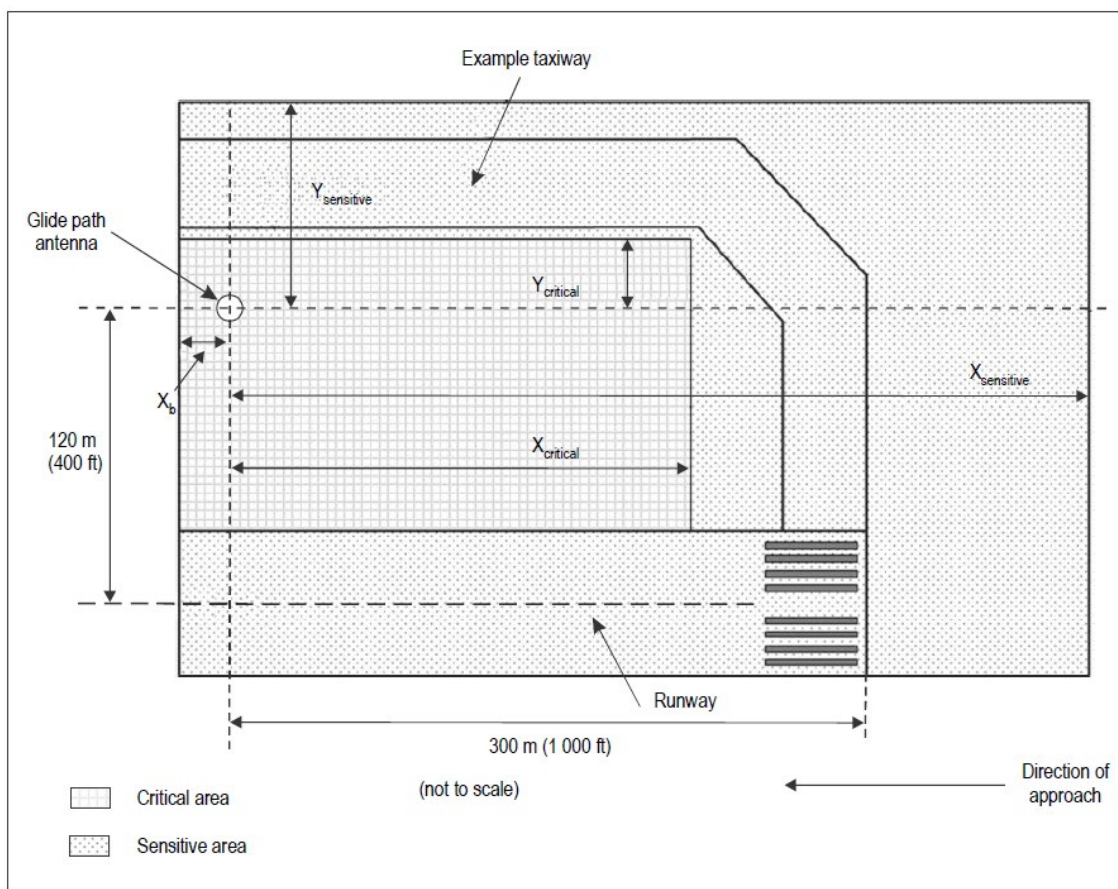
Figure 2: Example of glide path critical and sensitive area dimensions

Disturbances to ILS localiser and glideslope courses may be caused by fixed structures, such as buildings (static distortion), or moving vehicles or aircraft (dynamic distortion). The total ILS course distortion is determined by the summation of static and dynamic distortion, and this is used to define critical areas near each localiser and glideslope antenna.⁷ The critical area is surrounded by a sensitive area. These areas will differ for each approach. Figure 2 shows an example of the critical and sensitive areas around an ILS antenna.
