Engine nacelle strike and continued operation involving Boeing 737-8FE, VH-YIW

Faleolo Airport, Apia, Samoa on 23 April 2016

ATSB Transport Safety Report
Aviation Occurrence Investigation
AO-2016-042
Final – 30 June 2020

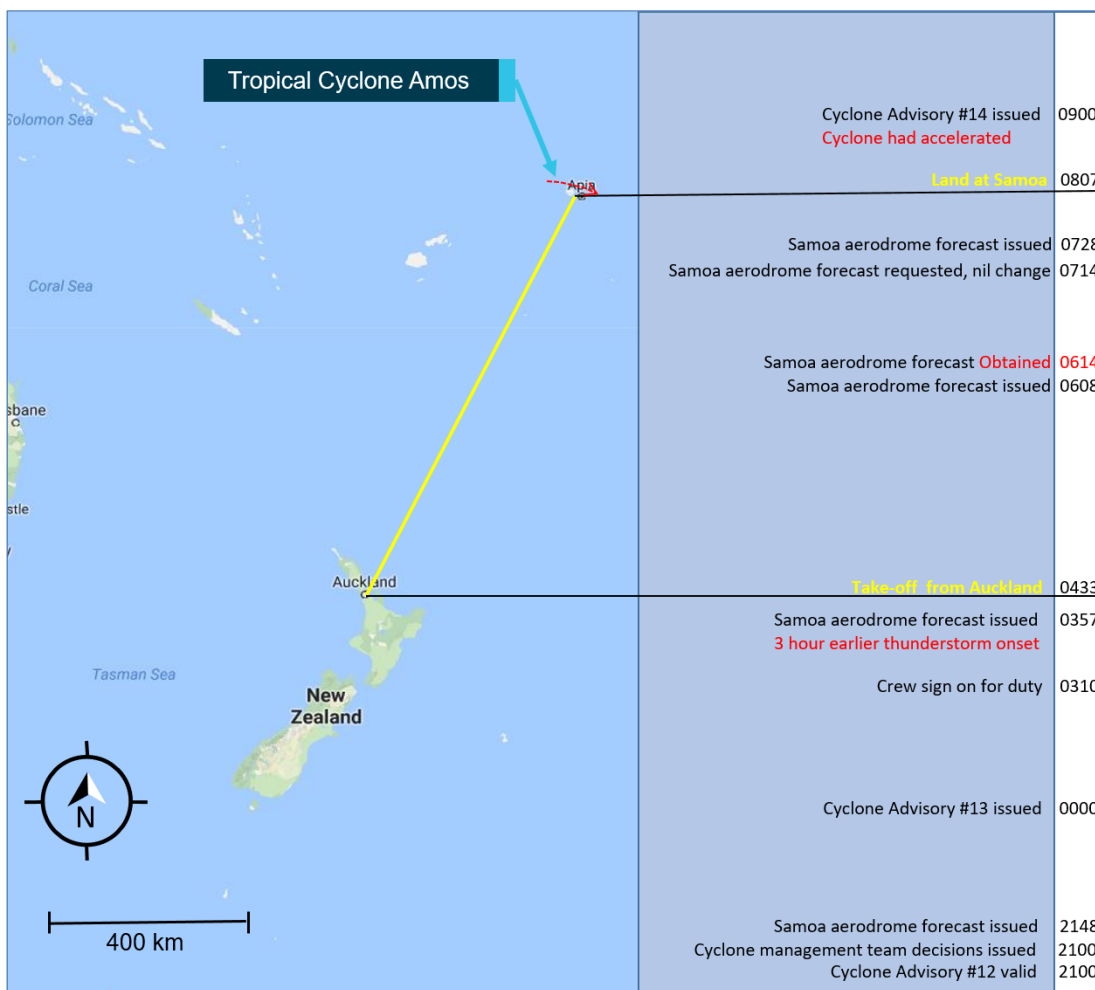
A summary of the available and obtained weather information is shown in Figure 3.

Figure 3: Image of the flight and the weather information available at different times

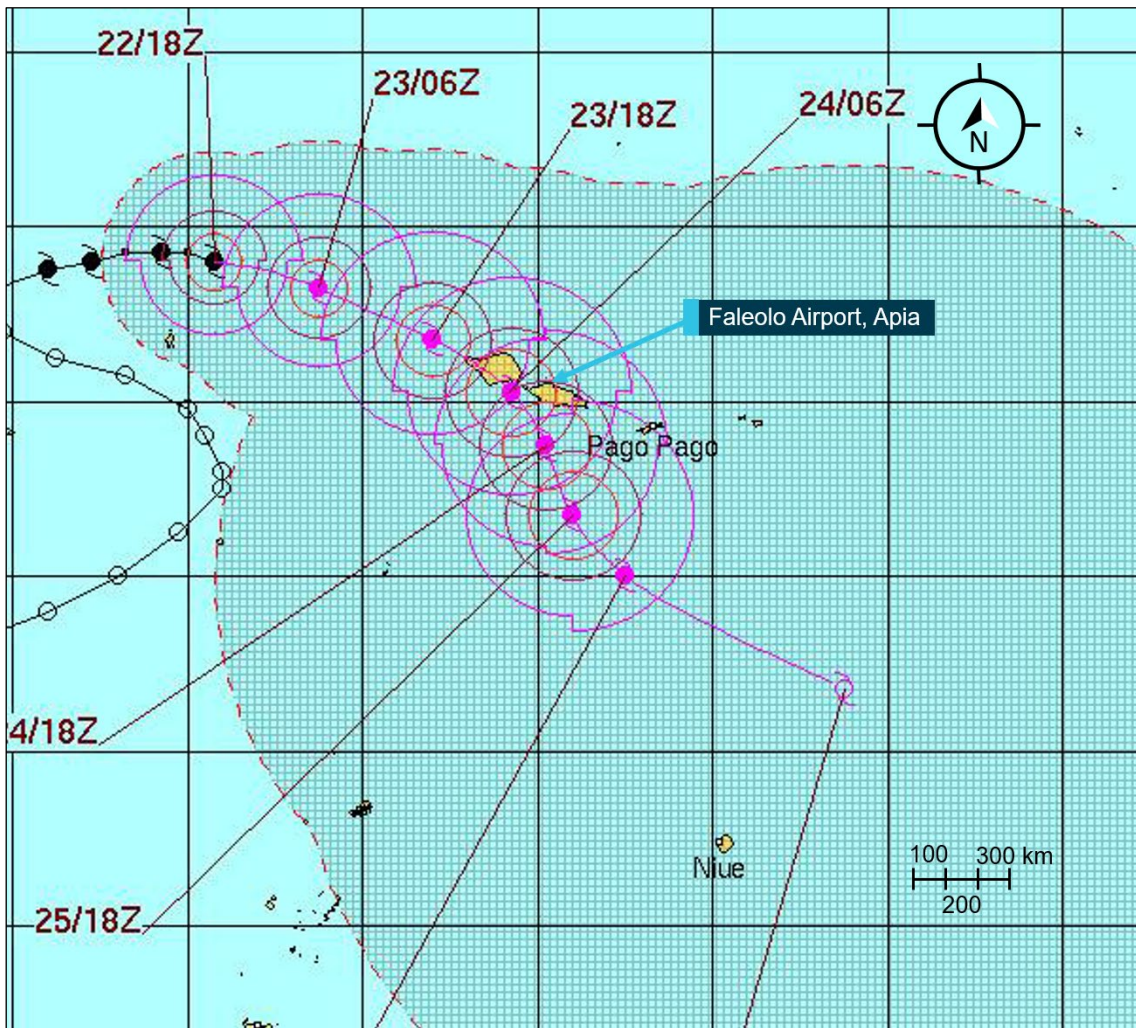
Advisory No. 12 was issued nine hours later, at 2100 on 22 April (Figure 4). It detailed that the tropical cyclone may turn right and pass to the south of Samoa and that TC Amos was due to pass the island at 0600 on 24 April, about one day after the proposed flights. However, the forecast expressed uncertainty on the direction of this turn. The advisory stated the next advice would be in 6 hours’ time, at 0300 on 23 April.

Prior to departure, the flight crew were provided with a briefing package including information from Advisory No. 12. The package included information on the weather system associated with TC Amos, which was forecast to start influencing Samoa and the surrounding region during the time of the flight. The package indicated that for the estimated time of arrival for VH-YIW, the centre of TC Amos would be approximately 260 km west of Faleolo airport with forecast crosswinds at the airport expected to be about 20 kt (within the aircraft’s operational limit).

Figure 4 : JTWC Cyclone Advisory No. 12, issued 2100 on 22 April – the forecast provided to the flight crew. The four-digit number gives the date and hours in UTC (Z) when the cyclone was forecast to be in that location. The concentric circles are isotachs - lines of constant wind speed surrounding the cyclone

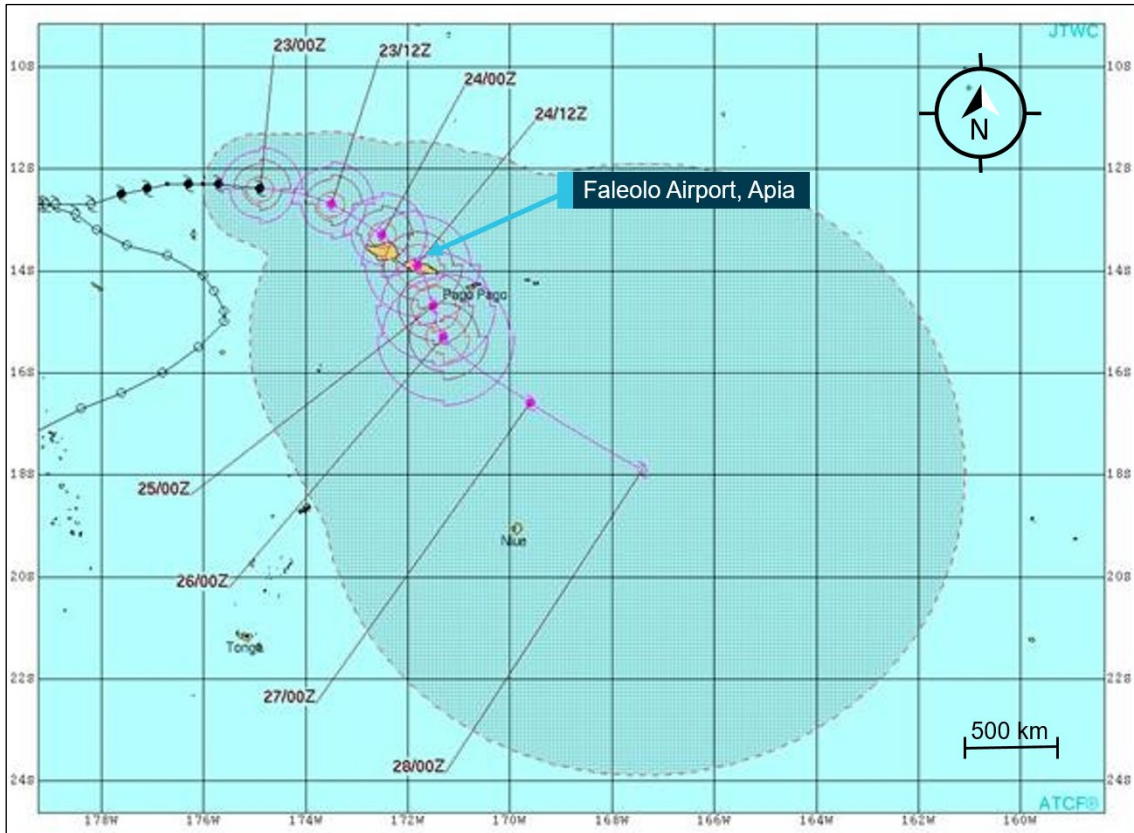
The flight crew did not receive Advisory No. 13, issued at 0000. This forecast expected the cyclone would pass 80 km closer to Apia at about the same time as forecast in the previous advisory, with a 10 kt reduction in peak intensity, still providing adequate time for the return flight to be completed (Figure 5). Advisory No. 13 was assessed by the CMT as not altering any operational requirements and consequently was not passed to the flight crew.

Figure 5: JTWC Cyclone Advisory No: 13, issued 0000 23 April – the last forecast issued before the incident

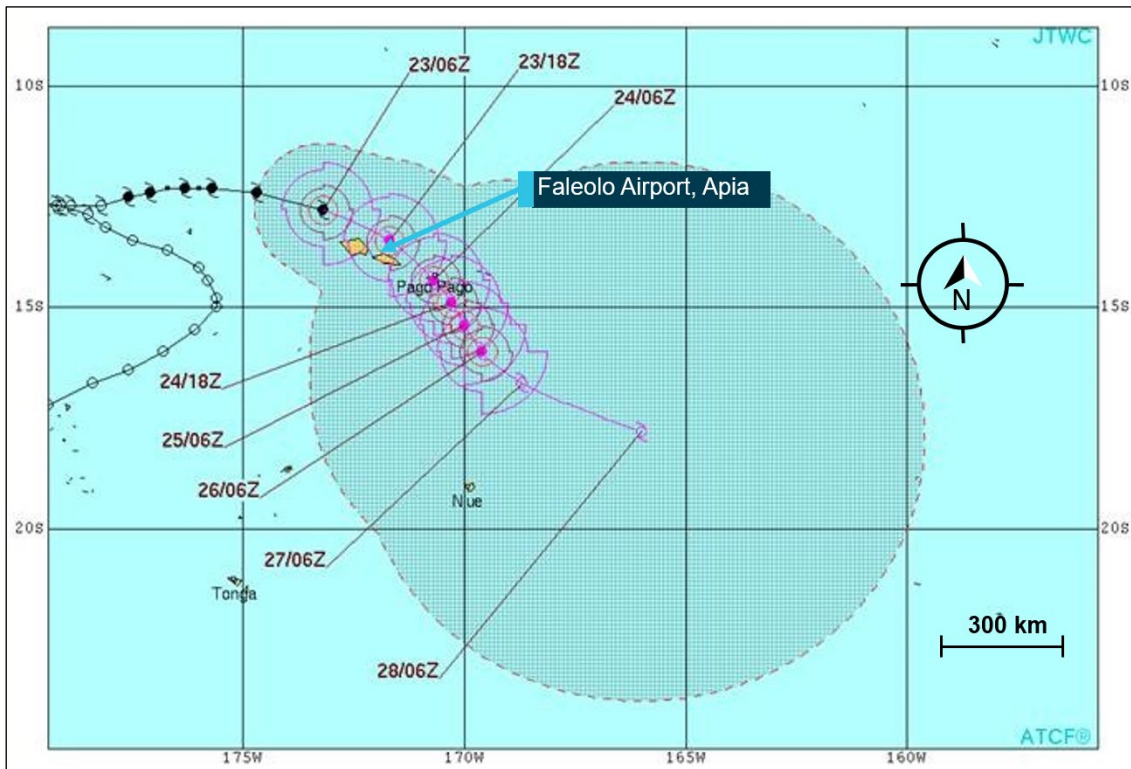
Advisory 14 also detailed that TC Amos was expected to pass about 25 km north of Apia 14 hours earlier than first predicted (Figure 6). The forecast also indicated the airport would be exposed to sustained winds over 64 kt on the following morning (24 April) as the cyclone passed close by.

Figure 6: JTWC Cyclone Advisory No: 14, issued 0900 on 23 April – issued after landing
