# Serious injuries on board *Berge Daisetsu*

Portland, Victoria 11 January 2018

**ATSB Transport Safety Report**  
Marine Occurrence Investigation  
338-MO-2018-001  
Final – 30 October 2019

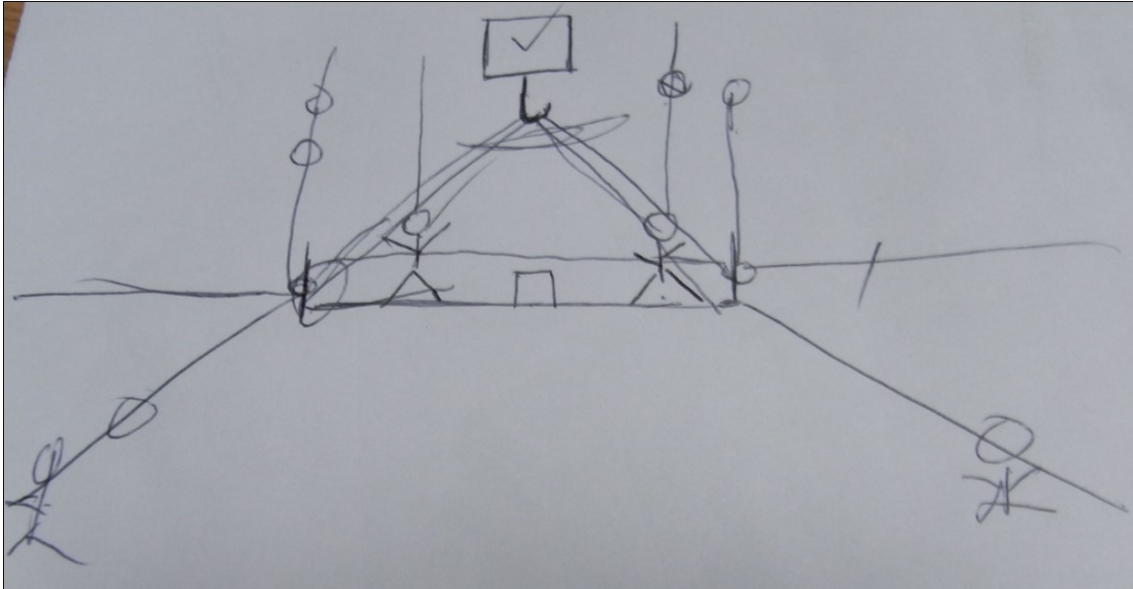
**Figure 3: Hand-drawn sketch of the work plan**

The two-day sea passage from Newcastle to Portland was spent painting the lower sections of cargo holds 1 and 4 and discussing and refining the plans for painting the upper sections. The chief mate and bosun discussed the rigging and a hand sketch of how the stage would be supported was made (Figure 3).
