Dewirement involving freight train YC77

Cooroy, Queensland, on 18 August 2018

ATSB Transport Safety Report

RO-2018-011

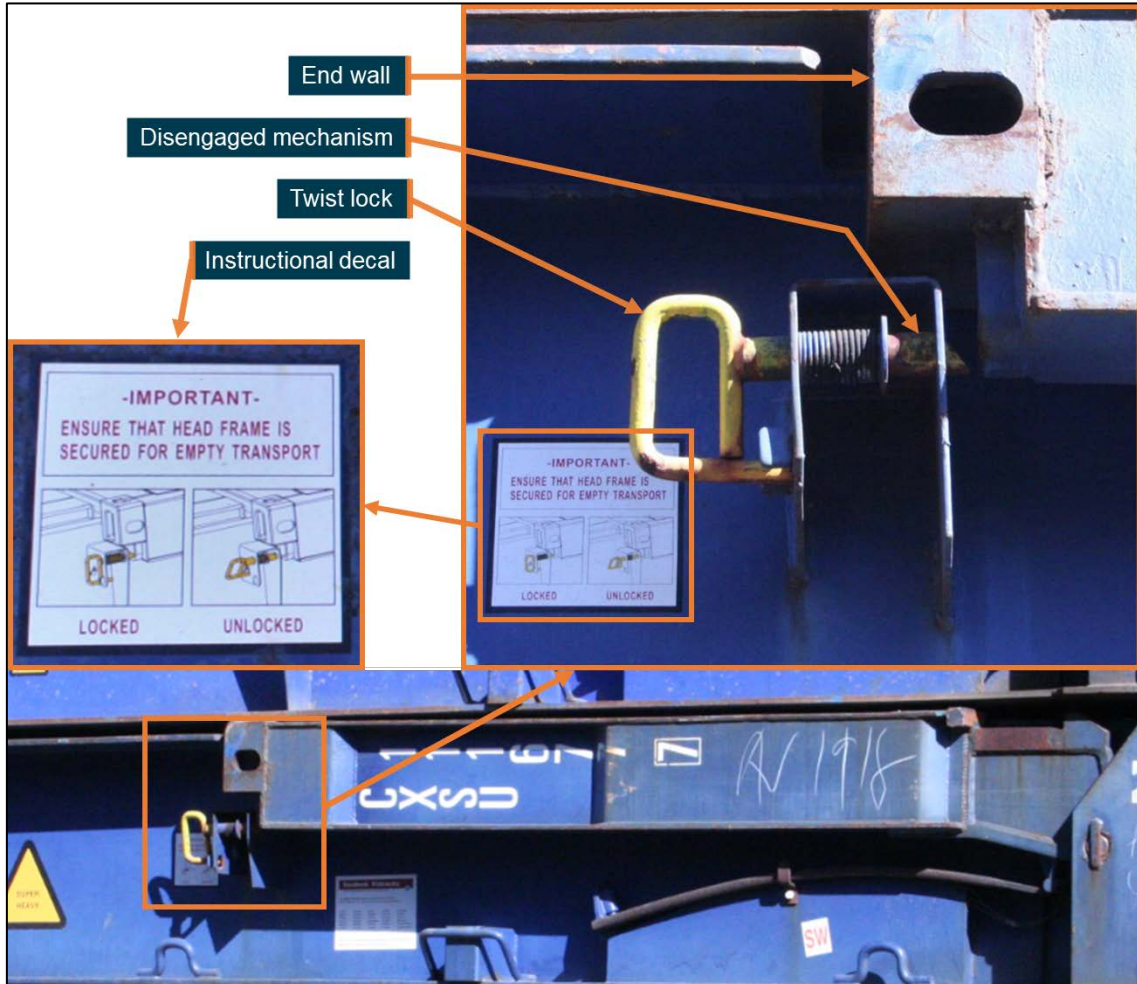
Figure 7: Twist lock mechanism for flat rack end wall

Flat racks with collapsible end walls were fitted with leaf spring or coil assistance for ease of raising. Once extended, two locking pins could be manually engaged to secure each end wall in the raised position. When collapsed, two twist locks (one on each side) could be manually engaged to secure each end wall in the down position (Figure 7). In addition, four spigots secured each flat rack to a flat rack below when nested, or to a flatbed rail wagon for transportation.

When travelling empty, Aurizon's document SAF/STD/022/SWK/BUS (*Loading and securing of freight manual*) required flat racks to have all four twist locks engaged. It also required an additional chain or two web straps over each end wall of the top nested flat rack. This ensured that the leaf spring / coil raise assist end walls could not extend upwards during transit.
