# Runway incursion involving Boeing 737 VH-XZM resulting in a rejected take-off involving Boeing 737 VH-VZL

Perth Airport, Western Australia, on 28 April 2018

**ATSB Transport Safety Report**  
Aviation Occurrence Investigation  
AO-2018-032  
Final – 1 October 2020

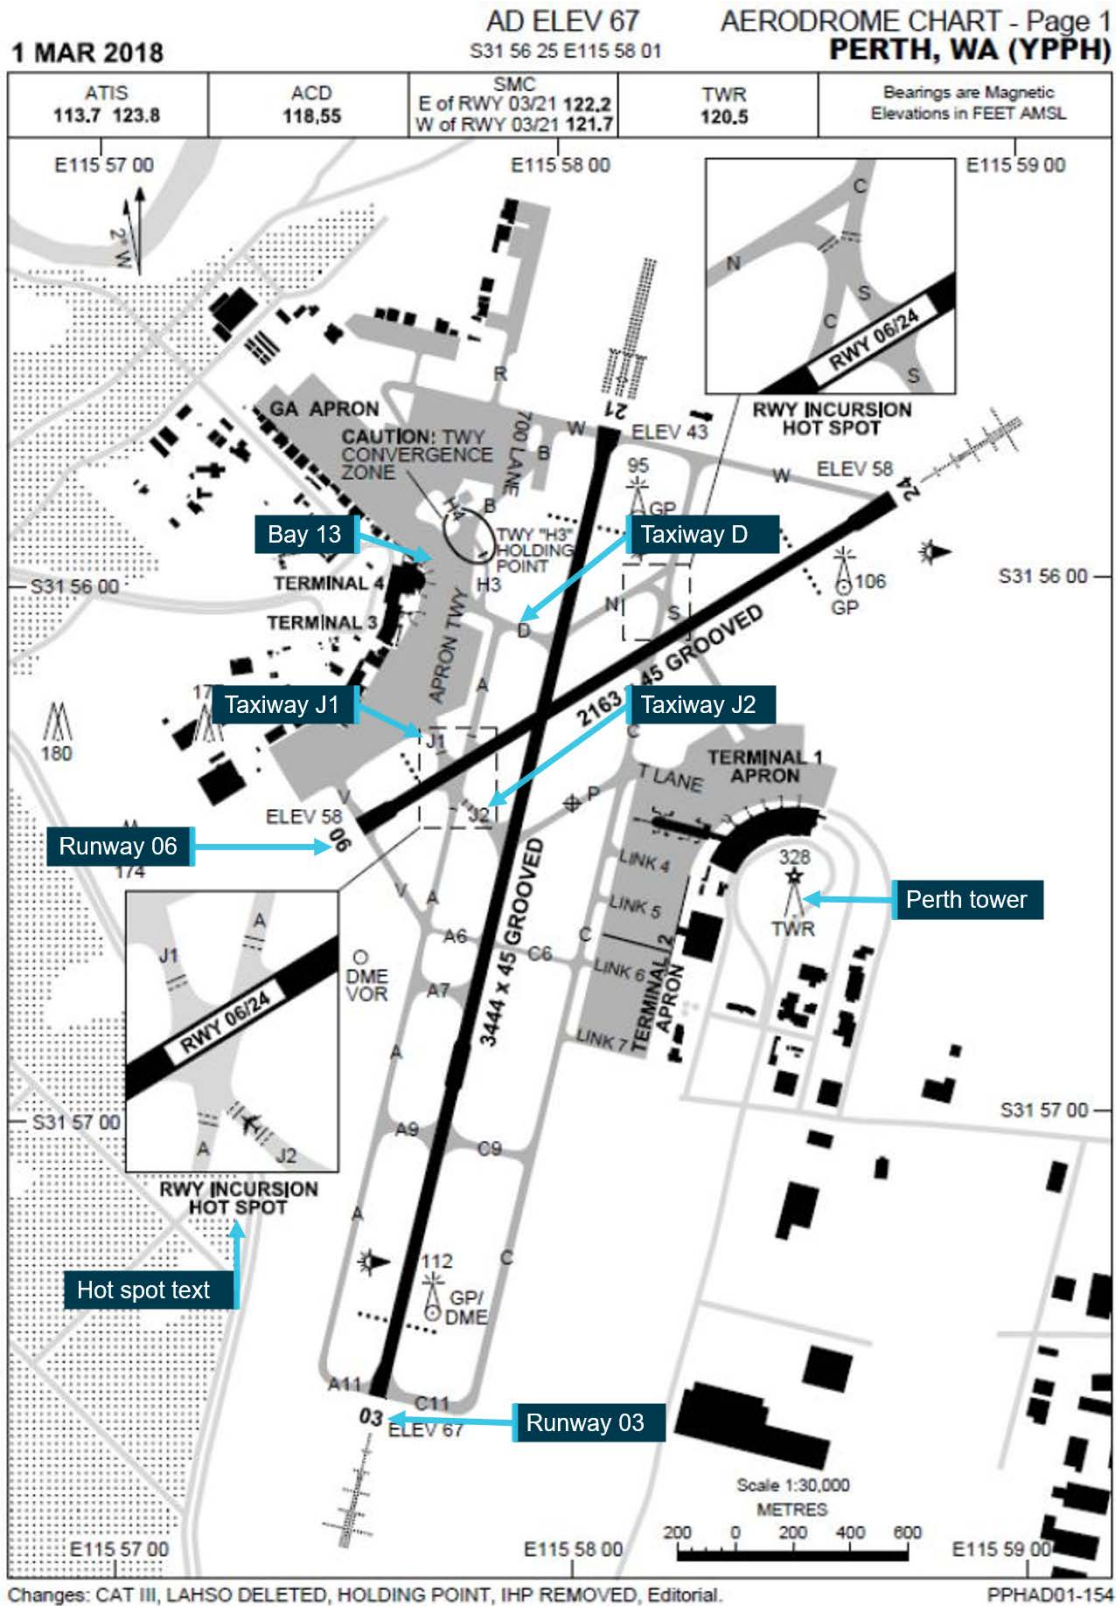
Figure 2: Perth aerodrome chart

Prior to descent, the FO conducted an approach briefing, noting taxiway J2 (Figure 2) was the preferred exit and they would need to get an ATC clearance to cross runway 06. The FO recalled being aware that taxiway J2 was a designated 'hot spot' but did not brief it as a hot spot or state that runway incursions happened there. The captain expressed a preference to request taxiway D, which was closer to the terminal building. At the completion of the briefing, the FO believed that the captain understood they would vacate runway 03 onto taxiway J2 unless they had a clearance to exit at taxiway D.

Perth Airport had two runways. The main runway was oriented 03/21 and the cross runway 06/24 (Figure 2). Both were 45 m wide and had a 150-m wide flight strip.<sup>10</sup>

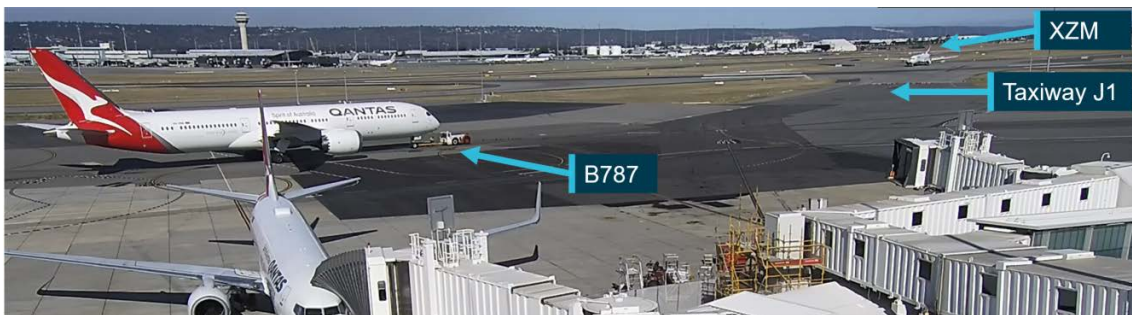
**Figure 5: Aircraft on the apron as XZM taxis toward runway 06**

As VH-XZM's flight crew had transferred to the SMC frequency at some point before 1442:11, they did not hear the stop instruction issued to VH-VZL and were unaware of that aircraft's presence and proximity. The captain continued taxiing towards runway 06 at about 10 kt, and then observed another aircraft (a Boeing 787) ahead on the apron (Figure 5). It had recently pushed back and was now blocking taxiway J1. The captain reported being distracted by the aircraft on the apron as it blocked their intended route on taxiway J1 and now required their aircraft to turn onto taxiway A.

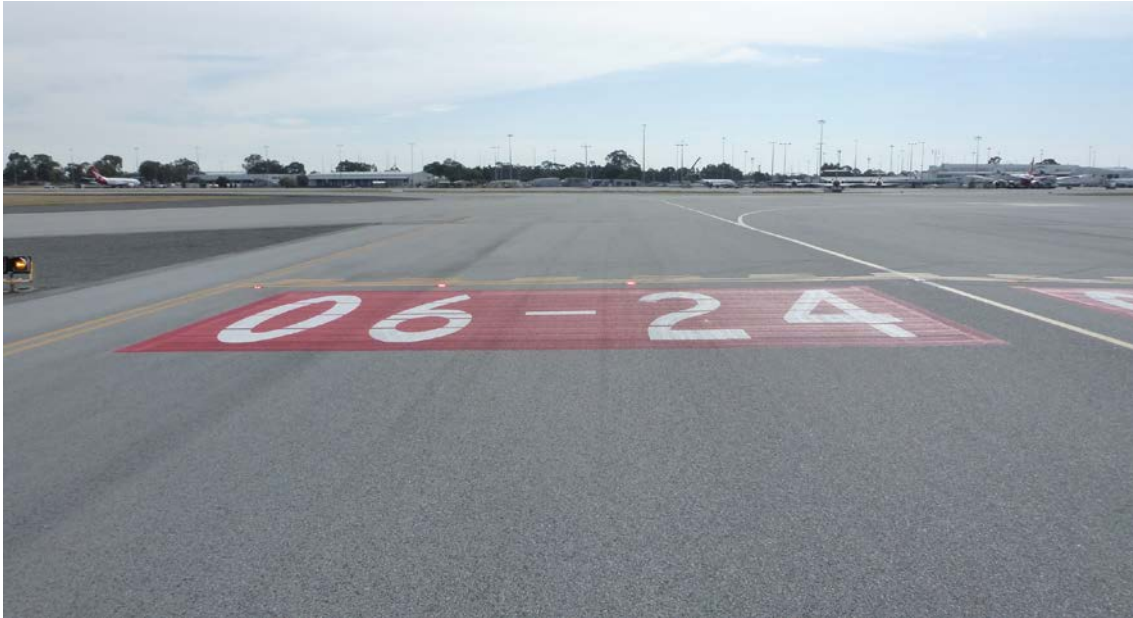
**Figure 8: Runway identifier (red and white markings) and stop bar (red lights) installed on taxiway J2**

Stop bars were intended to provide additional protection of runway/taxiway intersections to prevent runway incursions. They were a series of unidirectional lights at right angles to a taxiway centreline (Figure 8). The lights were spaced 3 m apart and located 0.3 m before a holding point. Stop bars showed red in the direction of approach to the stop bar. They were controlled by ATC

<sup>12</sup> Painted runway identifier markings (see Figure 8) were included in the ICAO standards and recommended practices but were not standard markings in the CASA MOS Part 139. The airport operator advised it sought CASA approval to install these markings as a runway incursion reduction measure.

and were independent of the runway guard lights. Additional raised lights at each end of the stop bar were not installed, nor were they required to be.<sup>14</sup>
