Derailment of freight train 6MP4

near Glenalta, South Australia on 21 April 2018

ATSB Transport Safety Report

RO-2018-009

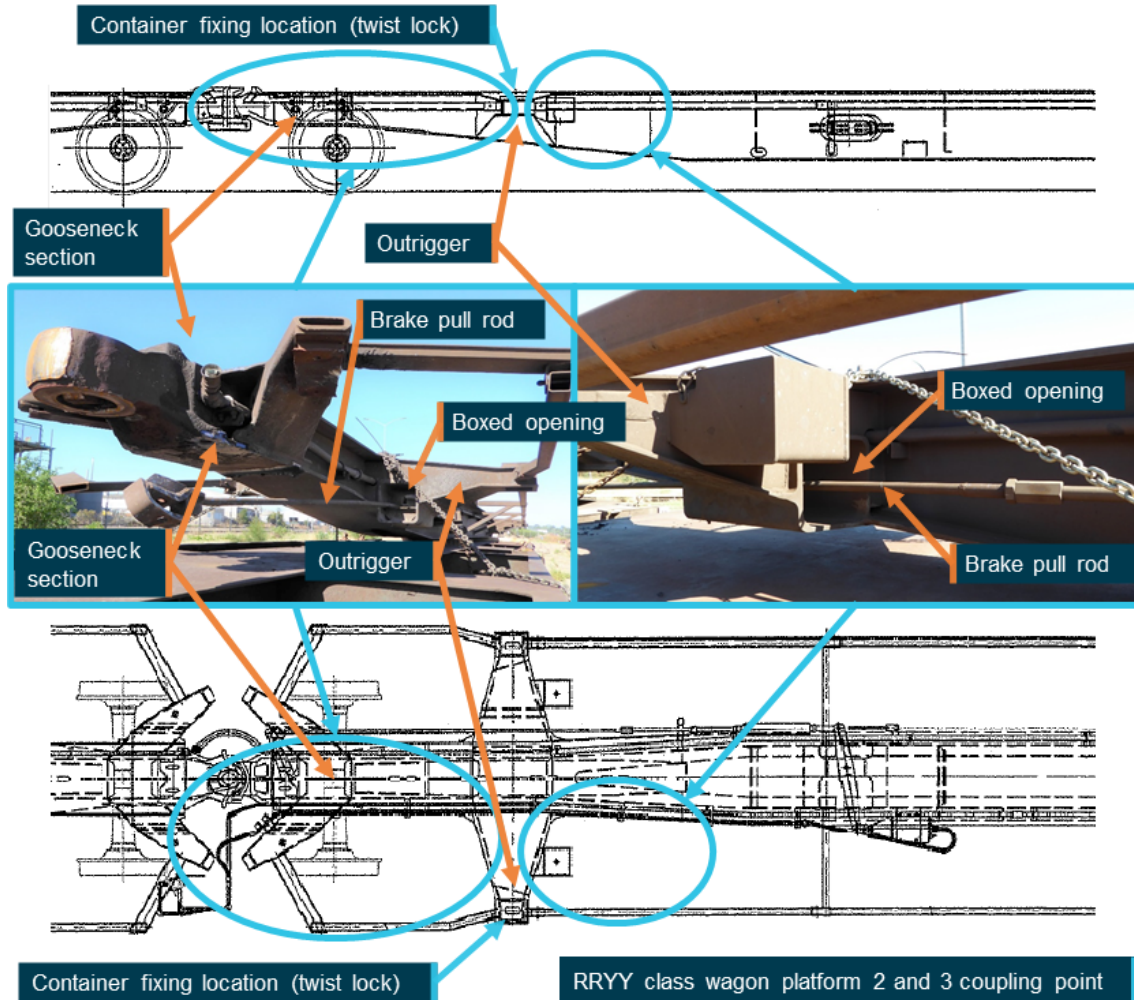
Figure 13: RRYY class wagon platform structure

For the RRY class wagon, the junction of the wagon's bottom centre sill plate with the container loading outrigger included a pull-rod boxed opening within the outrigger (Figure 13). The loading and unloading of containers on the RRY class wagons, accompanied by dynamic loading during normal operations, likely exposed this junction to cyclic strain and, as such, it would be susceptible to fatigue.
