Australian Transport Safety Bureau

Engine failure and forced landing involving Cessna 208B, VH-LNH

8 km north-west of Solomon Airport, Western Australia, 16 November 2016

ATSB Transport Safety Report
Aviation Occurrence Investigation
AO-2016-155
Final – 18 December 2020

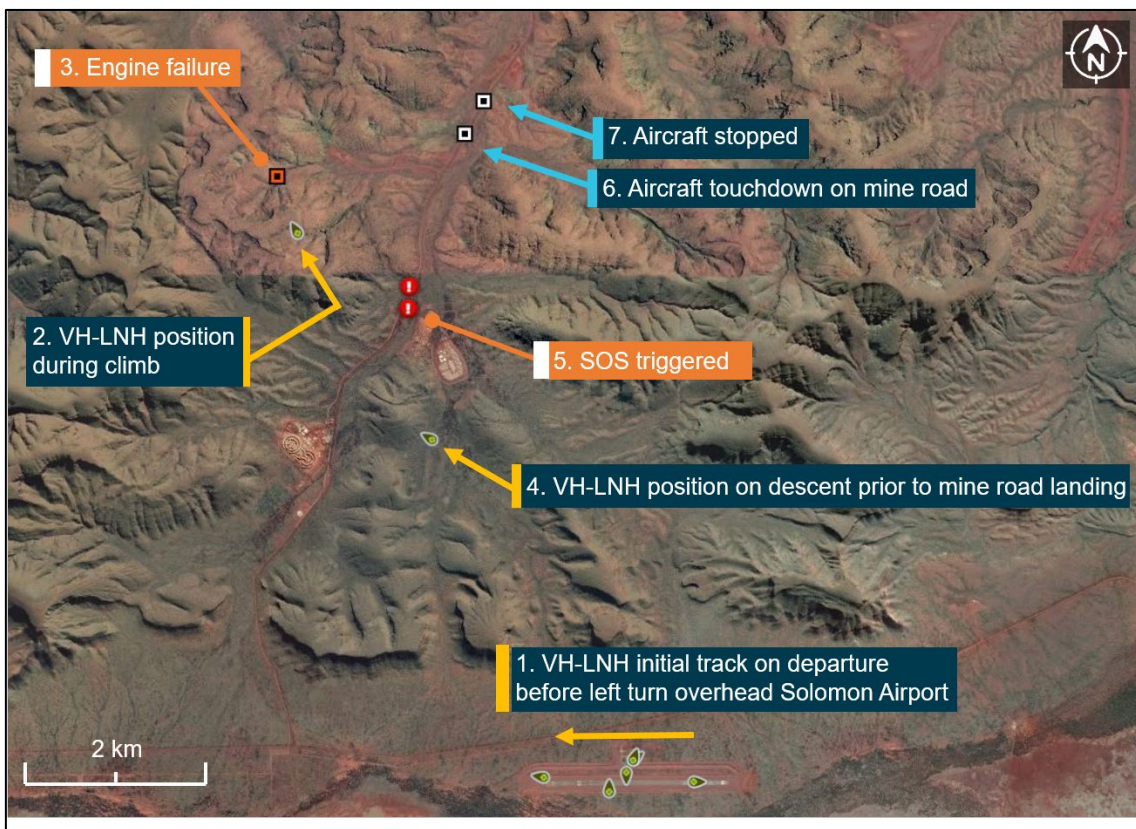
Figure 1: Sequence showing the aircraft departure from Solomon Airport, the pilot-reported location of the engine failure, and other events during the forced landing

A few minutes after taking off, while climbing through an altitude of approximately 4,600 ft above mean sea level (AMSL), the pilot-in-command reported hearing a 'loud bang' and 'grinding noise' from the engine followed by a decrease in aircraft performance. Blue and white smoke 'billowed' from the exhaust. Instruments within the cockpit showed rapidly reducing turbine speed and torque, indicating the aircraft's engine had failed. At this point, the aircraft was about 8 km from the departure airport.

The pilot-in-command manoeuvred the aircraft for an approach to the mine road from the south. Full flap was selected about 1,000 ft above the terrain. The flight crew observed three vehicles travelling along the mine road close to their intended landing area. Approximately 100 ft above the road surface, the pilot flashed the aircraft's landing lights to warn the driver of an approaching mine vehicle that the aircraft was preparing for an emergency landing. On touchdown, heavy braking was applied, slowing the aircraft until it came to a controlled stop about 150 m short of a bend in the road.

All passengers remained seated until instructed to exit the aircraft. The safety pilot moved the passengers away from the aircraft, while the pilot-in-command inspected for fire and other damage. Emergency responders from the airport arrived on scene shortly after. With the exception of some flat spots on the main gear tyres due to the emergency braking, the aircraft was undamaged. There were no injuries.

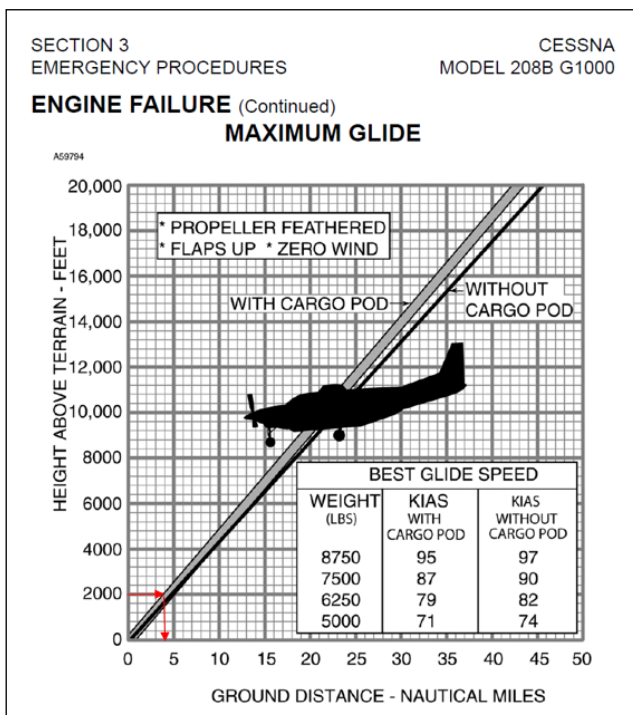
Figure 4: Cessna 208B maximum glide range with the glide distance highlighted

A graph of the Cessna 208B glide performance from the pilot operating manual is depicted at Figure 4. Calculations indicated that, based on the published data, it might have been possible for the aircraft to reach the airport in a glide on a direct track in nil wind conditions. However, given the south-westerly wind would have resulted in a headwind component, it was unlikely the aircraft would have reached the airport. The crew also considered that an attempt to reach the airport presented an unnecessary risk of a forced landing on unprepared ground in rugged terrain, and instead they opted to conduct the forced landing on the mine road.

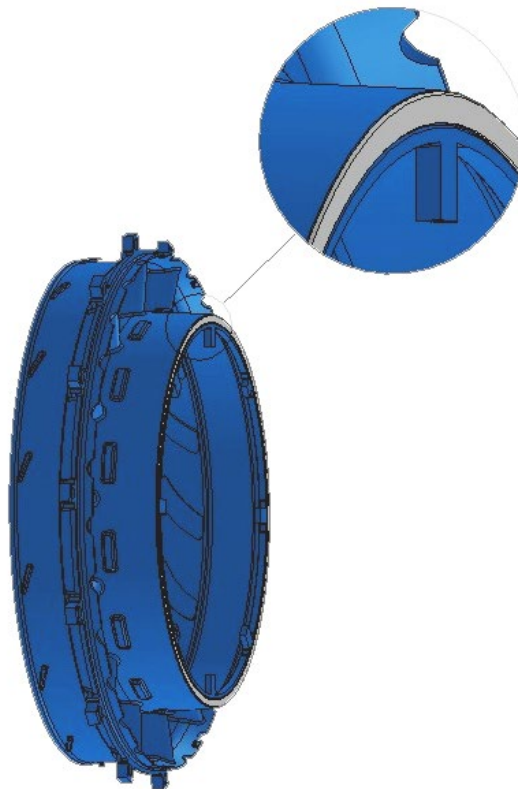
Figure 17: Illustration of a PT6A CT vane ring with the blue highlighted section displaying the approximate portion that is replaced as part of the STI 72-50-254 repair

In broad terms, the repair workflow involved replacing a major portion of the existing PWC vane ring through machining and welding processes. Following the machining processes, only a small portion of the original structure remained (Figure 17). A brazing process was then used to weld the remnant PWC part to the Southwest Turbine replacement casting, which contained the vanes and supporting structure. The CT vane was then finish machined and coated for oxidation resistance. The flow area was adjusted and the flow class recorded. The item then underwent non-destructive penetrant inspection for cracks in the structure, dimensional inspection and part marking (inscribing manufacturing identifiers), followed by a final inspection before being issued an authorised release certificate.

The remnant section of the original PWC part is identified as the grey ring located along the mounting flange. The ring of original material was kept while the remainder of the part discarded to be replaced as part of the STI 72-50-254 repair process.
Image source: Southwest Turbine Inc.
