# Level crossing collision between freight train 5KQ7 and a road coach

Norlane, Victoria, on 2 April 2020

**ATSB Transport Safety Report**

RO-2020-004

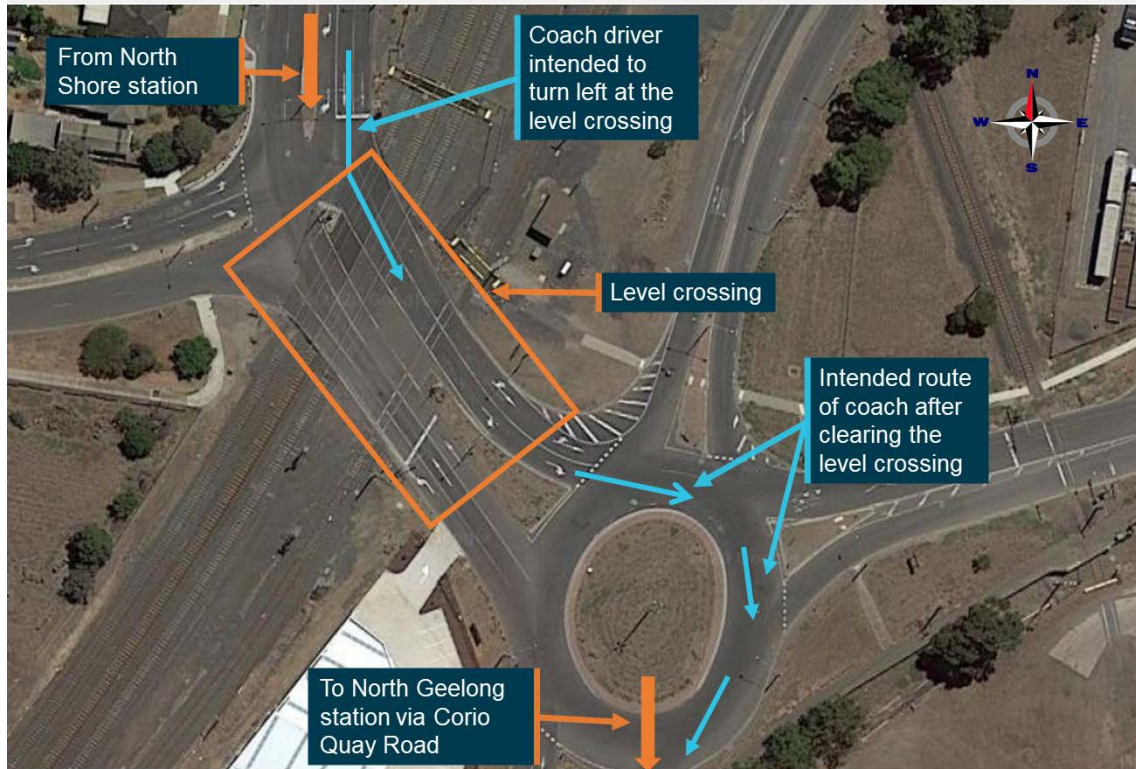
**Figure 3: Intended route of coach from Station Street towards North Geelong station**

No passengers boarded or alighted, and the coach departed the North Shore Station bus stop with the one passenger, bound for North Geelong Station. It was running to schedule. The coach was driven south in the bus lane, before moving across into the centre traffic lane of Station Street as it approached the level crossing at the junction with North Shore Road. The driver intended to travel in the right-hand lane across the level crossing and enter the roundabout on the right lane for an exit onto Corio Quay Road (Figure 3).

Panorama Coaches advised that the routes described in the manual were not mandatory. Drivers could use their discretion when selecting a particular route between stops. With reference to this occurrence, the training manual suggested that the coach take a right turn at the Station Street level crossing and travel along North Shore Road to North Geelong Station (Figure 11), whereas the trainer recommended turning left and crossing the tracks to follow Corio Quay Road (Figure 3) as it was shorter.

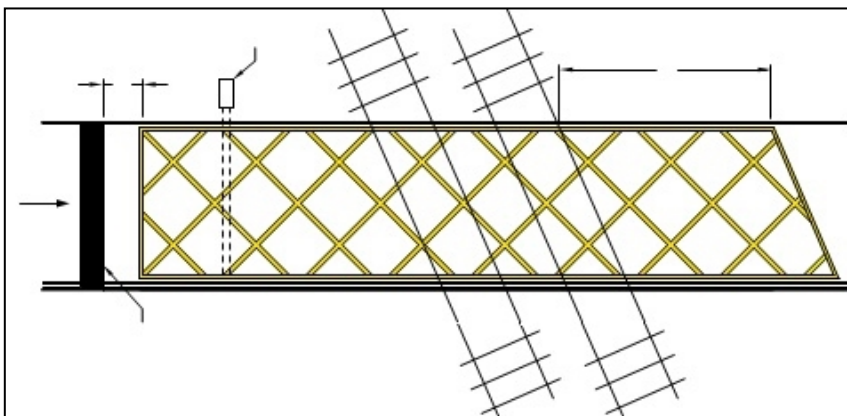
**Figure 9: Yellow box marking**

Post-occurrence inspection of the level crossing found that the stop line marking was approximately 1.8 metres from the boom barrier<sup>14</sup> when measured along the inner edge (or near side) of the street; AS1742.7 requires a minimum of 3 m.

Yellow box road markings are used to highlight the hazard zone of level crossings for road users. AS1742.7 specifies that they are only used to discourage traffic queuing on a crossing where the other treatments such as grade separation cannot be used.

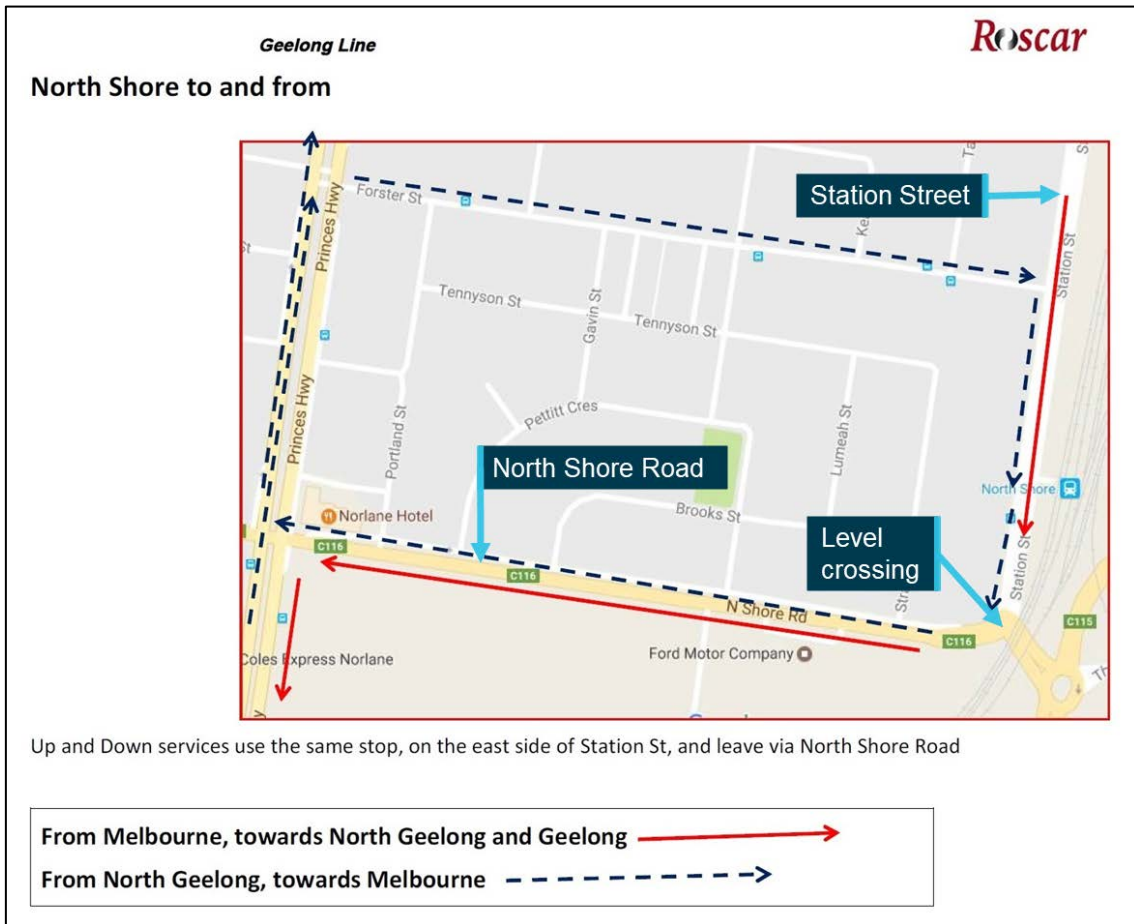
Figure 11: Training manual recommended route

As part of the training, the drivers were provided with a route map and taken on a route-familiarisation observer trip from Southern Cross to Waurn Ponds and back. On each leg they drove across Station Street level crossing, unimpeded. Whether trains would be operating at this time was not discussed in the training.
