# Landing gear damage involving Airbus A320, VH-VFL

Near Sydney, New South Wales, on 5 March 2020

**ATSB Transport Safety Report**

AO-2020-018

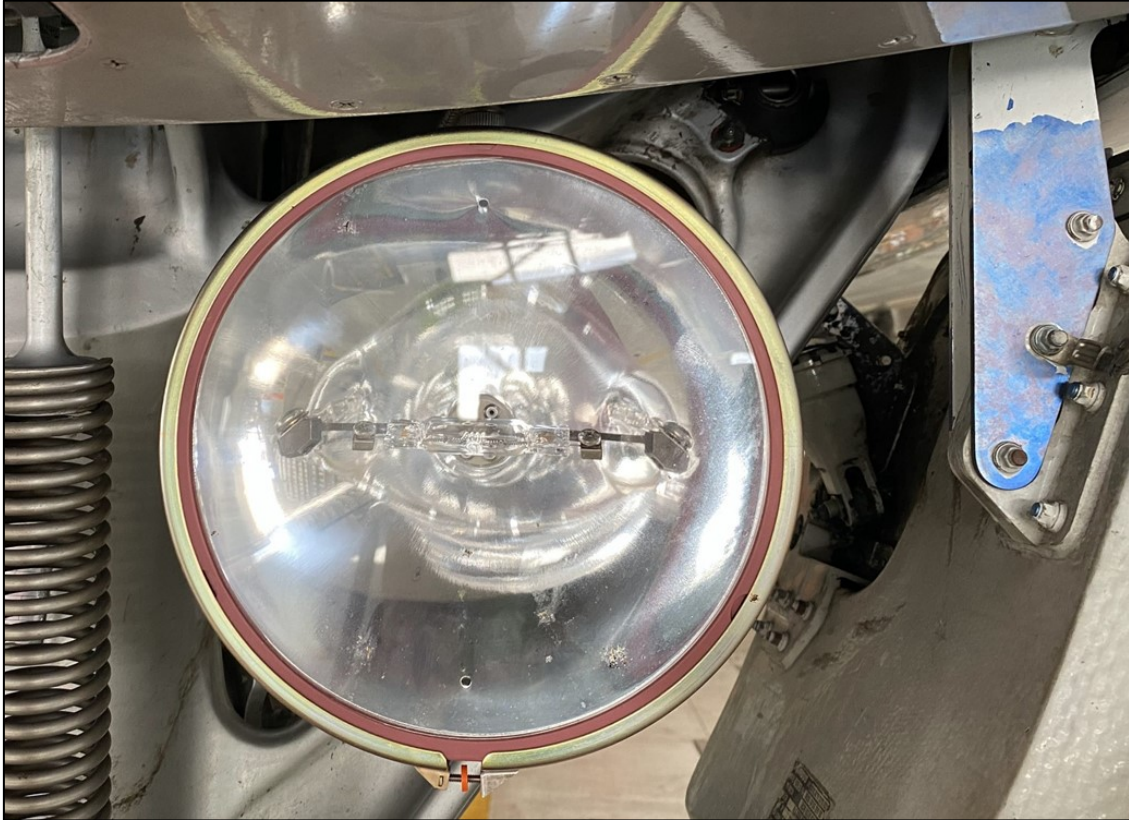
**Figure 3: Undamaged nose gear landing light with polycarbonate cover**

The nose gear landing light used a halogen lamp. The lens was made of glass, but it included a polycarbonate lens cover described by the manufacturer as very resistant to thermal shocks and mechanical impacts. An undamaged halogen lamp, installed on an A320, is shown in Figure 3.
