# Loss of control and collision with terrain involving Cessna 441, VH-XMJ

4 km west of Renmark Airport, South Australia on 30 May 2017

**ATSB Transport Safety Report**  
Aviation Occurrence Investigation  
AO-2017-057  
Final – 30 April 2020

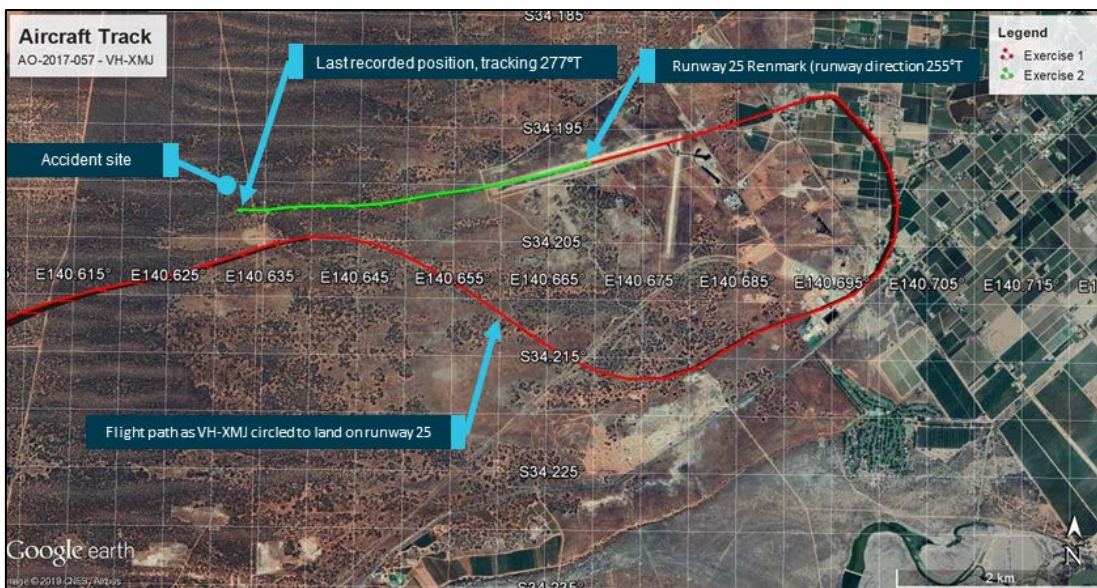
**Figure 1: Position information of VH-XMJ as the aircraft circled and landed on runway 25 (depicted in red), before backtracking and departing (depicted in green).**

The aircraft maintained the runway heading until reaching a height of between 300-400 ft above the ground (see the section titled *Recorded flight data*). At that point the aircraft began veering to the right of the extended runway centreline (Figures 1 and 15). The aircraft continued to climb to about 600 ft above the ground (700 ft altitude), and held this height for about 30 seconds, followed by a descent to about 500 ft (Figures 2 and 13). The information ceased 5 seconds later, which was about 60 seconds after take-off.

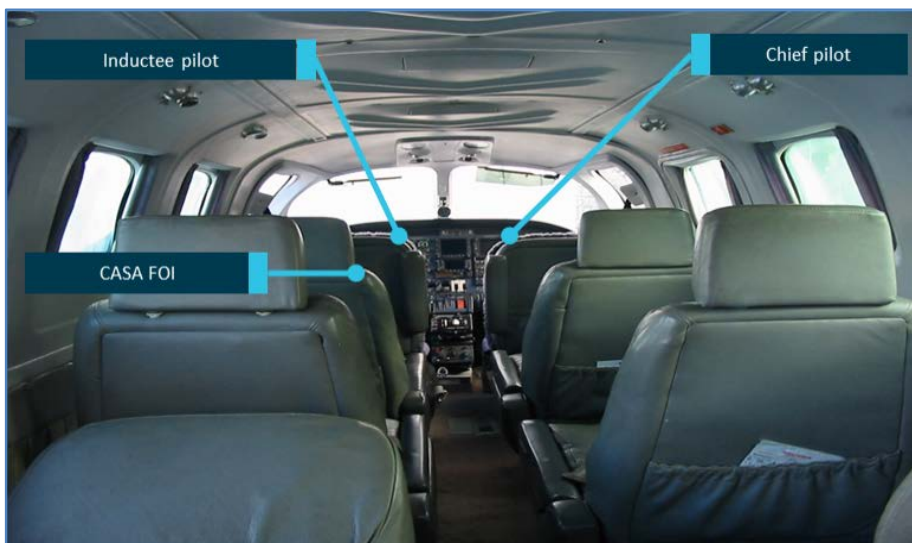
**Figure 18: Exemplar Cessna 441 in a similar configuration to the accident aircraft**

There is no jump seat<sup>15</sup> in a Cessna 441 aircraft, so the CASA FOI sat in the first row passenger seat, on the left side of the aircraft, behind the inductee pilot (Figure 18). From the seated position, he should have had some visibility of the chief pilot, and the controls and instruments, but was not likely to be able to read the instruments precisely.
