Landing gear failures involving a Gippsland Aeronautics GA8 Airvan, VH-BFS

Fraser Island, Queensland, 24 August 2019 and 31 October 2019

ATSB Transport Safety Report

AO-2019-045

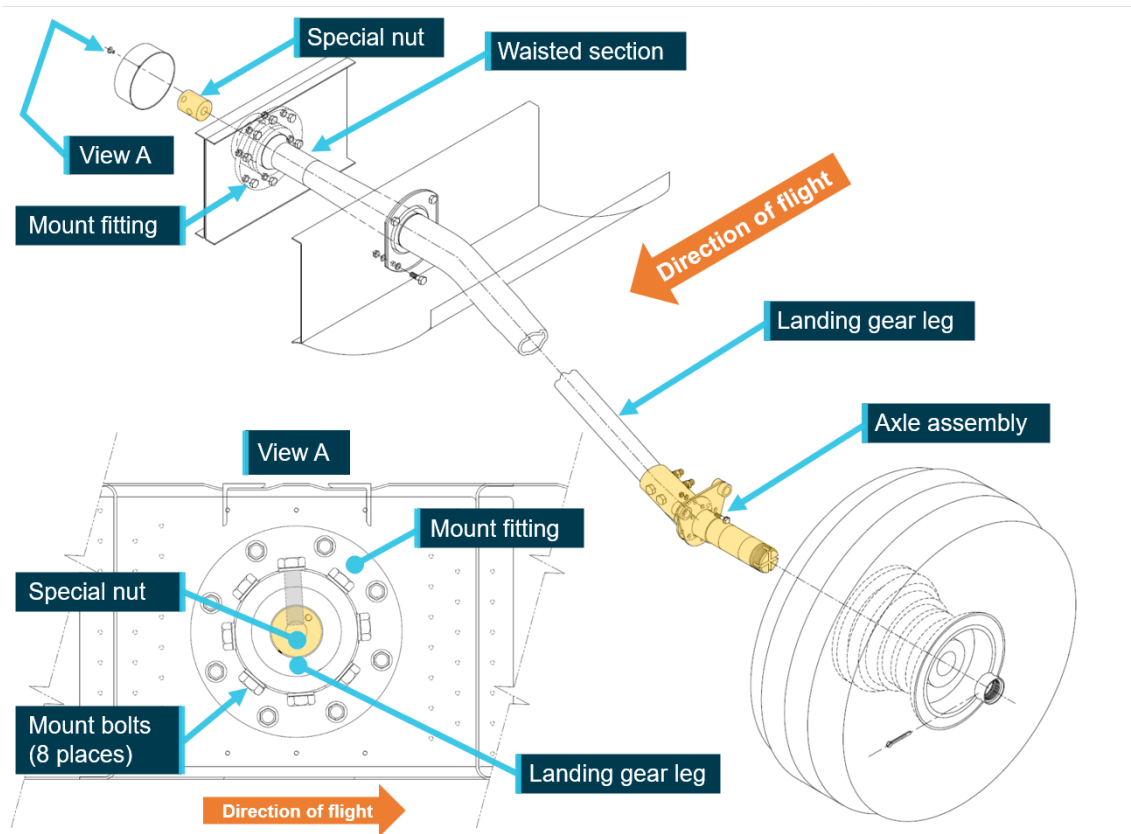
Figure 4: GA8 main landing gear assembly showing the location of the mount fitting, mount bolts and axle

In-service experience showed that the GA8 landing gear mount bolts would loosen slightly due to the vertical and ratcheting forces on the main landing gear during take-off and landing. Access to the upper mounting bolts for removal, installation and safety wiring was limited by their proximity to the underside of the cabin floor (Figure 4).

Soon after the GA8 entered service, the manufacturer made a design change so that a bolt retaining cap was installed over the mount fitting that covered the eight bolt heads. When installed, the cap ensured that the bolts could not wind out of the special nut and the bolt heads no longer needed to be safety wired. The design change was incorporated on the production line and could be incorporated as a non-mandatory modification to aircraft in service.

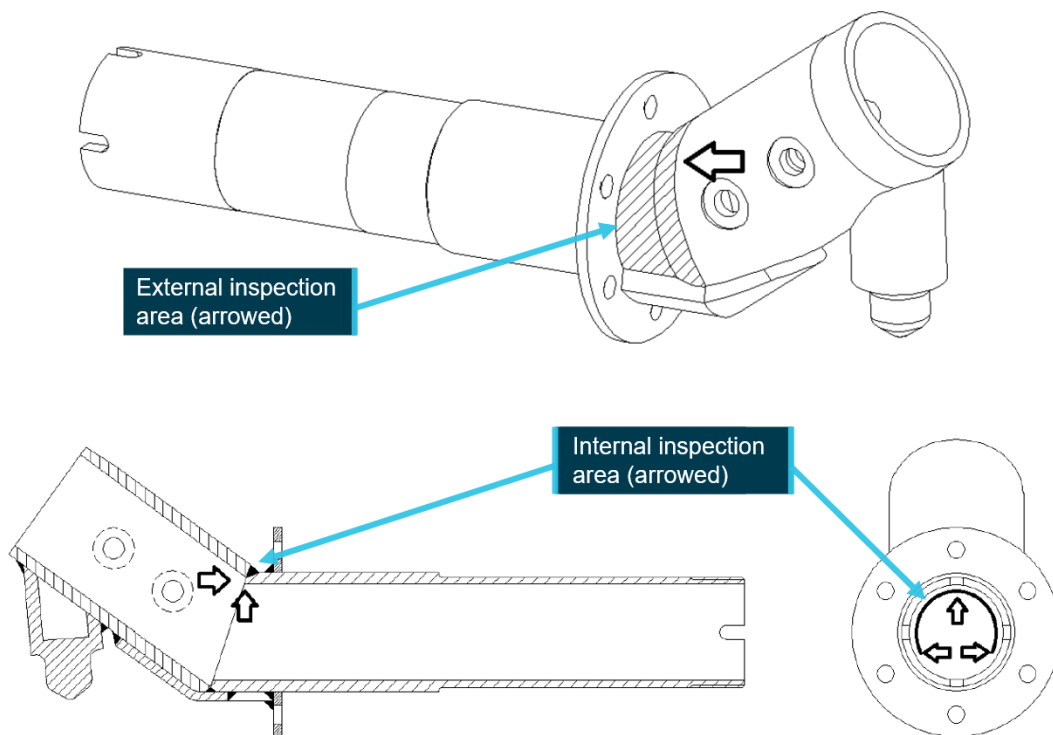
Figure 5: GA8 main landing gear axle assembly inspection areas

In response to a GA8 operator sustaining an in-service failure from fatigue cracking of a main landing gear axle, Gippsland Aeronautics issued service bulletin SB-GA8-2016-169 (*Inspection of the Main Undercarriage Axle Assembly*) in 2016. The associated issue was that cracks had been found to form on the upper side of the axle on the inboard side of the brake torque plate (Figure 5).

As a result of the initial service bulletin inspections identifying cracks in some instances, the service bulletin was re-issued to make it mandatory.⁴ The service bulletin was issued for a third time on 11 November 2016 to give operators time to comply with the non-destructive inspection requirements. That inspection was to be conducted no later than 11 February 2017 if the axle had accumulated 2,000 hours TTIS.
